Research Report No 50

DAMAGE STATISTICS OF ICE-STRENGTHENED SHIPS IN THE BALTIC SEA 1984 - 1987

**HELSINKI UNIVERSITY OF TECHNOLOGY
Laboratory of Naval Architecture
and Marine Engineering**

Espoo, April 1991

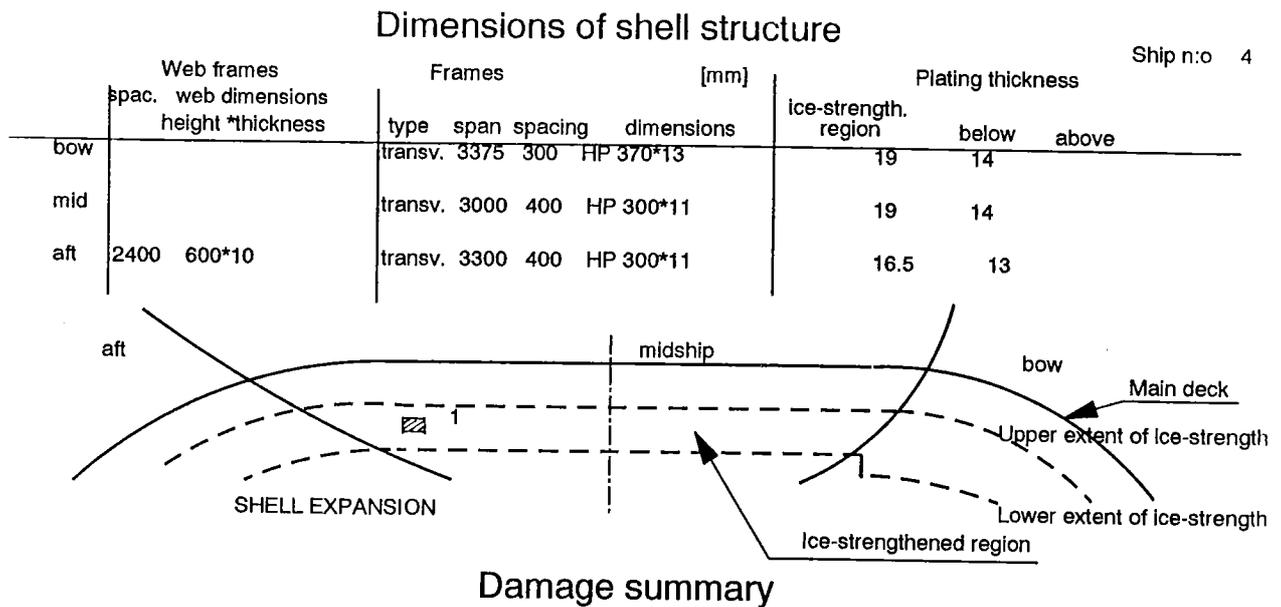
Only one small damage was observed onboard ship no. 4, Fig. 7 illustrates the damage together with the scantlings of the ship. The maximum deflection of the frame was about 10 mm and plating 20 mm. The exact date and position during the winter 1985 when the damage occurred is not known.

Fig. 7. The dimensions of the shell structure and location of the damage found from ship no. 4.

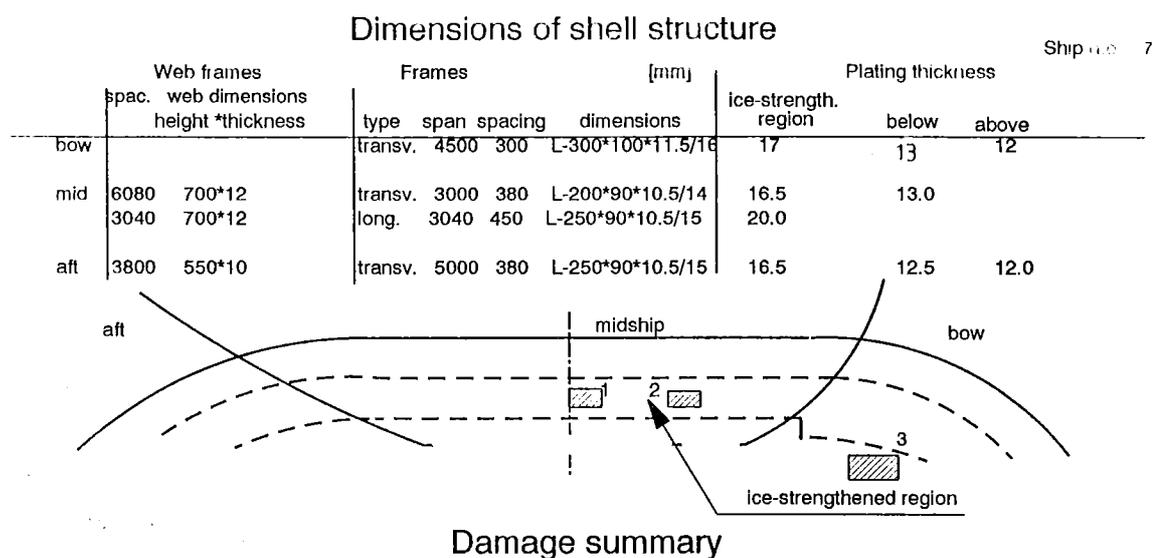
This ship had a number of small damages on the plating and two permanent deflections of transverse frames as is shown in Figs 8-9. The ship has both transverse and longitudinal framing system on the ice-strengthened region so that the longitudinal framing forms the upper part extending up to the level of the main deck. The permanent deflections of the plating are both on the transversely and

longitudinally framed area. The damages have developed during the long ice navigation history of the ship, which started during the year 1972. The bigger damages have most probably occurred on the 2nd of April 1982, when the ship was under heavy compression of ice about 12 miles southwest from the Kemi lighthouse. The draught of the ship was then 4.5 m at the bow and 5.95 m aft. Wind speed was about 15 m/s from the SW. Appendix 1/1 contains further details of the ice conditions.

Fig. 8. Scantlings of ship n:o 7 and ice damages found on the shell structures.

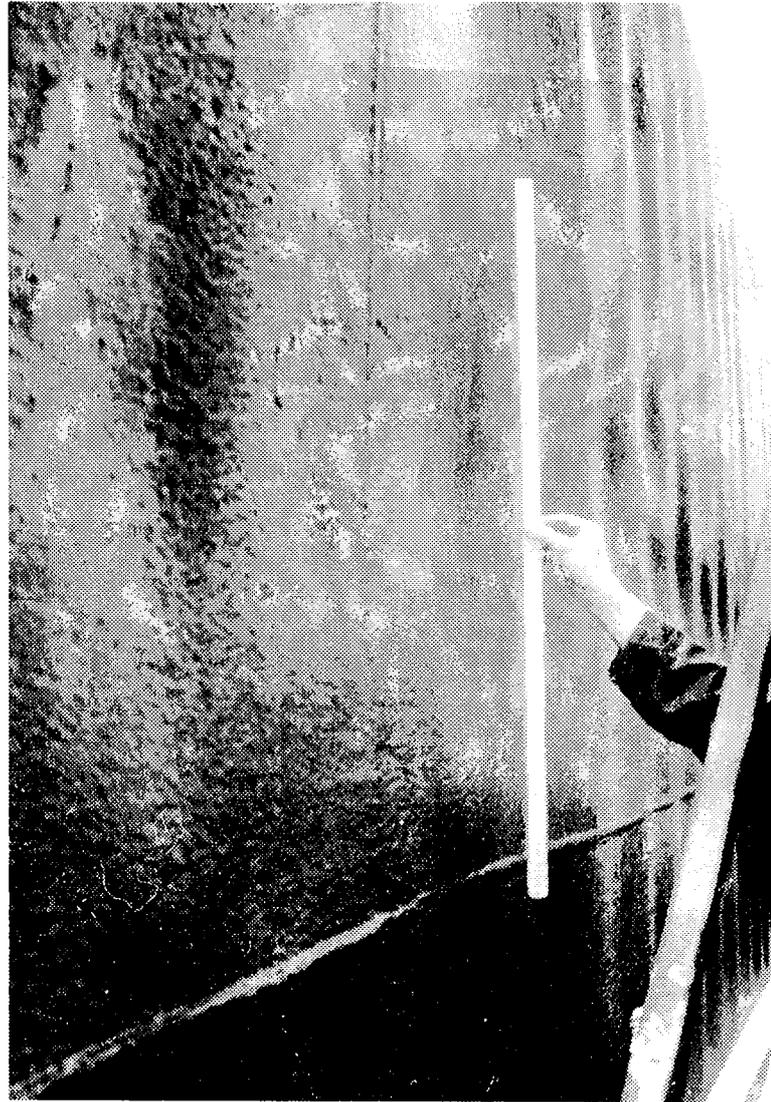
Fig. 9. Ice damage on the area 2 (fr. 90) of ship no. 7.

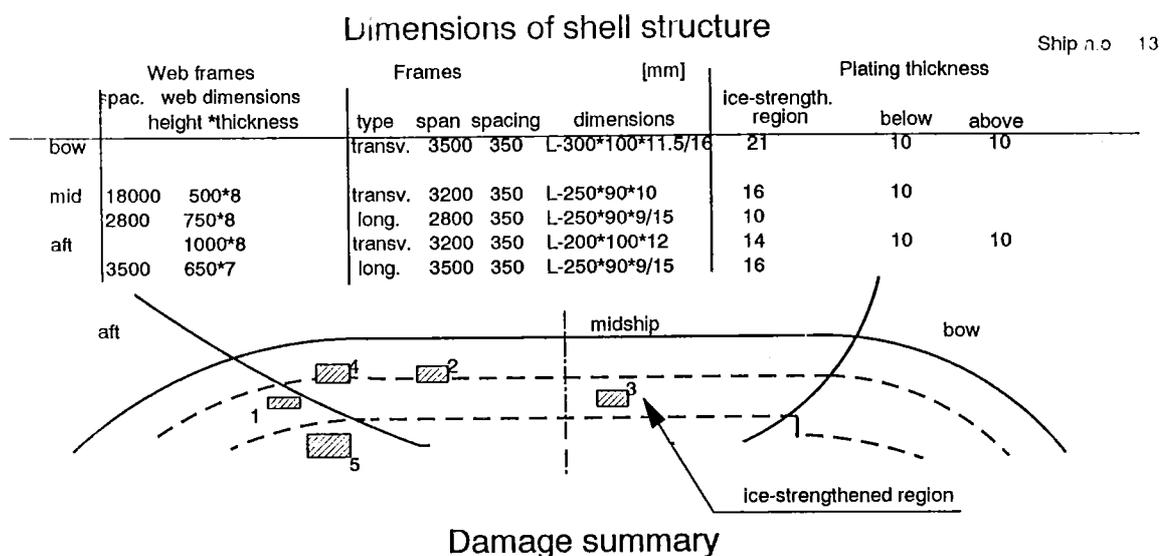
Ship no. 13 has also both transverse and longitudinal frames on the ice-strengthened region as shown in Fig. 10, along with the damages. Two of the longer damages are due to the buckling of the web of the webframe in the longitudinally framed area, see Fig. 11 and one is due to shear yielding at the lower end of a transverse frame. The damages on the webframes occurred on the 27th of March 1985, when the ship was in compressive ice about 40 miles south of the Nordvalen lighthouse with a draught of 8.1 m

Fig. 10. Dimensions of the shell structure and summary of ice damages on the ship no. 13.

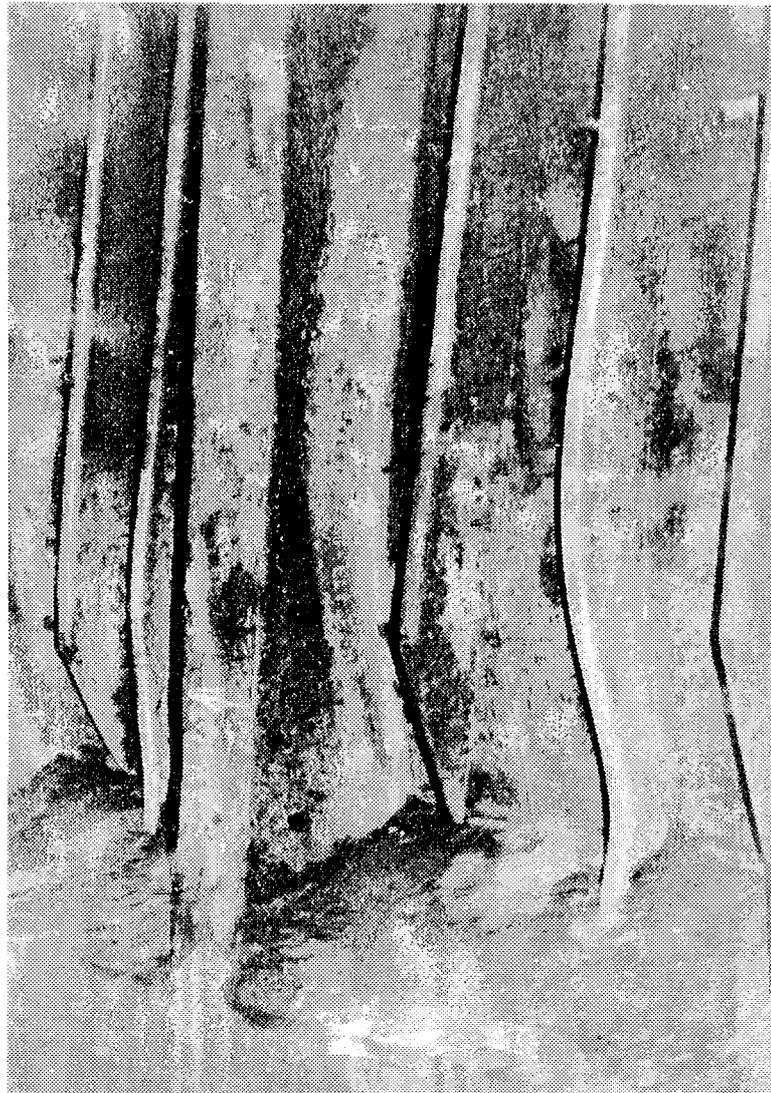
Fig. 13b. The damage at the area 1 of ship n:o 14.

The damages at the lower end of the ice-strengthened region and below it are due to the fact that the ballast capacity of the ship n:o 14 is too small during winter time, when the wing tanks cannot be used. The ballast draught is then only 4.2 m, leaving unstrengthened structure exposed to ice loads.

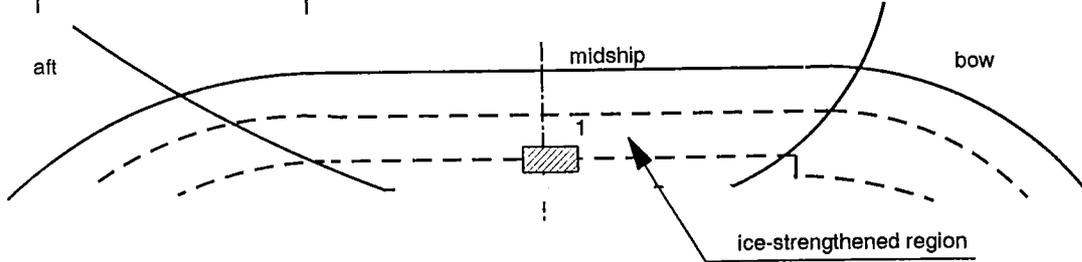
One damage at midship was found on ship no. 16, see Figs 14-15. The damage includes permanent deflection of the plating, frames and webframes. The deflections of the plating and frames are due to exceeding the yield stress in bending. The damage on the webframes is due to the buckling of the web plating. The ship made only one voyage during the winter 1986 and the damage most probably occurred in the beginning of March outside Rauma.

Fig. 14 The dimensions of the shell structure and description of the damage on ship no. 16.

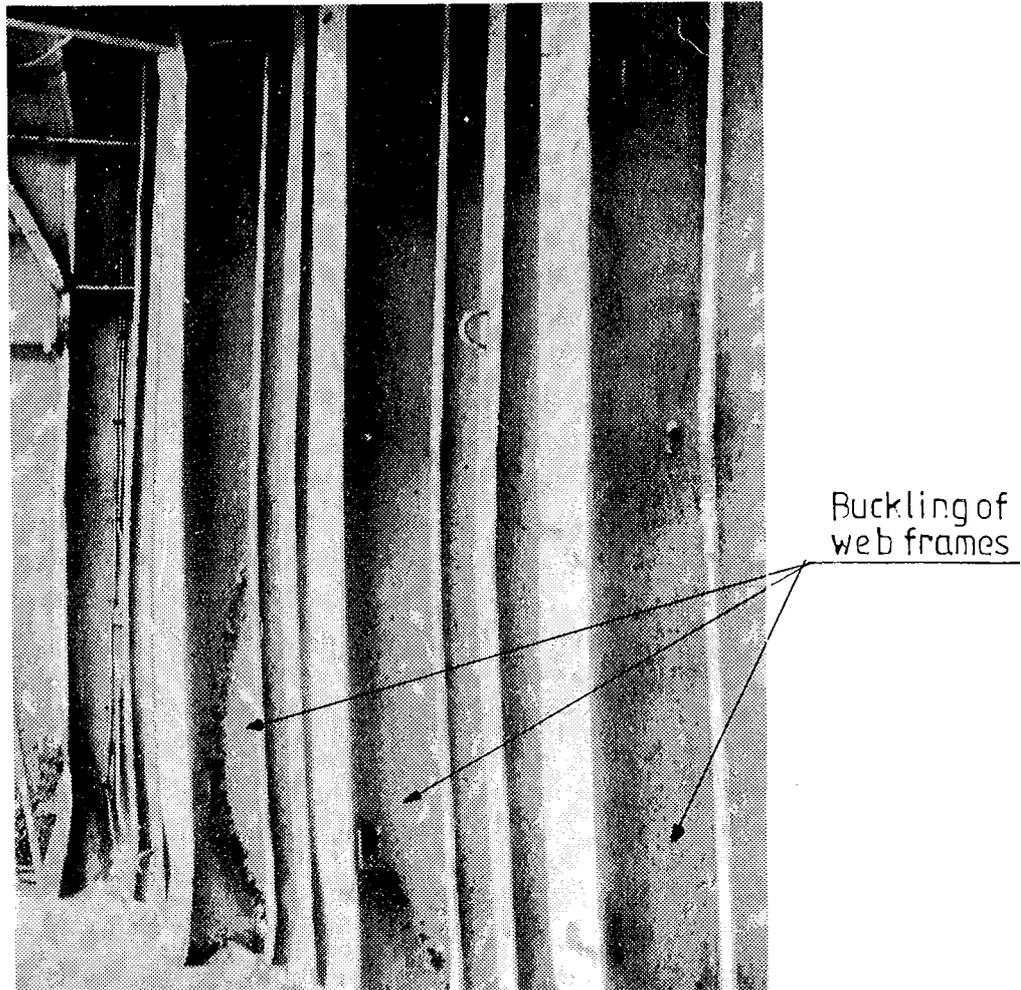
Fig. 15. The damage at midship of ship no. 16.

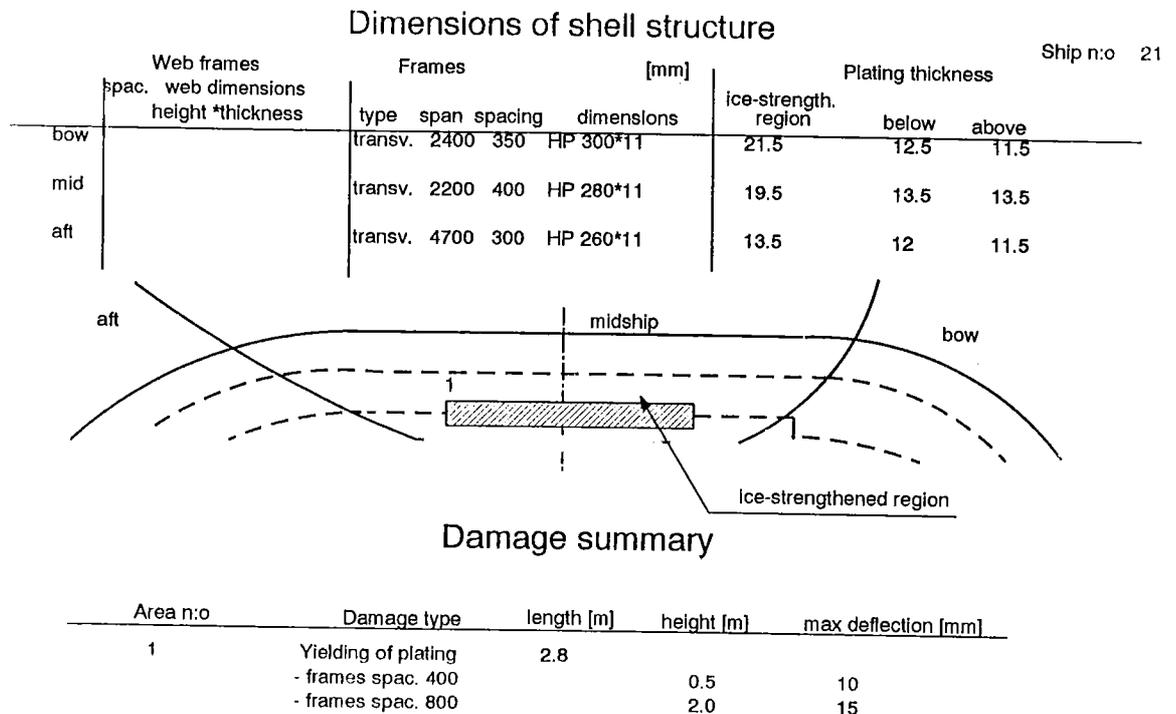
Ship no. 21 has some minor damages on the shell plating below the ice-strengthened region at midships as shown in Fig. 16. The damages were observed during the docking in summer 1986.

Fig. 16. Dimensions of the shell structure and permanent deflections on the shell plating of ship no. 21.

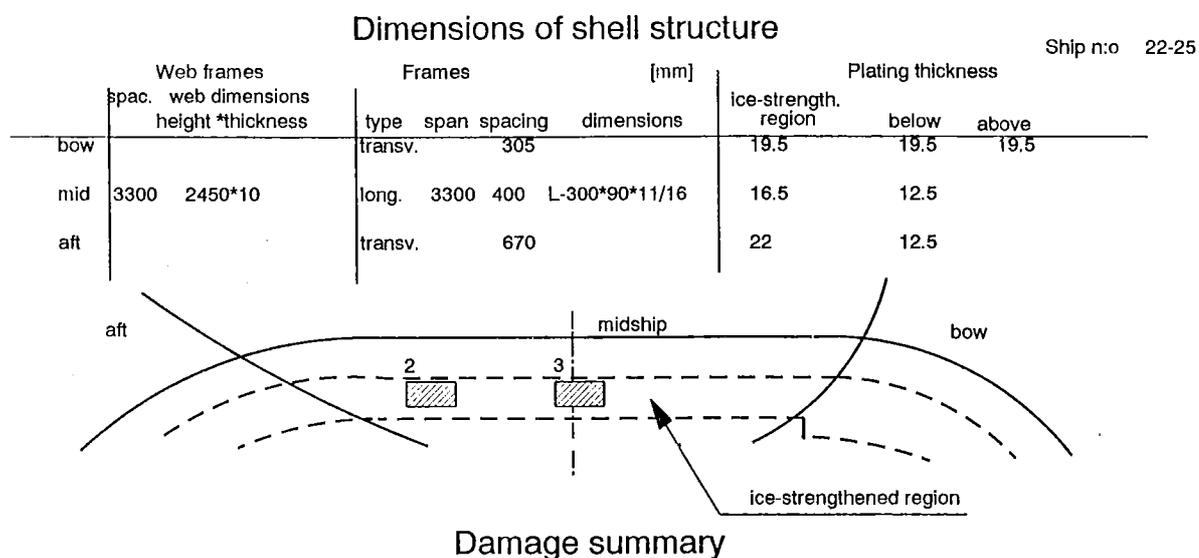
Area n:o	Damage type	length [m]	height [m]	max deflection [mm]
Longitudinally framed midship	Yielding of plating			30
2	Buckling of web frames Yielding of long. frames	7.5	2.8	50
3	..	6.7	2.0	30

Fig. 17. Dimensions of shell structure and summary of damages onboard ships no. 22-25.

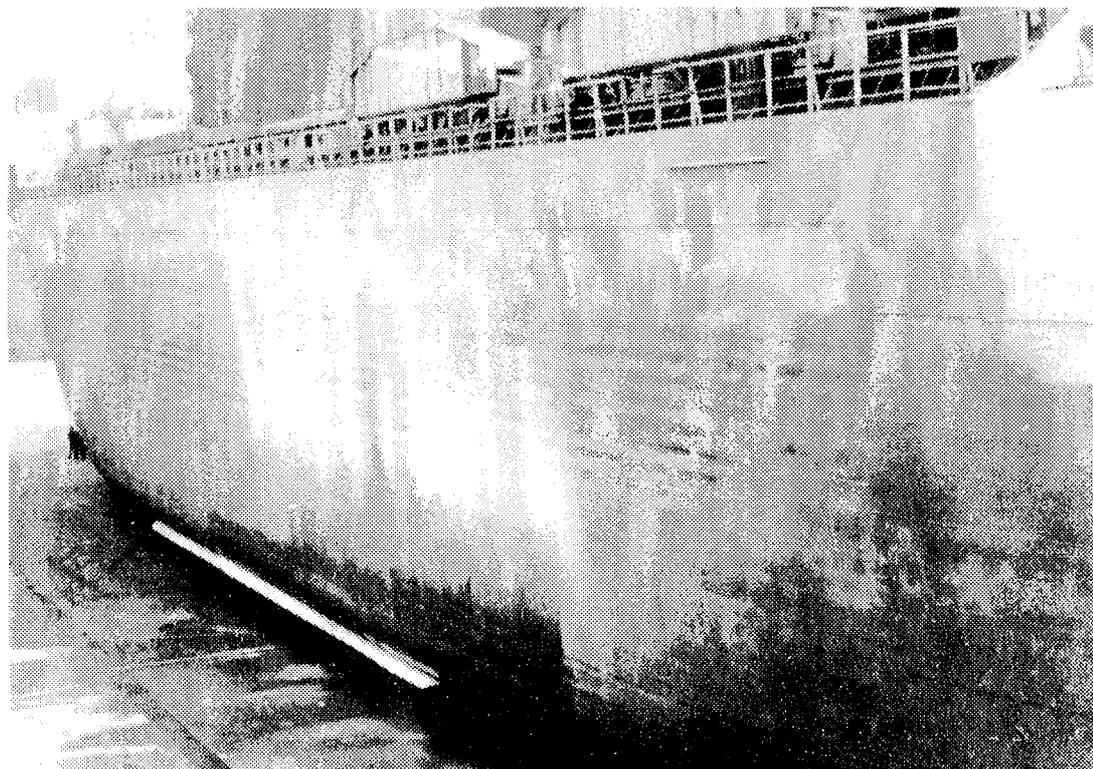
Fig. 18. General view of damages on board ship no. 24.

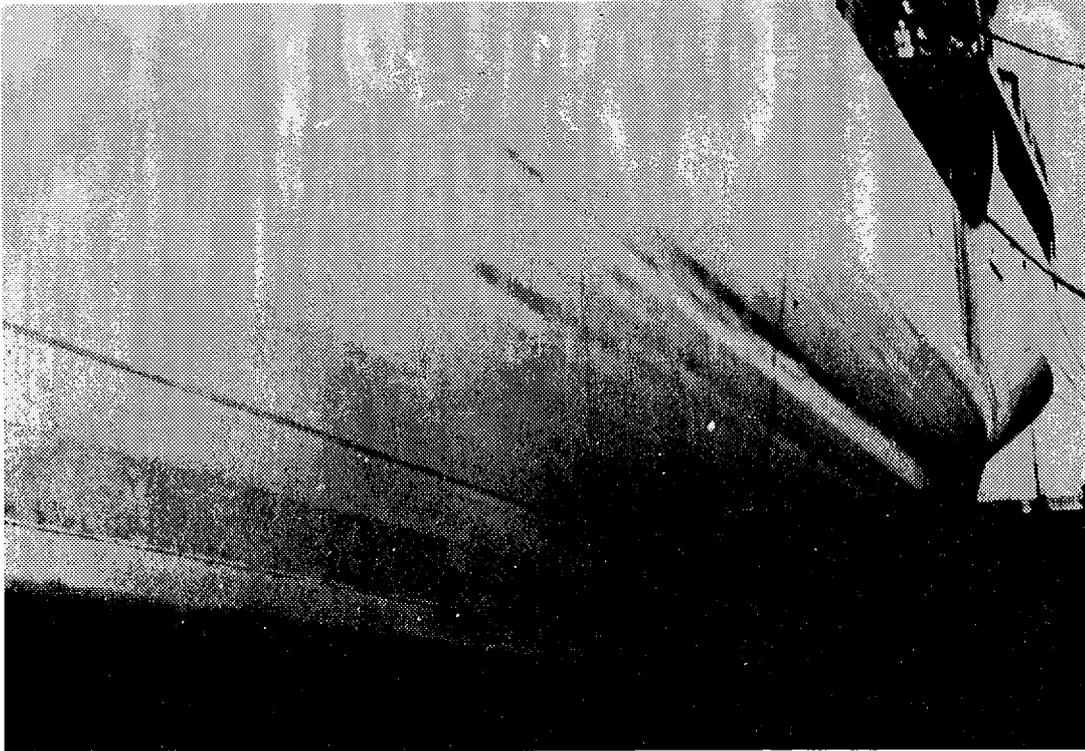
deflections on the longitudinally framed plating and Fig. 19 describes in more detail the damages of area 2 observed on board ship no. 23 during summer 1986.

Fig. 19a. General view of the damage on area 2 onboard ship no. 23.

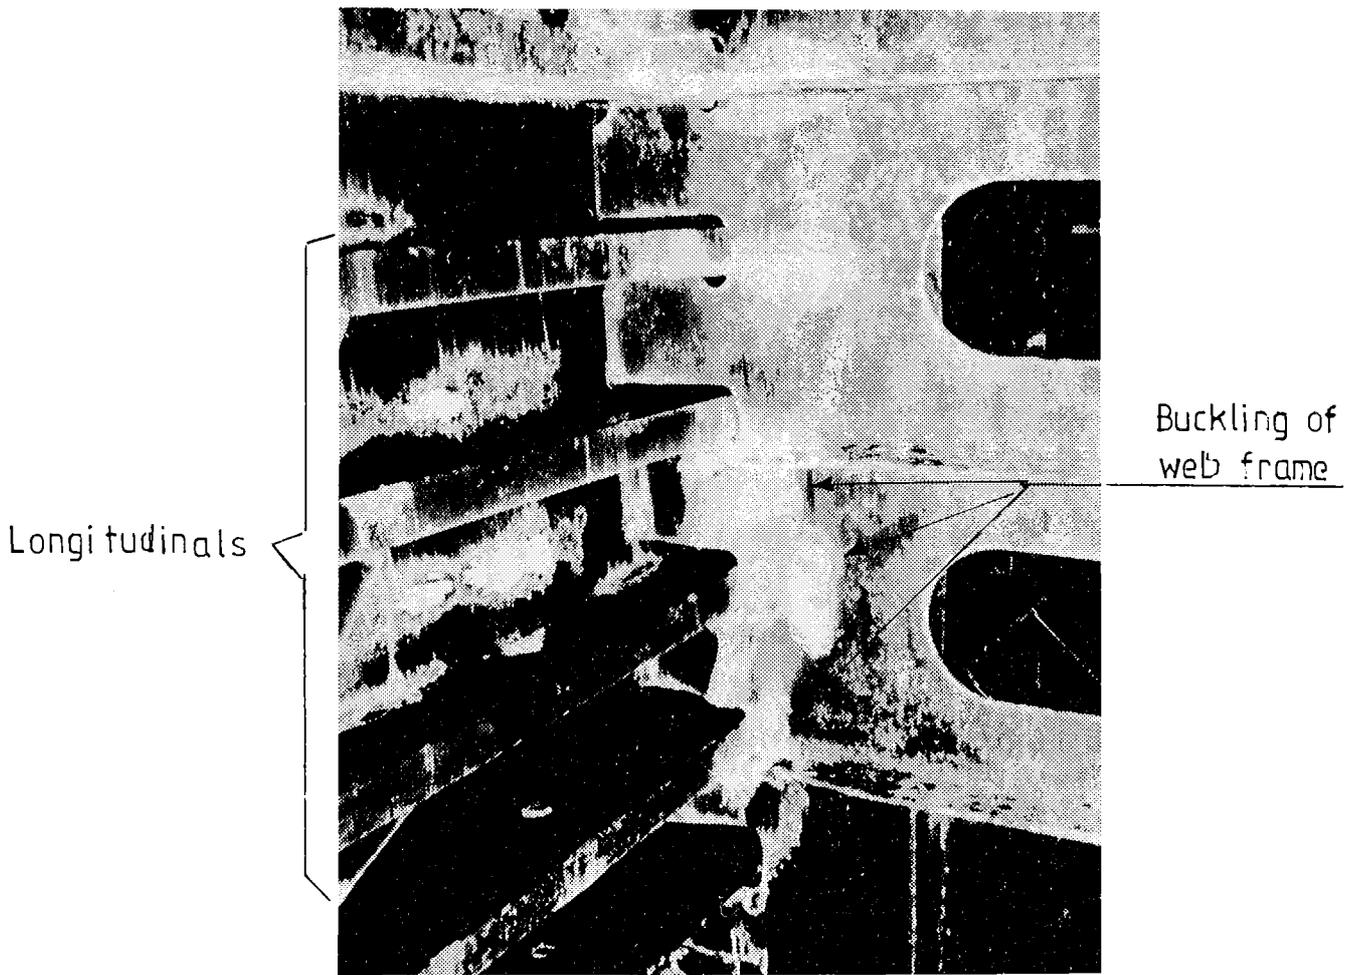
Fig. 19b. Inside view of the web frame buckling on area 2 of ship n:o 23.

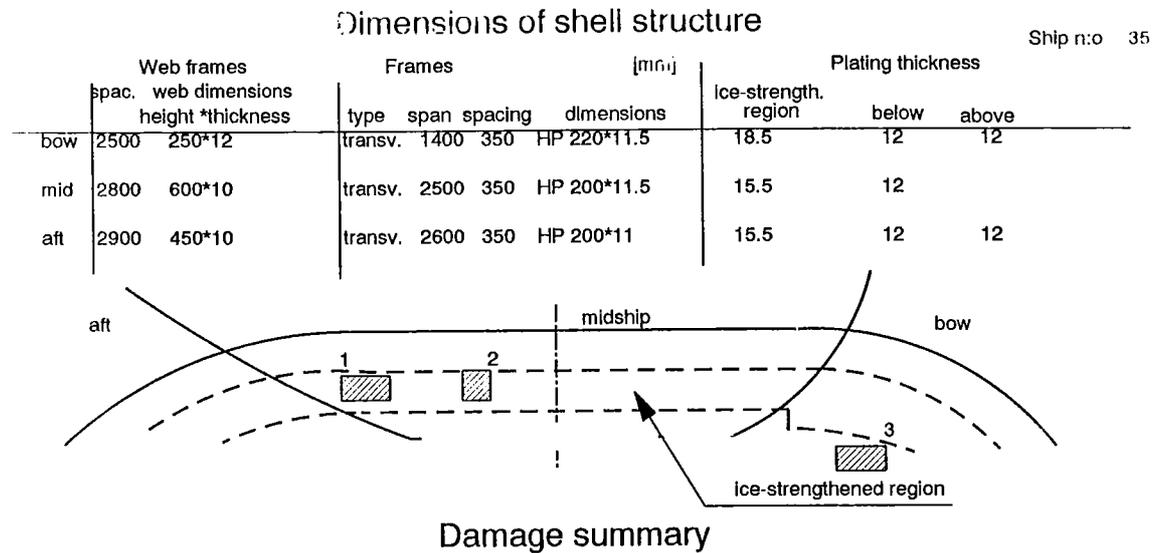
Fig. 21. Dimensions of shell structure and summary of damages onboard ship no. 35.

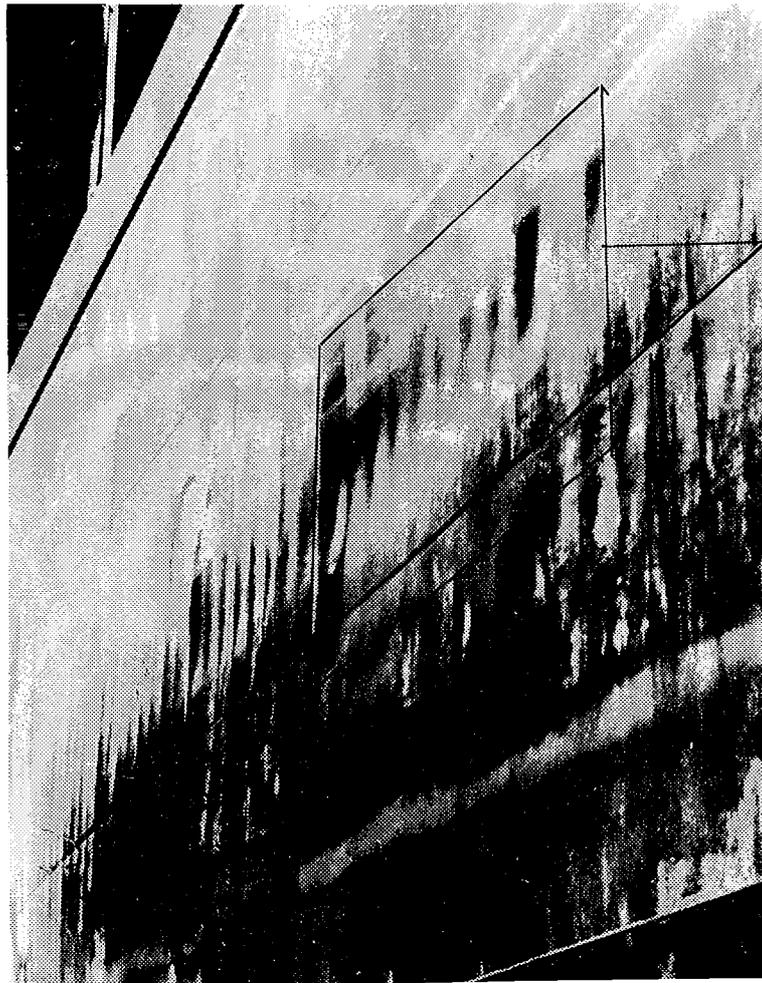
The stereographic photos were taken from the winter 1986 damage. The shape of the damage as determined from these photos is given in Figs 22-23. As can be seen the maximum permanent deflection of the shell structure is 55 mm. The deflection is largest at the after end of the damaged area with highest curvature near the web frame. This indicates that the ship was moving forward while the damage developed.

Fig. 22. The damage occurred during the winter 1986 on area 1 of ship n:o 35.

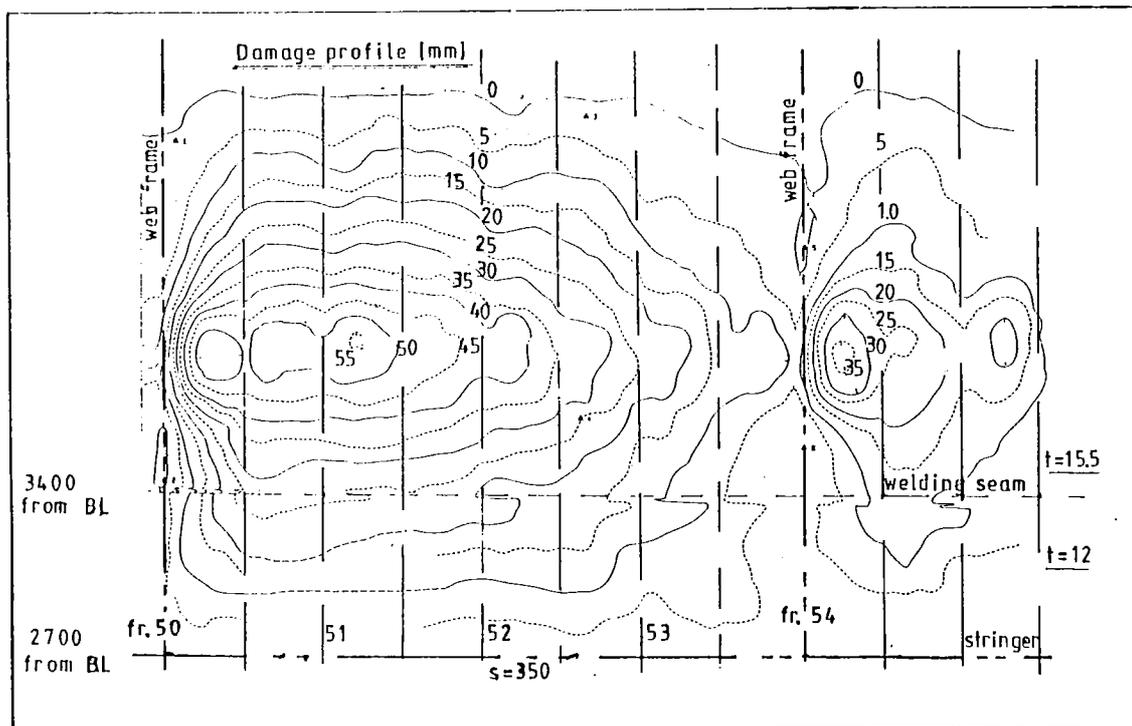
Fig. 23. The shape of the damage on area 1 of ship n:o 35.

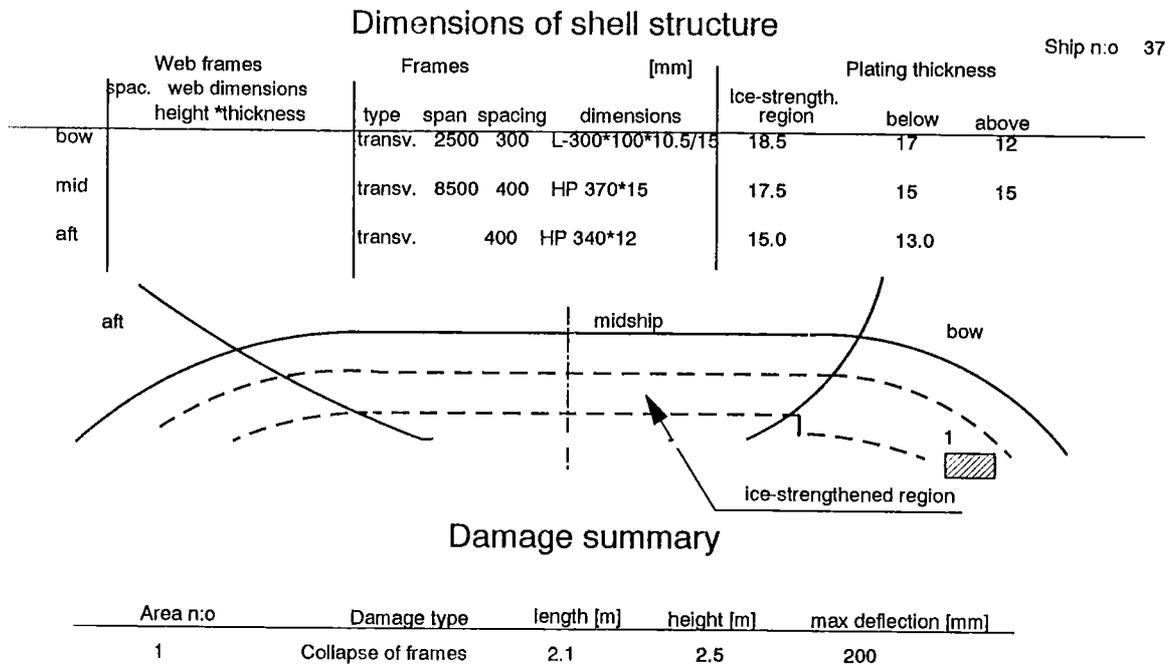
This ship has experienced one damage to the transverse frames on the bow ship. The damage took place in May 1986, when the ship hit some thick ice floes with fairly high speed. As a result about 5 frames collapsed and one also cracked due to shear at the upper end of the frame. The location of the damage is given in Fig. 24. Fig. 25 gives some photoes of the damage. The main reason for this damage is that the frame is attached at an angle of 45° to the shell plating, which decreases the plastic section modulus about 30 %.

Fig. 24. Dimensions of shell structure and location of the damage on the ship no. 37.

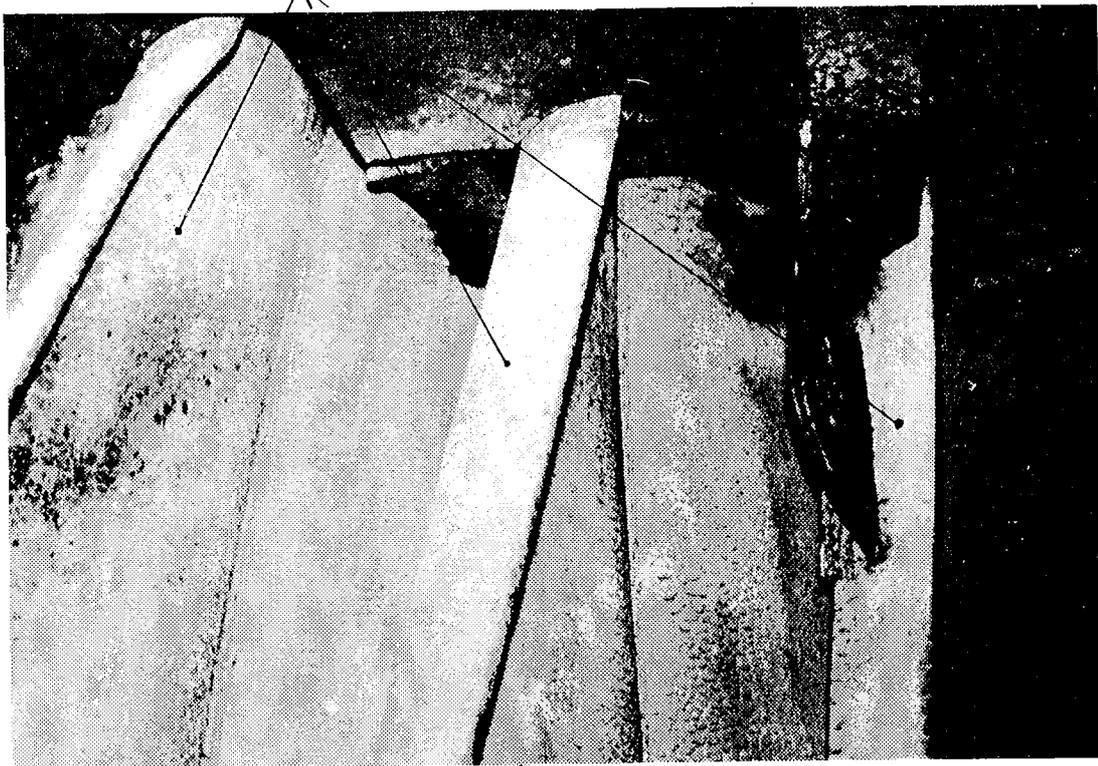
Transverse frames

Fig. 25a. Inside view of the damage on the ship no. 37.

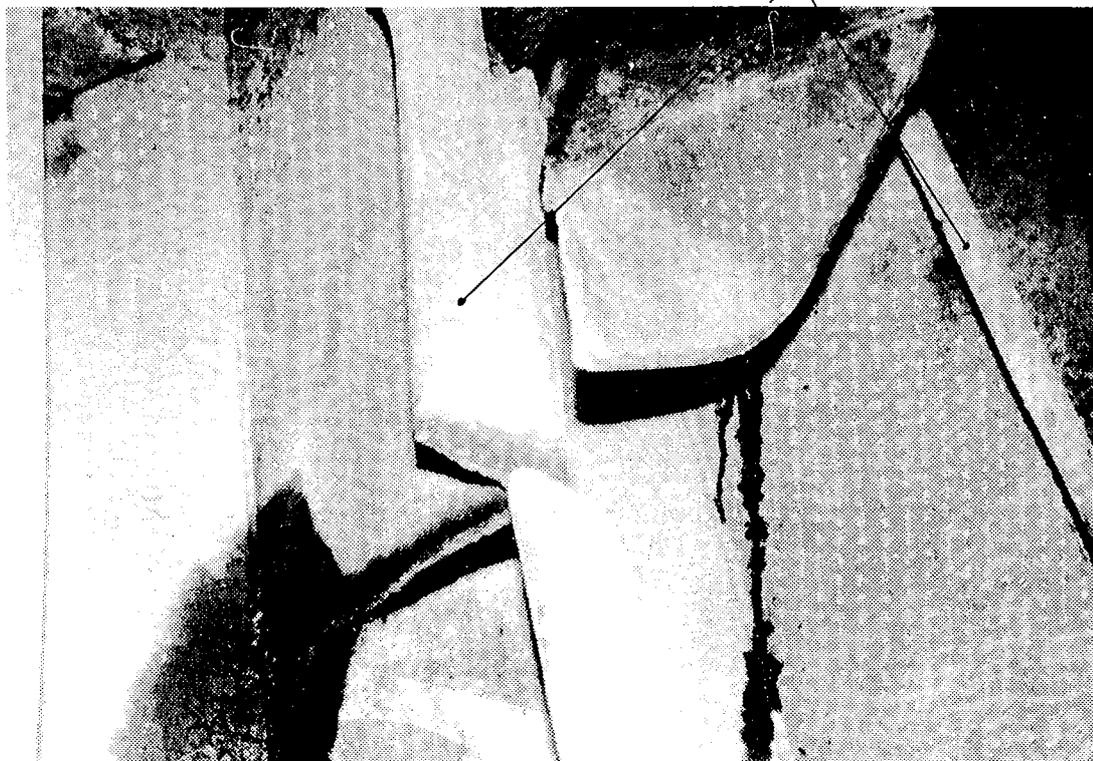
Transverse frames

Fig. 25b. Inside view of the damage on the ship no.37.

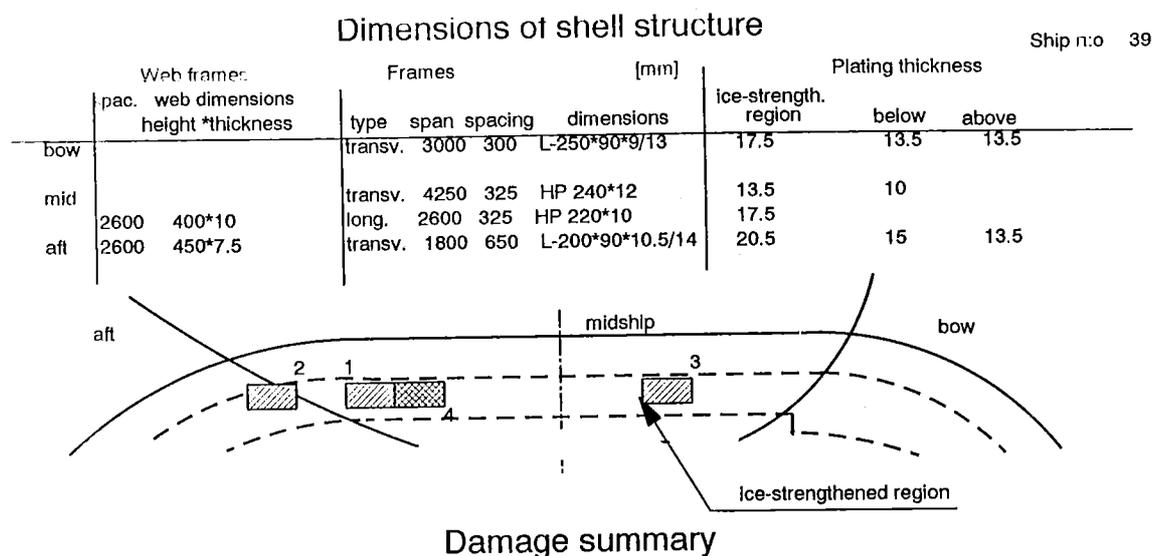
This ship was also damaged during the winter 1987 (area 4). The exact date for the incident is not known. The damage on the PB-side between frames 48-53.3 from the level of about 2 meters above the double bottom to about 0.5 m above the bottom of the upper wing tank. The maximum deflection of the damage was 80 mm.

Fig. 27. Dimensions of the shell structure and summary of damages onboard ship no. 39.

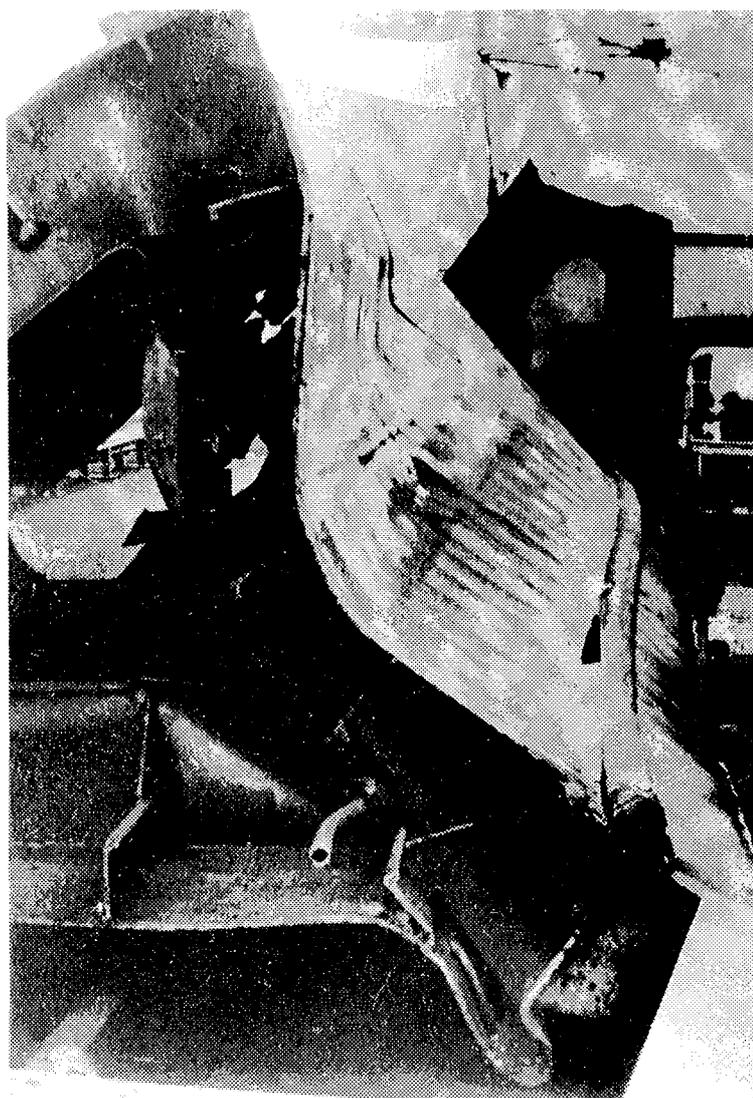
Fig. 28. The shape of the damage at the upper wing tank between frames 45-60 (area 1) of ship n:o 39.

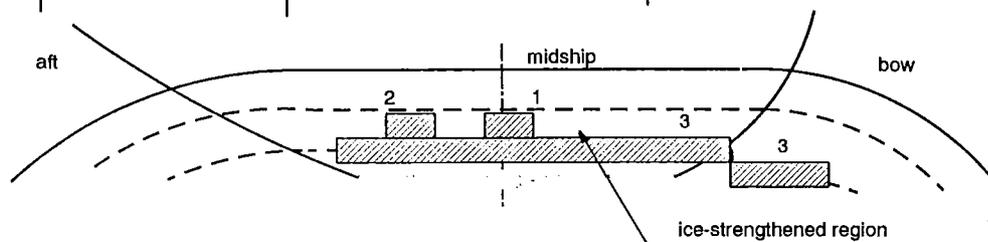
Fig. 30. Dimensions of shell structure and summary of damages onboard ship no. 45.

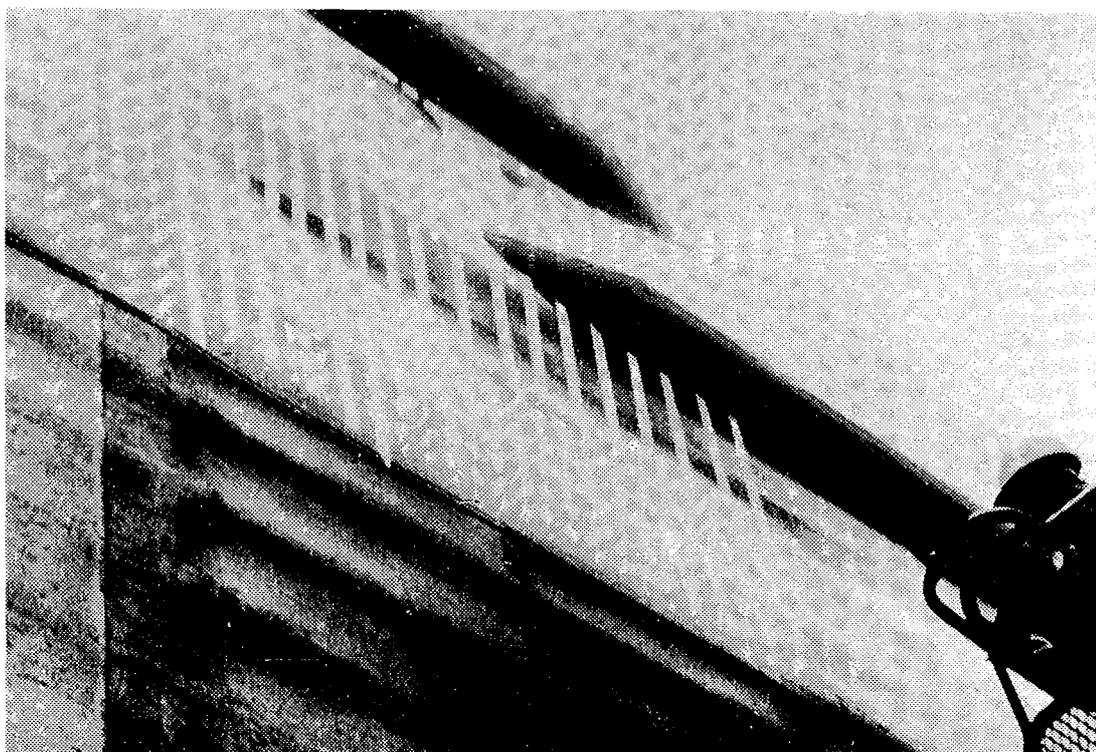
Fig. 31a. The shape of the damage at SB-side of ship no. 45 between frames 86-90 (area 1).

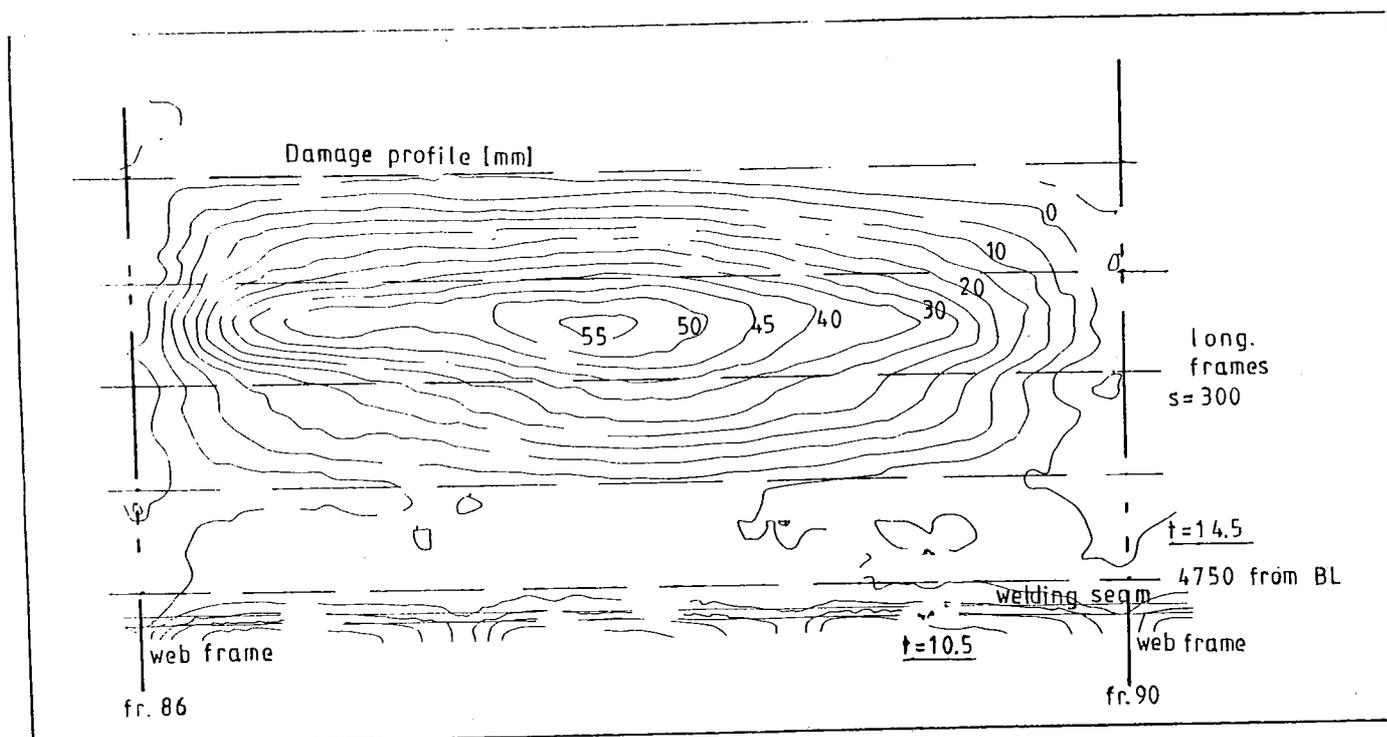
Fig. 31b. The shape of the damage at SB-side of ship no. 45 between frames 86-90 (area 1).

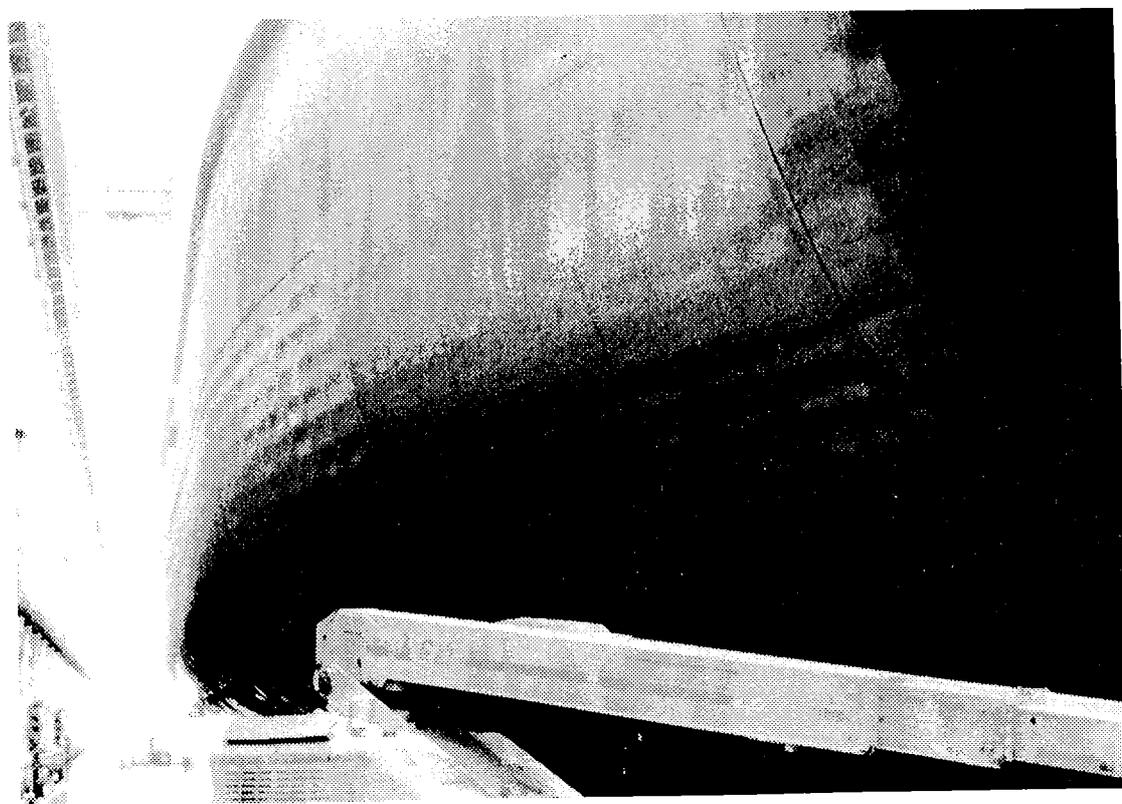
Fig. 32. The permanent deflection on the plating of area 3 on ship n:o 45.

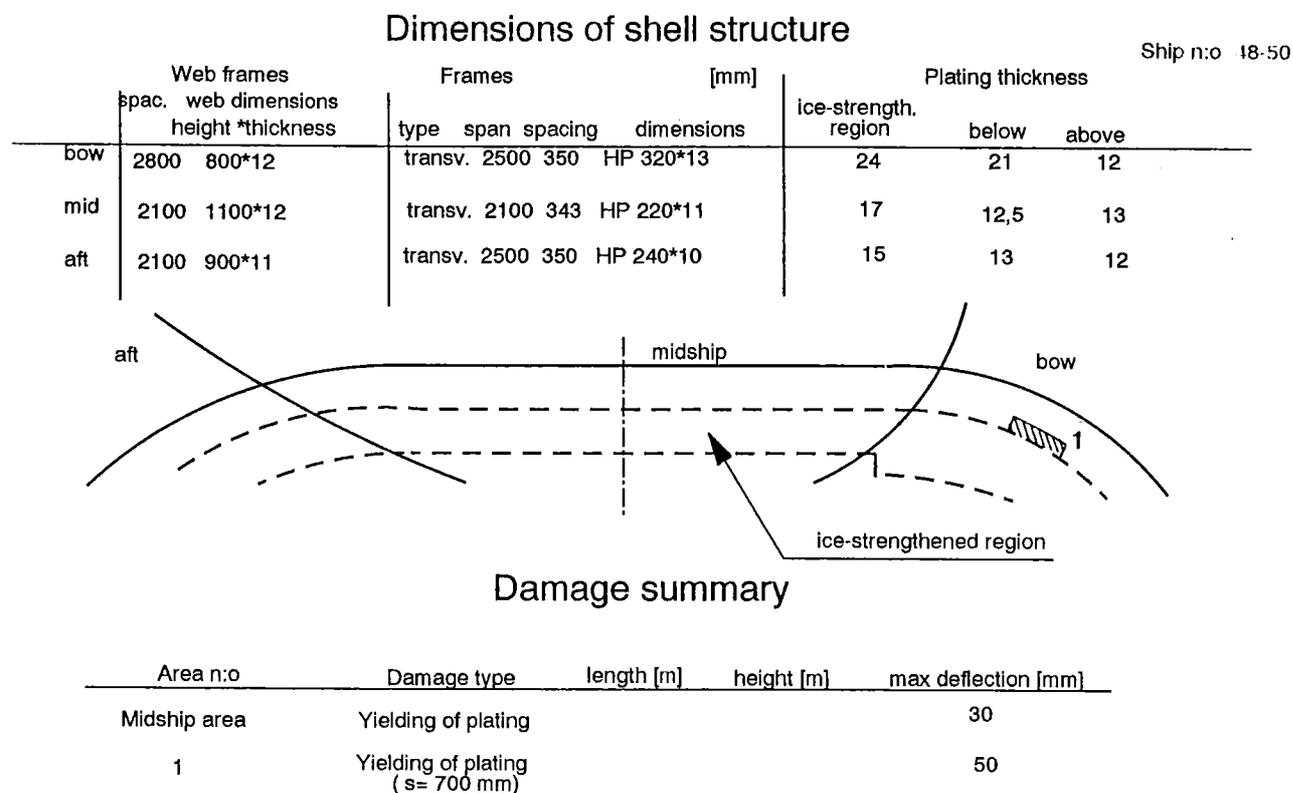
These ships are sister ships with similar damages. They have transverse framing at the bow and longitudinal framing at midships. The damages consist of denting of plating, which at the bow has occurred above the ice-strengthened region and at midships at the longitudinally framed ice-strengthened region, see Fig. 33. Ship n:o 47 is also a sistership to these ships and she has similar damages, which have, however, occurred while navigating to the Canadian Arctic. Therefore these damages are excluded from this report.

Fig. 33. Dimensions of shell structure and summary of damages onboard ship no. 48-50.

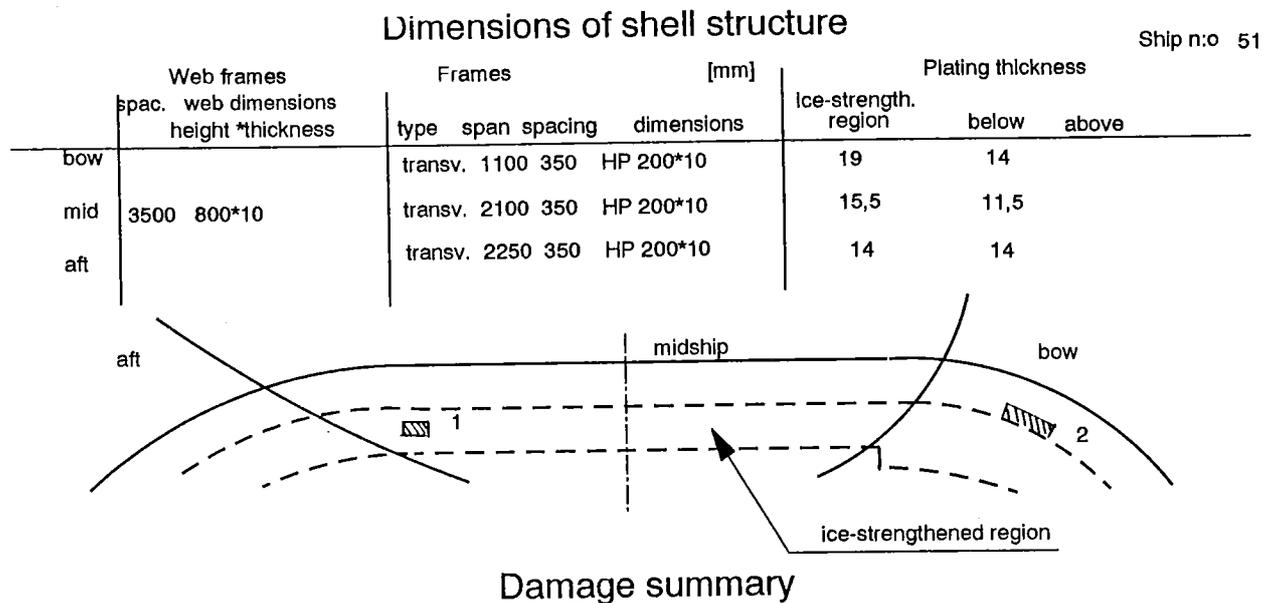
Similarly to the ships no 48-49, this ship also has damages on the plating above the ice-strengthened region at the bow and at the ice-strengthened region at the after end of the midship region, see Fig. 34. The ship is transversely framed.

Fig. 34. Dimensions of shell structure and summary of damages onboard ship no. 51.
