STYRELSEN FÖR
VINTERSJÖFARTSFORSKNING
WINTER NAVIGATION RESEARCH BOARD

Research Report No 54

**INCIDENTS AND ACCIDENTS IN WINTER NAVIGATION IN THE BALTIC SEA,
WINTER 2002 – 2003**

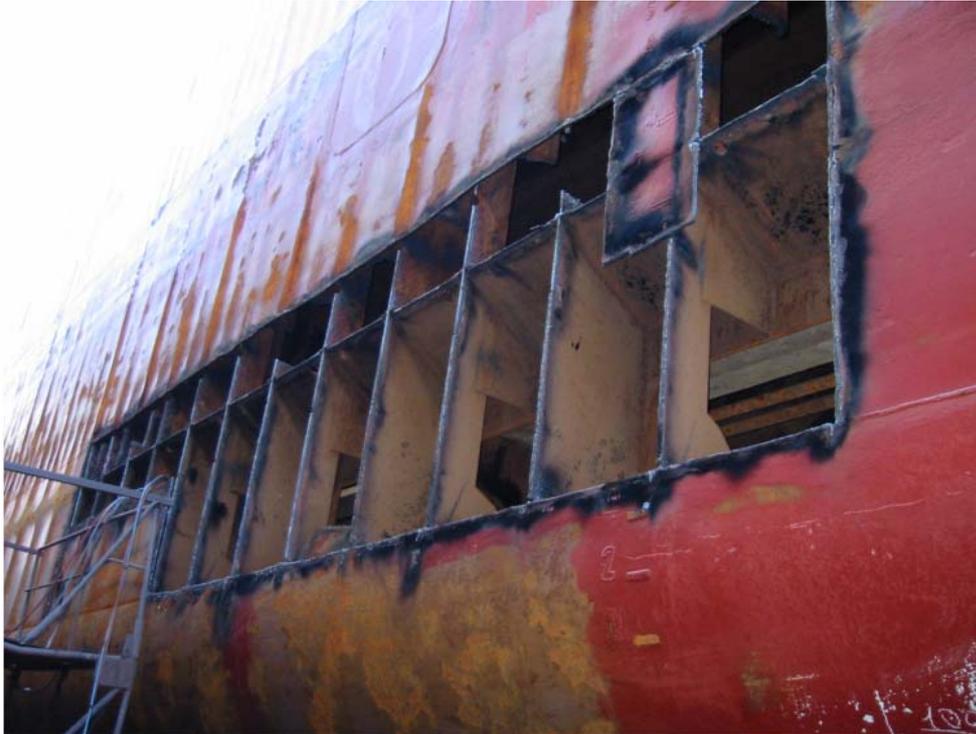
The ship was docked on Tallin's shiprepair yard on June 2003 for one week. The main reason for docking was replacement of the damaged side plates (Fig. 6). All the dents were cumulated during 22 years of ships operation. Replacement of plates was now made for the first time. Most of the dents were in the midship area on the sides, between frames 60 to 100. Dents were smaller towards the bow. The most damaged plates had already been removed, but the dents on the rest of the plates were about 50 mm deep. According to the ships master, the damages had occurred when turning in ice, and most of the damages had already happened during the first four years of operation. The dents evolved only slightly during the following years. Because of the turbulent flow behind the dents, some of the plates had eroded to thickness of only 5 mm (originally 13-15 mm). Together 19 tonnes of new 14,5 mm thick steelplate was replaced on the ship sides. In addition, there was a dent on ship bow, which had happened when the towing fork of an icebreaker collided into it. There were also few small dents on the bottom of the ship, most of them 30-50 mm deep. The bolt covers on propeller had fallen away every winter and they were not replaced for five years. There was no damage on the bolts and the propeller. There were no damages in the rudder, because the ship does not reverse in ice.

The ship had been operating the whole winter 2003 between the ports of Luleå and Raahe. Operation was mainly in ice channel, except one three week period when there was a lead in the ice field and the operation could be done in open water. Last winter was no exception compared to other winters in their operation area. There was one hard compressive ice situation, when the crew started to prepare to abandon the ship, but the compression eased off before the icebreaker came to help. There was no damage to the ship because of this incident. The ship has an ice class IA and it has transverse framing. The ship is docked every second year.

Figure 6. Renewed plating in the mid ship area of a bulk carrier.

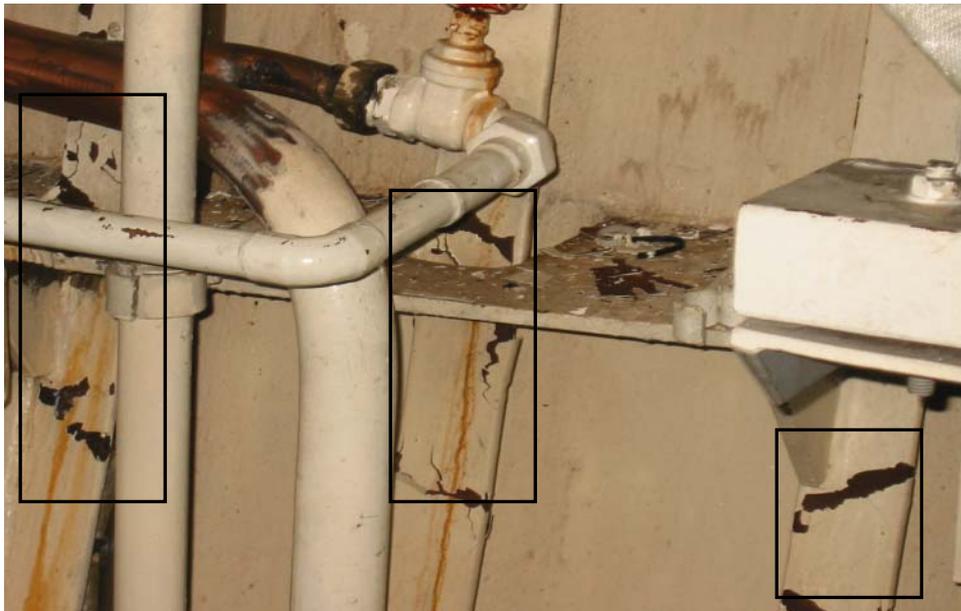
The consequence was that 8 frames in SB side (frames #15-19 and #21-24) and 4 frames in PB side had a permanent deflection of 10-30 mm 20 cm below the water line depth. In

addition the frame supporting brackets buckled and some pipelines were broken. Plating between the frames had only minor permanent deformation (about 10 mm). The ship has transverse framing system. The frame spacing in the ice belt is 270 mm and the frame span is 2.4 m. The frame dimensions are L-100x65x10. In Figure 8 three damaged frames are shown. Later the same winter the ship had a propeller damage, damages for shell plating in the bow thruster tunnel, slightly indented shell side plates (SB) between frames # 13-25 and bilge keels damage (replaced about 40 m). These damages were observed on 18th of March 2003.

Figure 8. Damaged frames in the mid ship area of ship number 66.

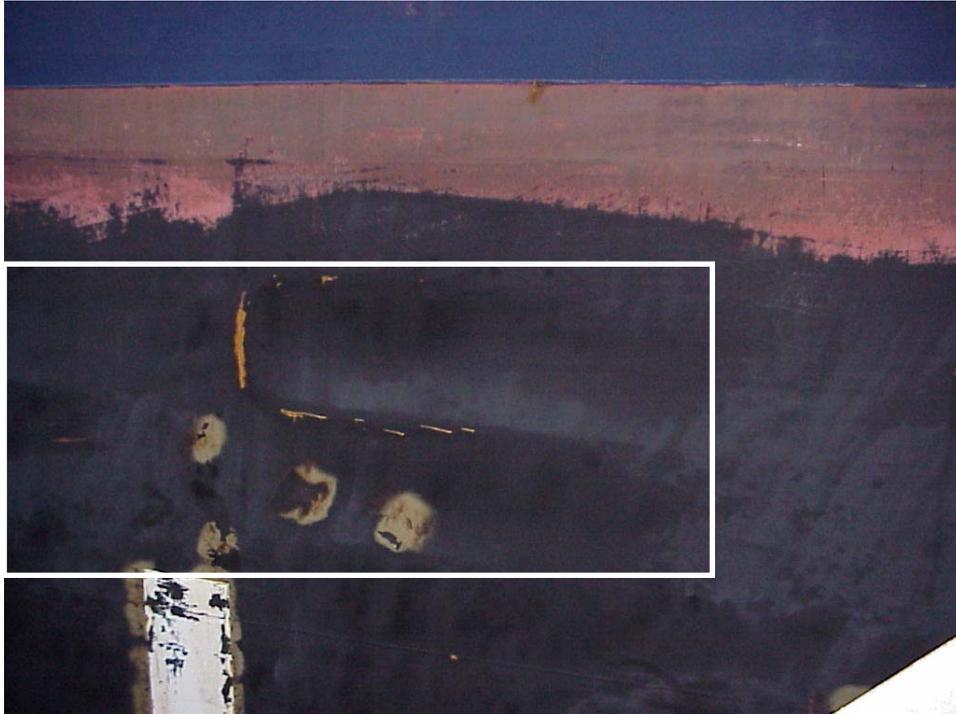
The ship was on her way from St. Petersburg (Russia) to Fredericia (Denmark) when she got stuck in compressive ice near Suursaari (27°30'E, 60°00'N) on 11th of January 2003. The ship was carrying cargo. During the compression the ice blocks piled up against SB side of the ship. The plating in the mid ship area (SB, flat side) got permanent deflection in the area of two frame spacing for a length of about 100 m (frames #65-125 and #135-195). The maximum indents were about 30 mm. In Figure 9 part of the damaged area of the tanker is presented. The draught was 14 m and the damaged area was about 1.5 m below waterline. According to the ship's master the vertical extension of the ice belt is too narrow. The ship had an ice damage (dents) below the ice belt during winter 1994. The reason was contact with the edge of an ice channel in ballast condition.

The ship is built according to the Finnish-Swedish ice class IC. It has longitudinal framing system in the mid ship. The frame spacing in the ice belt is 800 mm, the thickness of the plating is 18 mm, the frame type is P-280x11 and the frame span is 3.2 m. The difference of the ship and the icebreaker beam is over 10 m. This means that the ship has to break ice during icebreaker assistance.

Figure 9. The permanent deflection of the side plating of the 95000 DWT tanker. The picture is taken from ship side in the mid ship area. The vertical extent of damage was two frame spacing (1.6 m) and the maximum indent shown in the picture was about 30 mm deep.

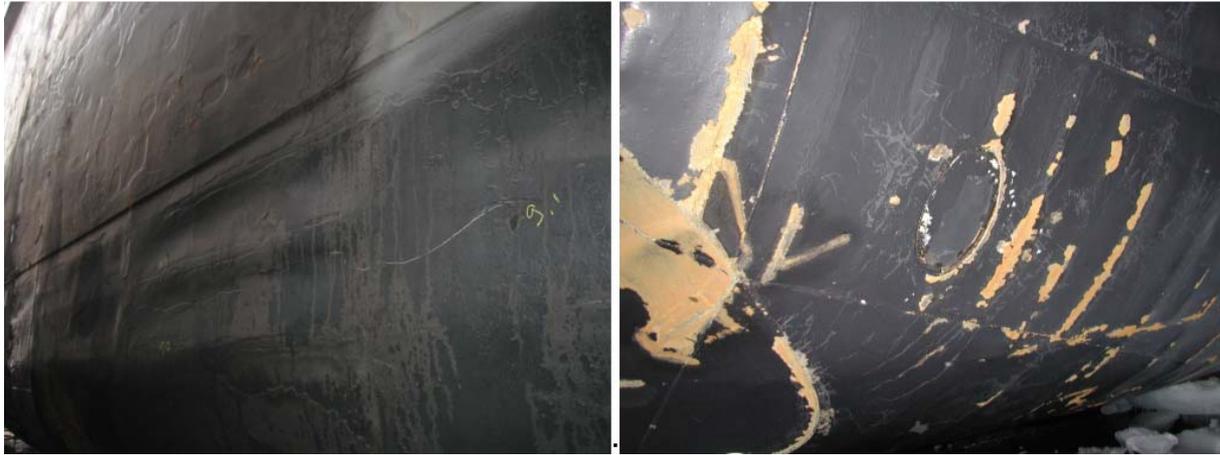
During the docking several damages were found and the repair took for one month. The shape of the thruster tunnel in the bow was renewed. During the past years ice blocks had caused several small cracks in the entrance of the tunnel. In the bow area below the ice belt the plating had several dents on both sides. The maximum deflection of the plating between frames was about 50 mm. This plating was replaced and new frames were added between old ones so that the frame spacing in that area decreased from 1.3 m to 0.65 m. During the docking 7 new frames were added to the both sides. In the aft area plating was replaced on an area of about 4x4 m². There were several dents in the mid ship area below the ice strengthened region and in the bilge areas (Fig. 10). The maximum indents in the mid ship were 30 mm. The ship has a mixture of transverse and longitudinal framing system. In the bow area the plate thickness is 18 mm in the ice belt and 9.5 mm below the ice belt. The damaged areas were below the ice-strengthened region.

Figure 10. The permanent deflection on the plating below the ice strengthened region of ship number 55.

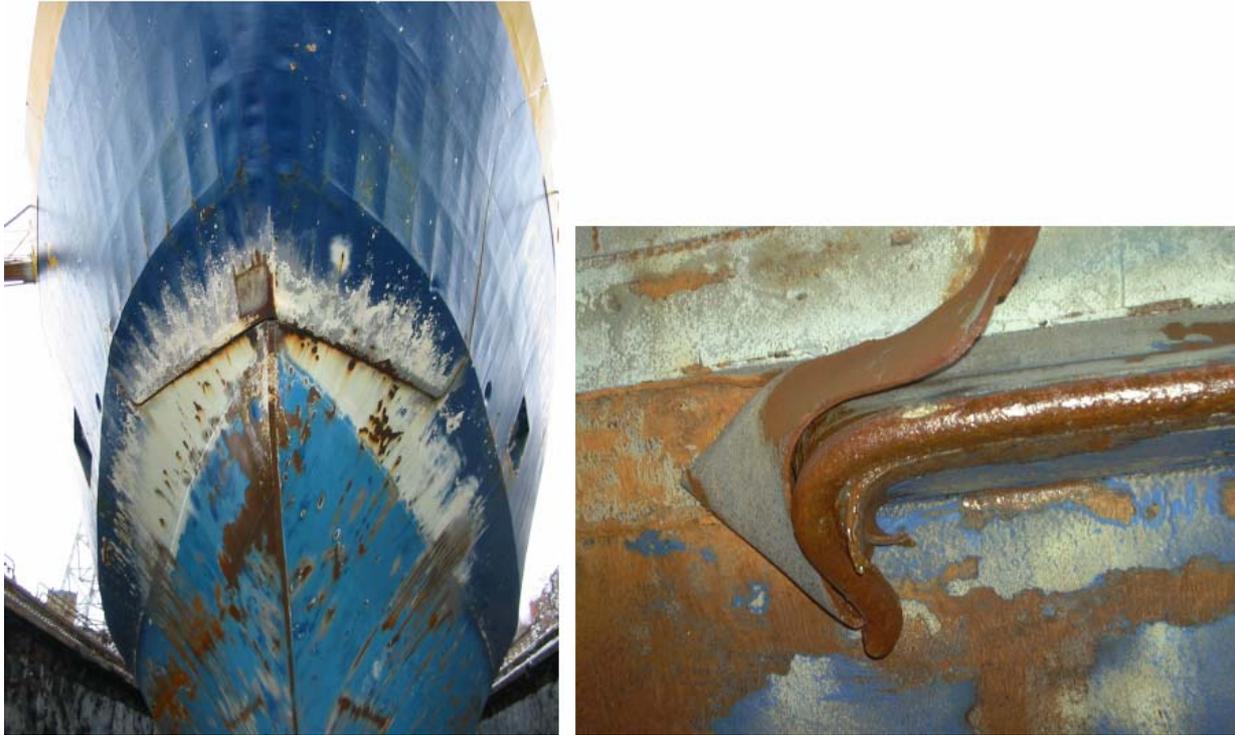
Bilge keel was damaged on the PB-side and it was replaced for a length of 7 m. There were permanent deformations of the bow plating above the ice belt (Fig. 11). Those are caused by navigation with high speed in an ice channel. Smaller dents of the plating were observed on several locations on the ice belt and below the ice belt. The painting was worn off due to ice abrasion.

Figure 11. Permanent deflections above the ice belt (left picture) and damaged bilge keel (right picture) of the passenger ferry. Bilge keel was peeled off the shell plating for a length of 7 m.

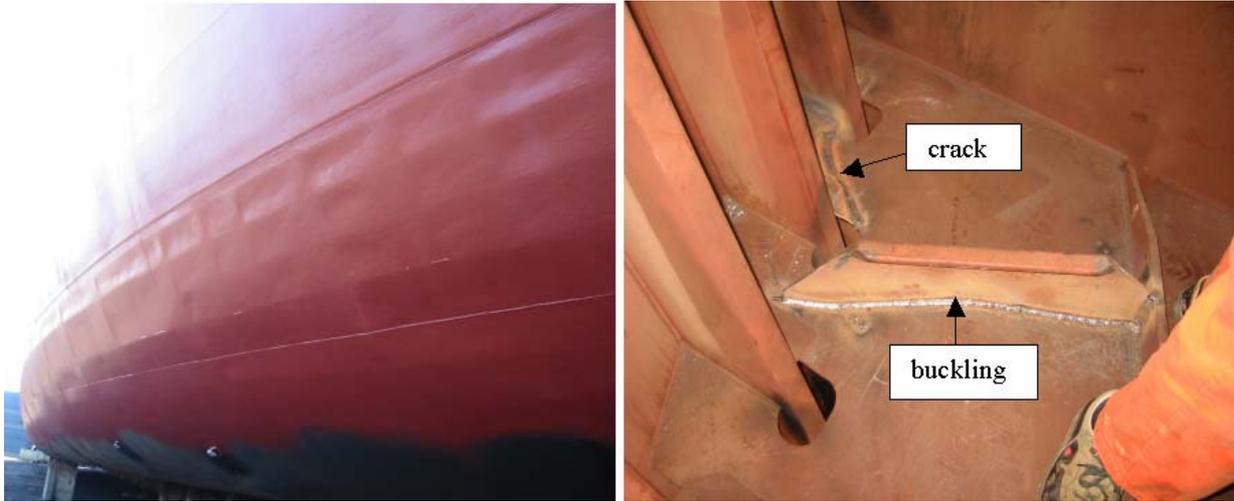
In the forepeak at the water line level a couple of frames and brackets were buckled. In the bow area there were cracks and buckling in the junction between frames and stringers. These damages were just above and below the ice belt (Fig. 12). Below the ice belt and on the bilge there were 20-30 mm deep dents. The dents were located between frames #130-176 i.e. length of 40 m. Below the waterline 60 % of the painting was worn off. This is partly due to ice abrasion.

The thickness of the plating in the ice belt is 27 mm in the bow and 17.5 mm in the mid ship. Below the ice belt the plate thickness decreases to 14 mm. In the bow area the ship has transverse framing (frames #167-180) but otherwise longitudinal framing. The frame spacing in the bow area is 600 mm (300 mm in the ice belt) and otherwise 800 mm (400 mm in the ice belt). The frames in the bow area are of type P-280x11.

Figure 12. The damages below the ice belt and damages of inner structures of the ship number 44.

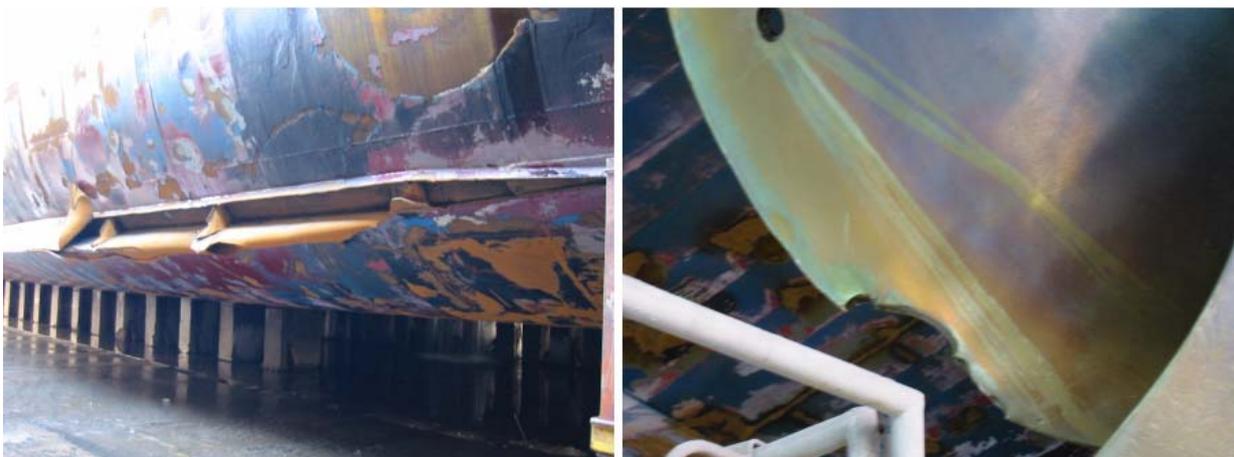
The ship was docked in May 2003 due to propeller damage. The ship operated during winter 2003 regularly between ports in Helsinki and Tallinn. The blades of both propellers were damaged in ice in the port of Tallinn. The reason is not known. The painting was worn off on many locations and the bilge keels were damaged on both sides (Fig. 13). The bilge keel on SB-side was ruptured for the length of 7 m and on PB-side for the length of 4.5 m. The probable reason was collision with the edge of an ice channel. There were permanent deflections of the plating in the bow area. The dents were located on the ice belt and on the bilges. The dents were 40 mm deep at maximum. The ship has transverse framing and the frame spacing is 800 mm (in the ice belt 400 mm).

Figure 13. A bilge keel rupture and a propeller damage of ship number 100.

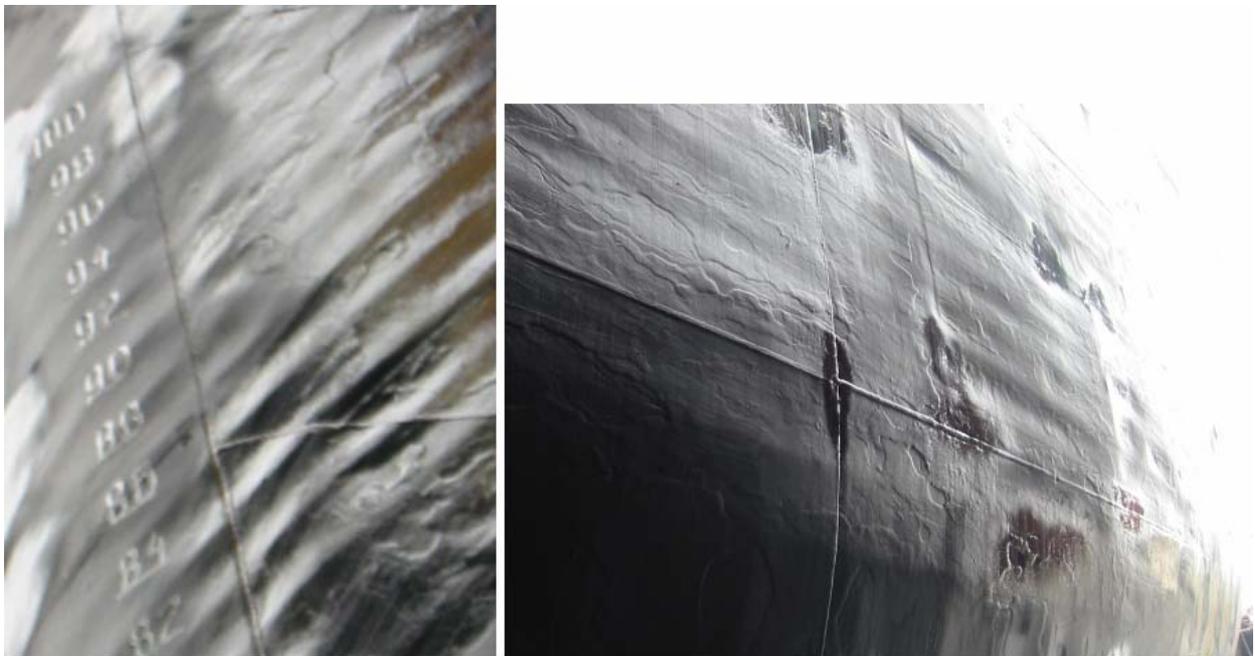
These ships are sister ships and the damages found were quite identical. Both ships have stronger hull than what Baltic ice class IA Super demands. Ships operated during winter 2003 between the Gulf of Finland and the Bothnian Bay. During the past years they had also operated in the arctic waters. Ships had indents on several locations (Fig. 14), but those are probably due to operating in multi-year ice in arctic waters. They had up to 50 mm deep dents in the forepeak. Smaller dents were found in the bow and in the mid ship in the ice belt. Below the ice belt there were up to 30 mm deep dents in the bow, mid and aft areas. The damaged areas were of a length four frames spacing and height of three stringers spacing at maximum. The ships have transverse framing in bow and aft areas. The frame spacing on the bow ice belt is 350 mm, the frame span is 2500 mm and the frame type is HP320x13. The thickness of the plating is 24 mm.

Figure 14. Dents in the bow area of a chemical tanker due to collision with multi-year ice.

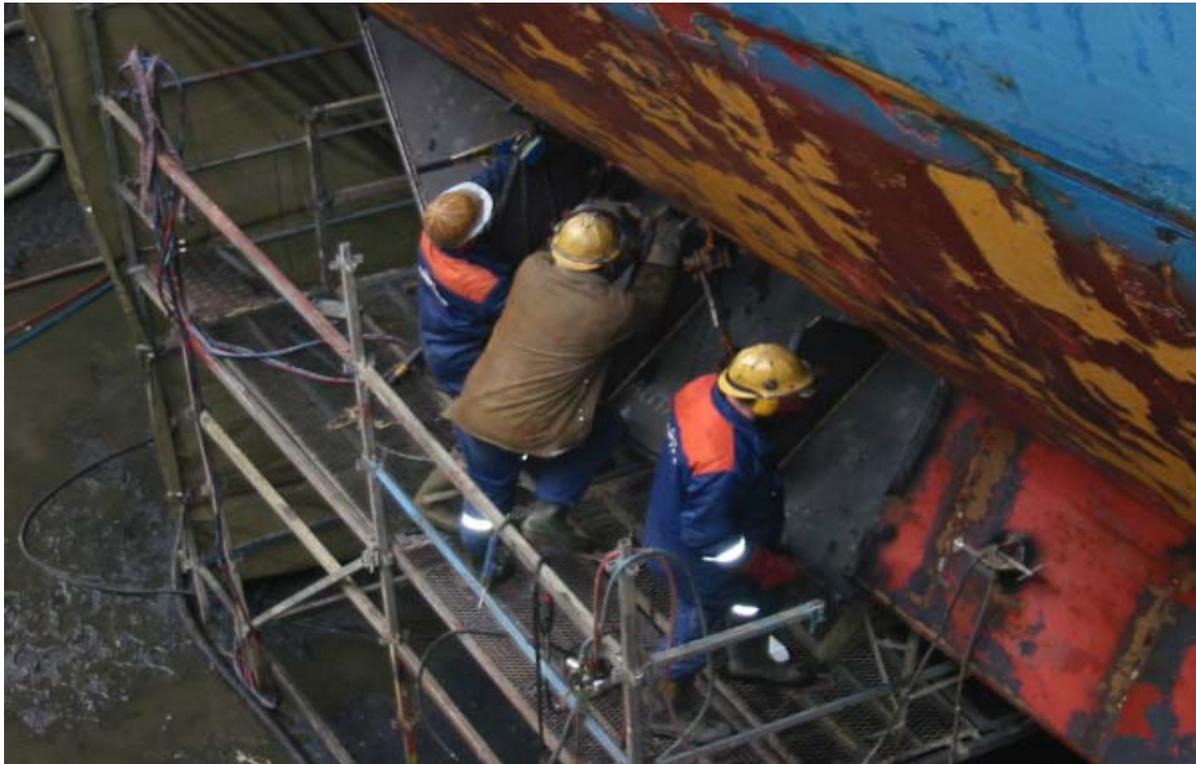
Five types of minor ice related damages were found. The bilge keels were ruptured from both sides for a length of 4 m (Fig. 15). The bilge keels were welded to flat bars and the flat bars

were welded to the ship side shell. Also these flat bars peeled off the ship hull. These damages occurred possibly in the ice channel near the port of Turku. Two seawater well gratings in the bottom of the ship fall off due to ice pieces. The gratings were bolted on with 8 bolts. The aft thruster was broken due to ice pieces in the port of Turku or in the port of Mariehamn. The painting was worn off from the bottom of the ship. On the bow area there were 10-20 mm deep dents on the plating. The dents were located in the ice-strengthened region and below the ice belt. This ship has transverse framing.

Figure 15. Replacement of the damaged bilge keels for ship number 99.

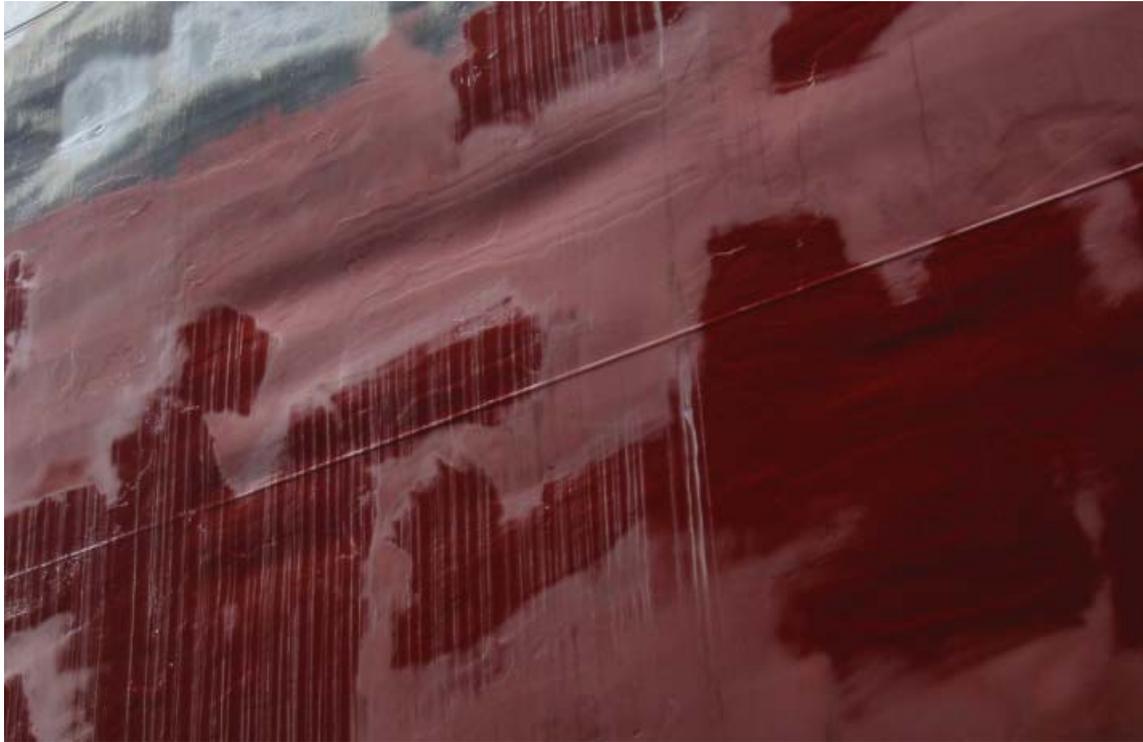
deflections of 30 mm deep (Fig. 16). The damaged area was within 3 frames and 3 stringer spacings.

Figure 16. Permanent deflections of ship number 101.

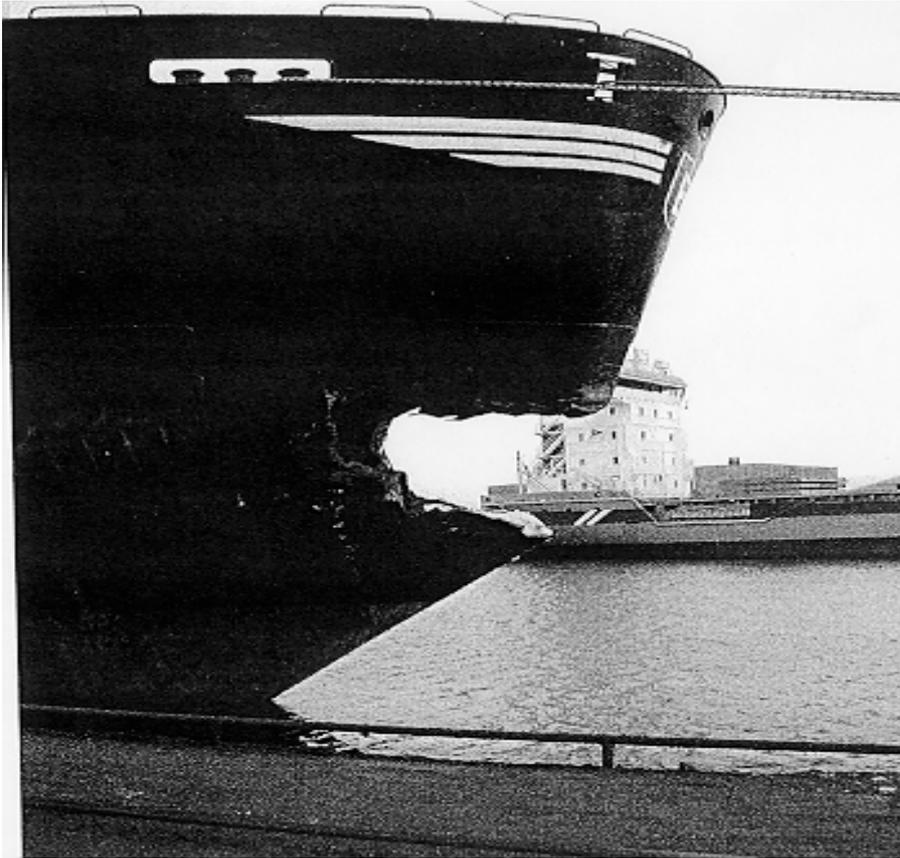
Bow damages of a ship after collision with icebreaker towing fork in the Bothnian Bay is shown in Figure 17. Icebreaker got stuck in heavy ice and the assisted ship could not avoid collision. The damaged area was located on the forepeak 2 m above the water line. The hole was 2 m wide and 5 m deep. Also icebreaker's towing fork was damaged.

Figure 17. Damaged bow due to collision with an icebreaker.

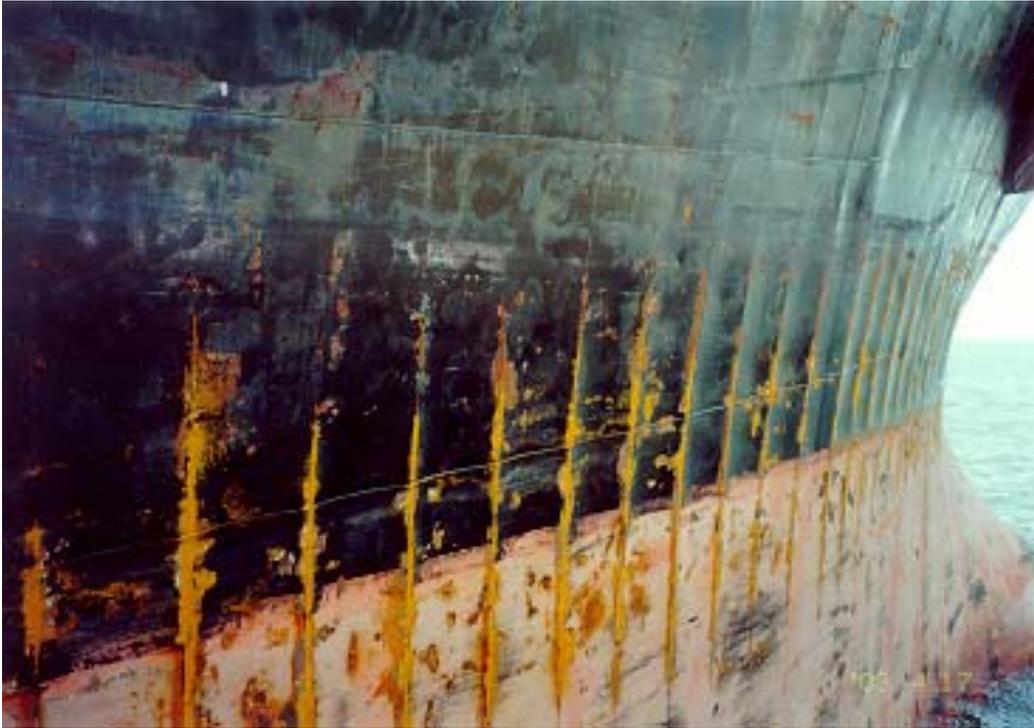
The bulk carrier (ship number 12) in Figure 18 belongs to ice class II. The ship was damaged during icebreaker assistance between 19th and 25th of March 2003. The ship followed an icebreaker with full propulsion power in ridged and rafted ice in the Gulf of Finland. The ship crew was evacuated due to water leakage into the ship hold and after that the ship was docked for repair. Frames # 247-181 on both sides were buckled (from fore peak to bow shoulder). The plating on the PB-side had two fractures and several dents of max depth 150 mm at the water line depth. The plating on the SB-side had several deep dents but no fractures. Around the fractures the permanent deformation of the plating was about 200 mm deep. The fractures were of length of 2 m in horizontal direction. Two frames were broken off due to fractures. The frames, the plating and the stringers on the damaged area were renewed. The ship has transverse framing system. The thickness of the plating in damaged area was between 13 mm and 15 mm. The frame spacing is 850 mm.

Figure 18. Damaged areas of a bulk carrier (ship number 12).

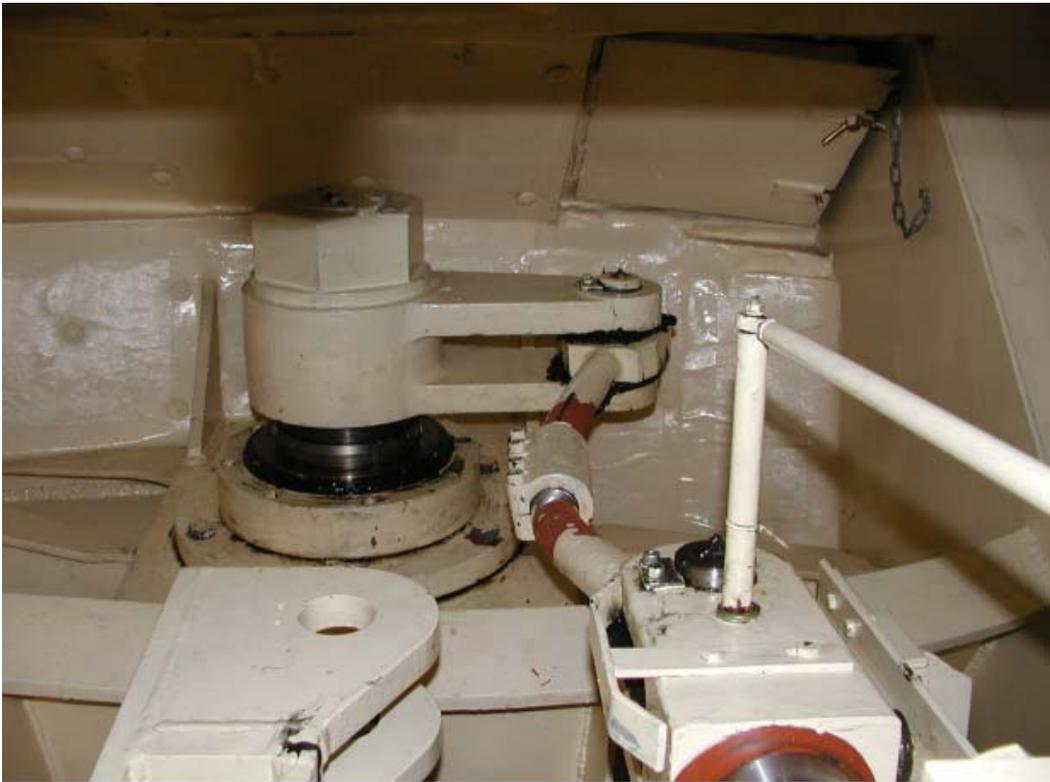
An example of a damaged rudder machinery is shown in Figure 19. As can be seen the joint rod has buckled. The damage occurred in early March 2003. The ship had to back in ice and the rudder was overloaded due to ice. On the rudders there were minor dents due to ice loading.

Figure 19. Damaged rudder machinery.

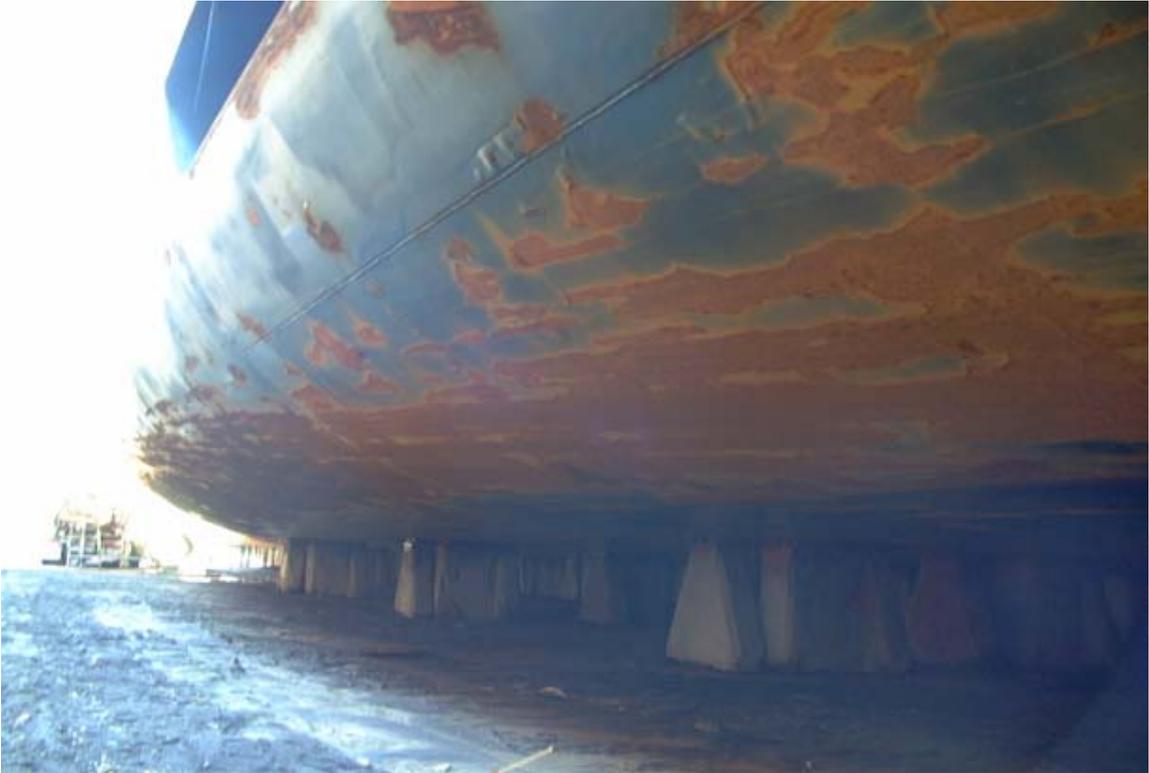
The passenger-car ferry (37 700 BRT) in Figure 20 operated between Helsinki and Tallinn during winter 2003. The ship has ice class IA Super. The painting eroded off due to ice abrasion on the bow ship (water line height) and from the mid ship towards bow in the bilge and the bottom areas (PB side) for a length of 40 m. Abrasion and corrosion from inside or outside of the ship side shell may decrease the plate thickness for several millimeters. So it can reduce the strength of the structure substantially. In the bow ice belt there were minor dents (about 10 mm deep) on the plating. Overall this ship was in good condition.

Figure 20. Wear of the painting due to ice abrasion of a passenger-car ferry. The surface damage was located in the bilge and bottom areas of the ship hull.
