Research Report No 55

**THE OBSERVATIONS OF THE PERFORMANCE OF SMALL
TONNAGE IN ICE, WINTER 2003**

Topi Leiviskä
Helsinki University of Technology
Ship Laboratory

15.4.2004

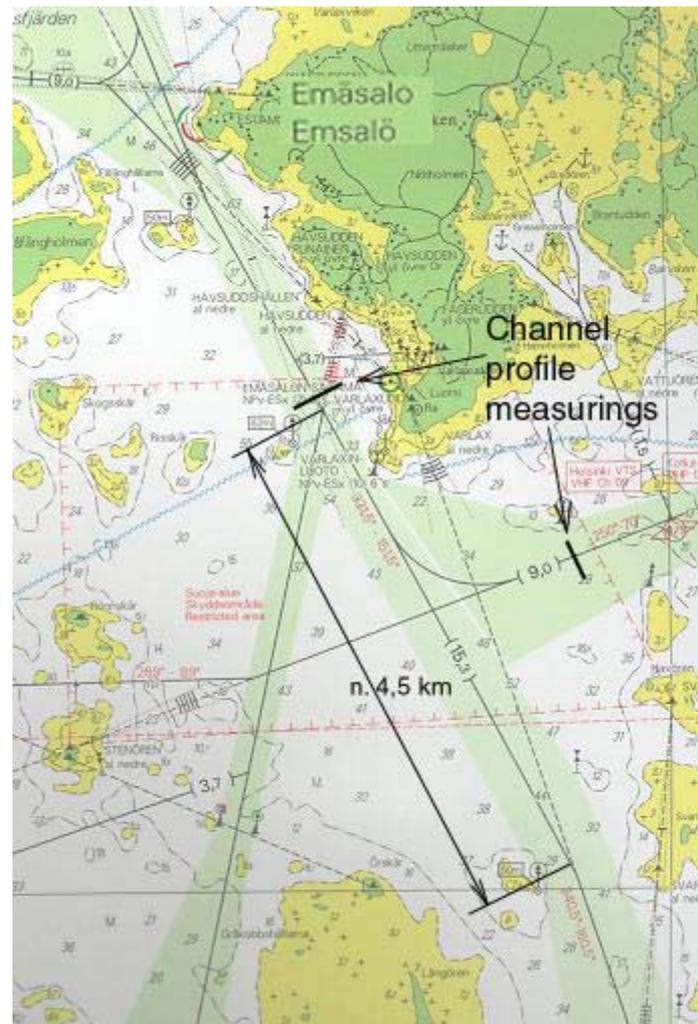
Figure 4. Channel profile measurements west and south of Emäsalo.

The channel profile was measured in four different locations: west of Emäsalo, close to the port of Loviisa, west of Ruissalo and south of Emäsalo. Figures 4...6 show the locations of the measuring areas. The dates of the voyages and channel profile measurements are shown in

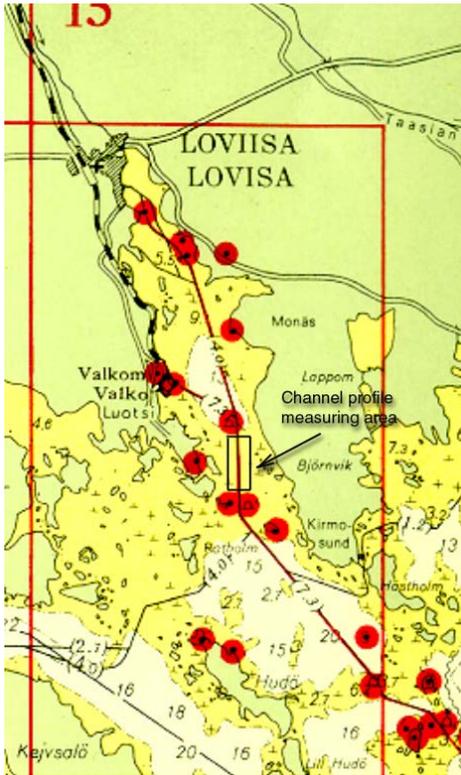
Figure 5. The channel profile measuring area in Loviisa.

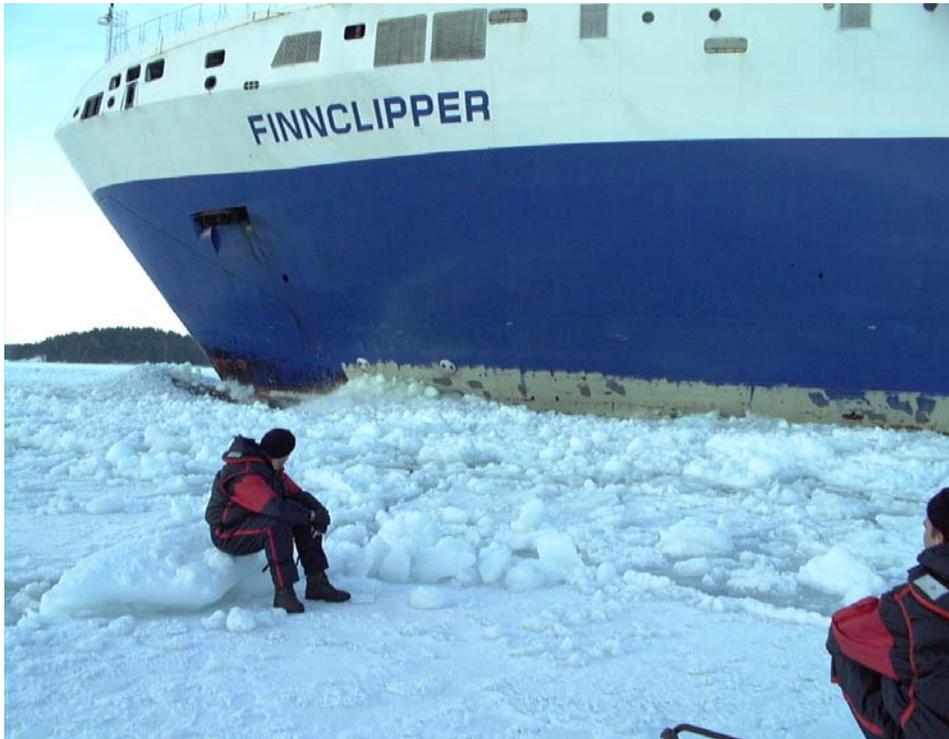
Figure 7. A ship interrupting the channel measurements west of Ruissalo.

typical situation for channel cross-section measurements is shown in Figure 7 where the measurement team is waiting for a ship to pass the ice channel under measuring.

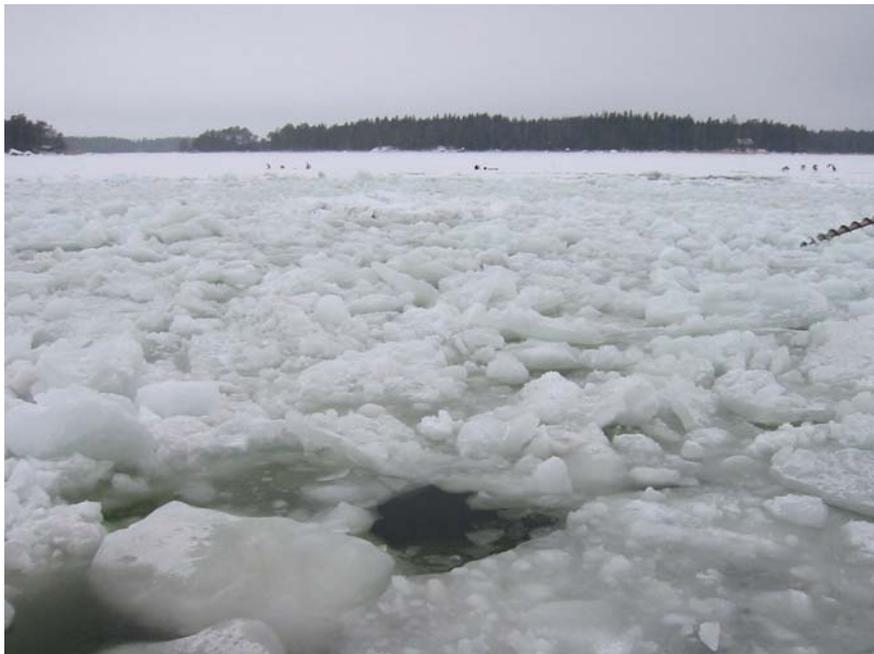
Figure 10. Loviisa channel 11.2.2003.

Both profiles could be measured over the whole channel because of an about 5 cm thick consolidated layer. The average mid channel thickness was 0.35 m. The profiles are given in Figure 9 and a photo of the channel in Figure 10.

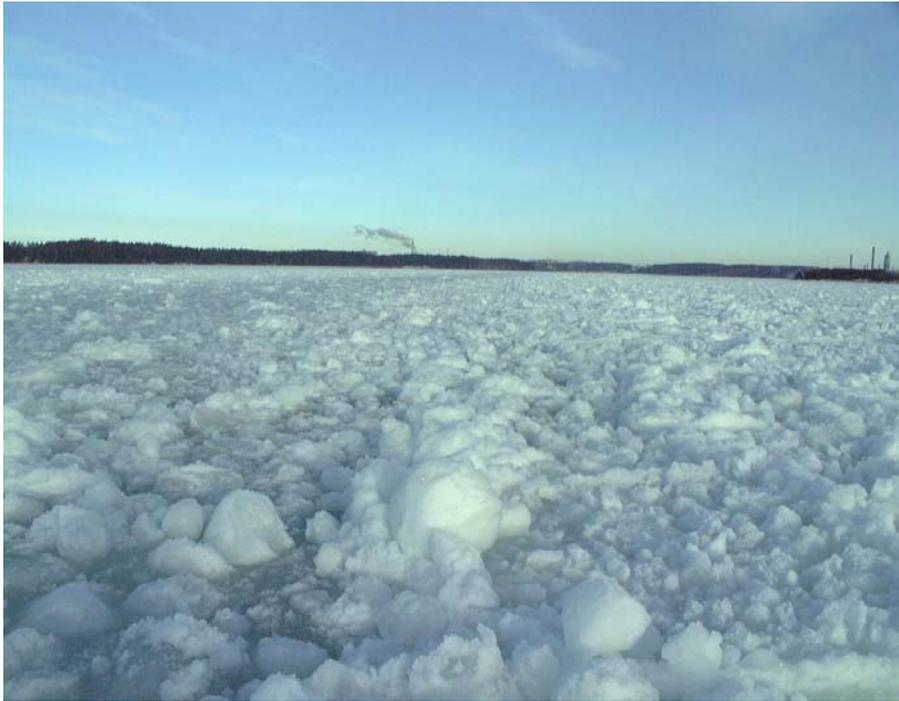
Figure 11. Ruissalo channel 18.2.2003.

Four profiles were measured west of Ruissalo. This channel was a relatively much operated light channel and could therefore not be measured in the central line. Figure 11 shows the channel and Figure 12 the profiles.

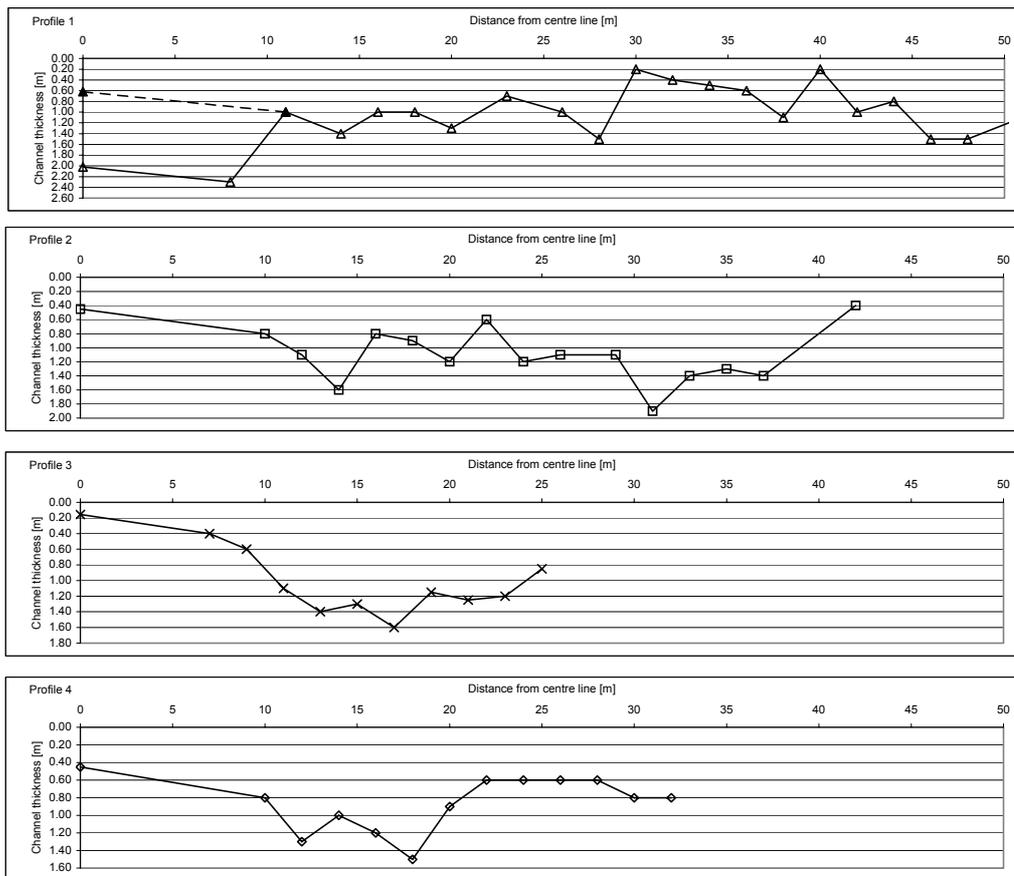
Figure 12. Four channel profiles measured west of Ruissalo 18.2.2003.

The mid channel thicknesses were estimated using again the two degrees slope angle between the measured thickness closest to the centre line. The visually estimated mid channel thickness was 0.50 m which profiles 2...4 support. The last measured thickness in profile 1 was 2.30 metres, which is the highest measured value. In this case there were probably ice floes one upon the other and if the mid channel thickness is estimated using the second last measured point the it would then be 0.62 metres which is close to the other mid channel thicknesses. The average mid channel thickness is thus 0.42 m.

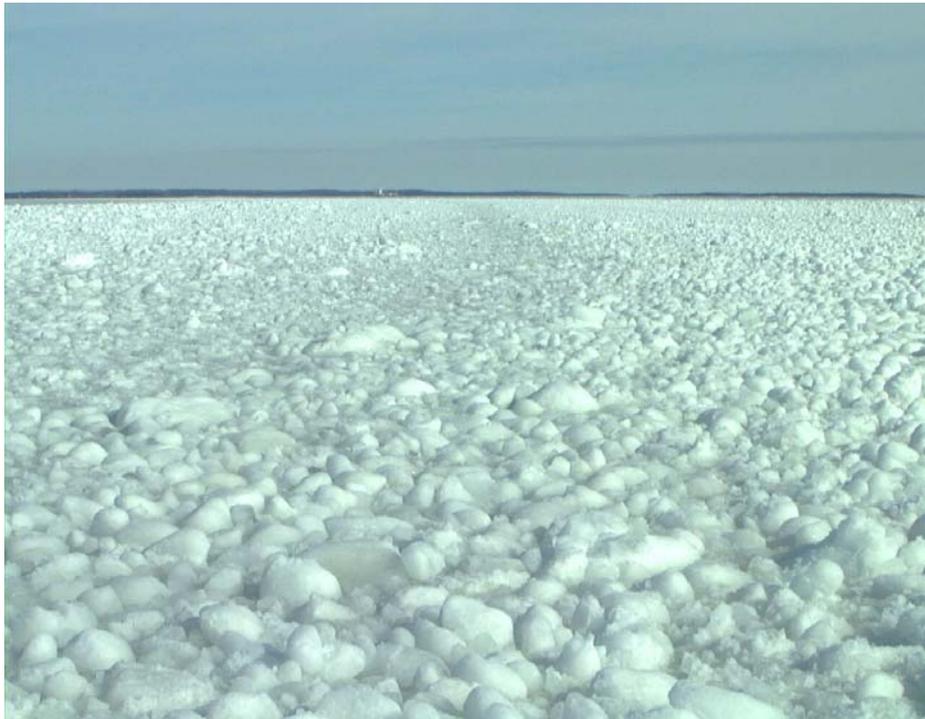
Figure 13. The channel of the archipelago fairway leading east from Emäsalo.

The last channel profile measurements were made south of Emäsalo 26th of March. The channels of the deep fairway leading out of Sköldvik and the archipelago fairway eastwards (Figure 13) were measured. The mid channel thickness of the archipelago channel was 0.35 metres but if the cross sectional area of the channel from centre-line to 6.25 metres, that is about B/2 of the observed vessels, is converted to correspond to the cross section of the rule channel with the slope angle of two degrees the mid channel thickness is 0.60 metres shown in Figure 14 as a dashed line.

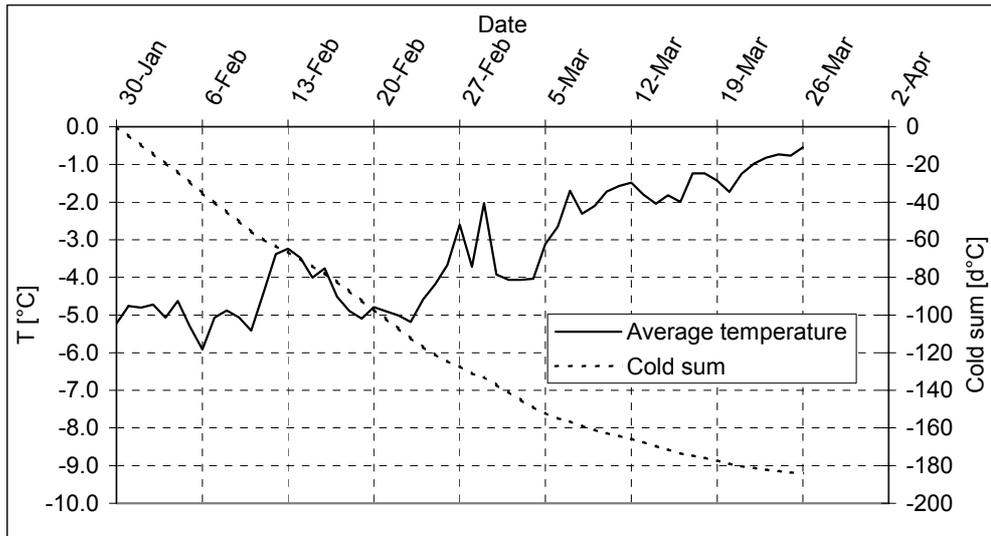
Figure 16. Average day temperature and relative cold sum for the period between the 30th of January and 26th of March 2003 in Isosaari.

When the cold sum in degree-days is calculated for the period between the two measurements and the mid channel thickness is assumed to be dependent on the square root of the cold sum, we can plot the mid channel thickness as a function of the date. Figure 16 shows the temperatures and the cold sum during the period between the measurements and Figure 17 shows the channel thickness as a function of the date.

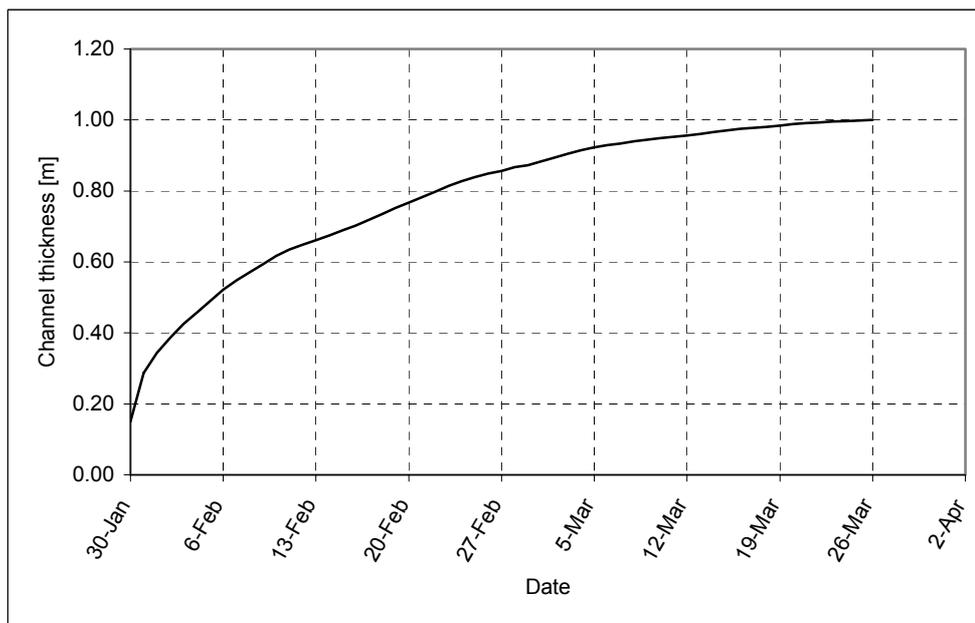
Figure 17. The estimated growth of mid-channel thickness as a function of date.

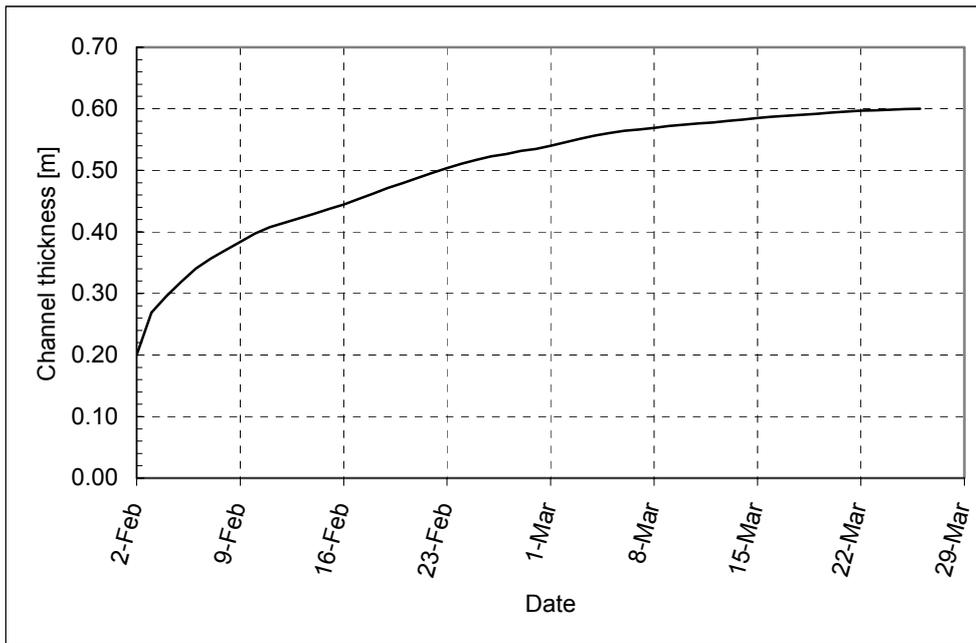
Figure 18. The estimated channel thickness of the archipelago fairway.

The profile of the channel of the archipelago fairway leading east from Emäsalo was measured the 26th of March and the mid channel thickness was 0.60 metres. If we assume that this channel formed equally to the Sköldvik channel, the thickness of this channel can be presented as a function of the dates (Figure 18).

The archipelago fairway was opened to the traffic the 2nd of February and the ice thickness at the area was about 0.45 m so the mid channel thickness is assumed to have been 0.20 m at that time. Ship C passed the measuring point three days later and the mid channel thickness was already 0.32 m and *Ship G* passed the measuring point in the 13th of March, when the channel was about 0.58 m thick according to Figure 18.

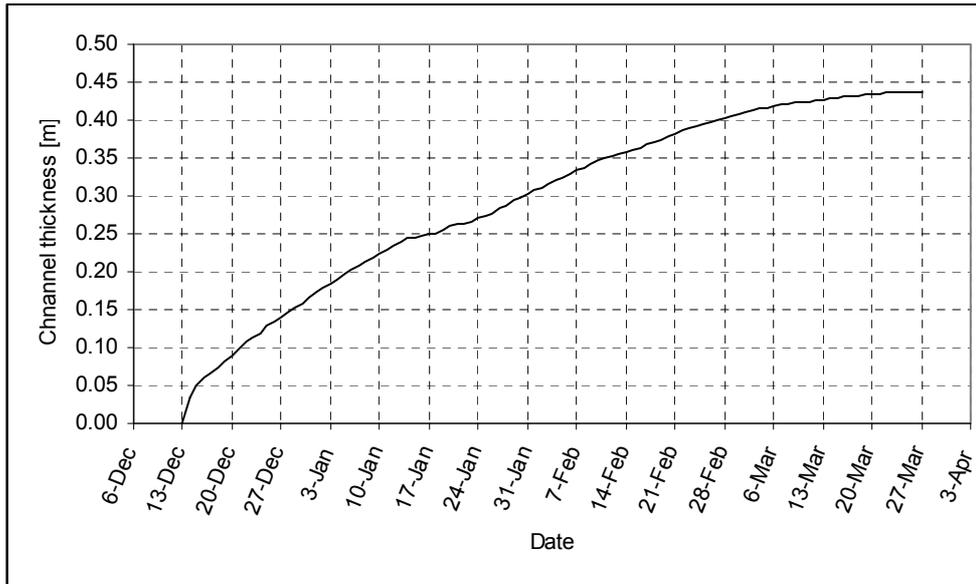
Figure 19. The mid channel thickness of the fairway leading to Loviisa.

The channel leading to Loviisa was navigated during the whole winter and it was measured the 11th of February and the average mid channel thickness was 0.35 m. The average daily temperature in Isosaari was continuously below zero degrees starting the 13th of December and the ice thickness out of Loviisa was 5-15 cm the 12th of December. Figure 19 shows the growth of the mid channel thickness starting from December 13.

The figures above are based on only a few measurements of the channel thickness and on the assumption that the channel thickness is proportional to the square root of cold sum. Because the channels could not be measured the same days as the voyages were made, some channel thicknesses had to be interpolated or extrapolated. The channel thicknesses used in the evaluation of the performance of the vessels in ice are presented in Table 5. The Emäsalo channel for Ship C was not the same channel than for the other ships but it was the Sköldvik channel west of Emäsalo and therefore the thickness is 0.15 m, which was defined in the 30th of January 2003.

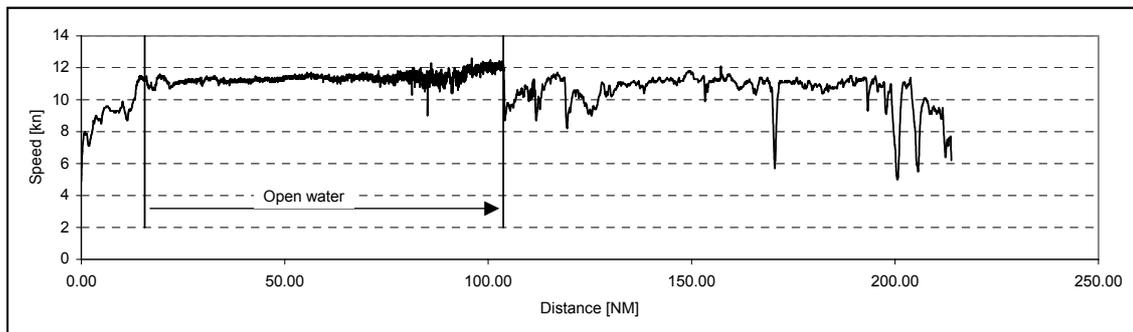
Figure 20. The speed of *Ship A* as a function of distance during her voyage from Inkoo to Parainen.

In the beginning of the voyage before the open water leg *Ship A* navigated in an old channel. The channel was relatively light because it was not very much navigated and the date was only the 26th of January. The speed during this leg was between six and ten knots. After the open water leg the vessel navigated in a very light ice channel where most of the slowing downs are because of some external reason. The ice channel was a very light quite newly broken channel with open water areas in the middle and a visual estimation from the bridge indicated that it did not have any actual side ridges. Since the ice class of the vessel is IA super, the vessel should have been able to sustain almost the open water speed of 13,7 knots in ice channels but she did not.

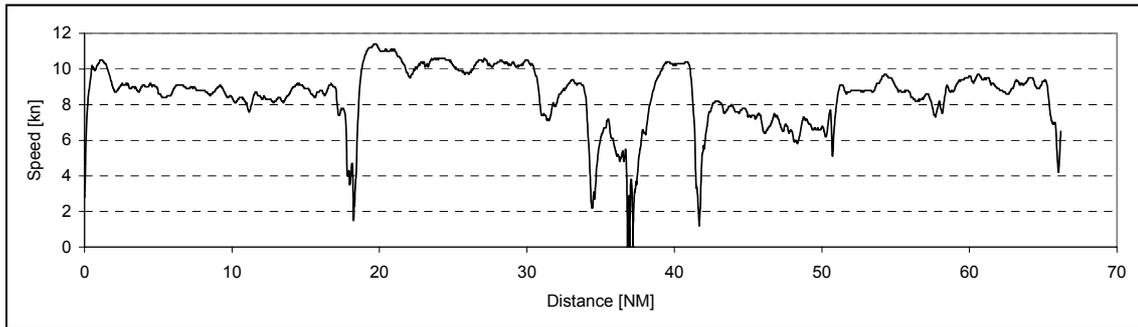
Figure 21. The speed of *Ship B* as a function of distance during her voyage from Loviisa to Hamina.

Ship B started the voyage well making a good time with the speed of 8...9 knots in a light ice channel. But when the ice channel got a little heavier or when the vessel turned or yielded to other ships the speed decreased dramatically. In some cases the speed dropped down to approximately two knots and several times down to five knots until she got stuck. After getting stuck she had to wait for 2 hours and 20 minutes to get free when another ship overtook her. The ice channel during the whole route should not have been very heavy and she still had difficulties in some locations, which indicates that she was close to her limits of capability in navigating in ice.

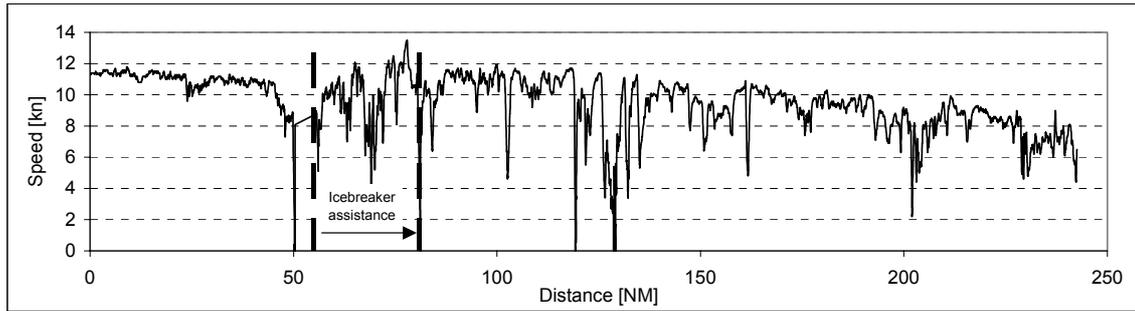
Figure 22. The speed of *Ship C* as a function of distance during her voyage between the position south of Hanko and Loviisa.

The difficulties before the archipelago fairway east of Helsinki are understandable because of the very heavy ice conditions where other more powerful ships also had difficulties. East of Helsinki the ice channel was light and she could keep up a speed of approximately ten knots. The archipelago fairway ice channel had been broken and taken into use only a few days earlier. So it could not have been very heavy in any locations and definitely not even close to one metre in the middle. Yet the speed dropped down to seven and even five knots when the ice channel got a little heavier. If the ice channel had been a little older she would probably have had difficulties to continuously keep up the speed of five knots.

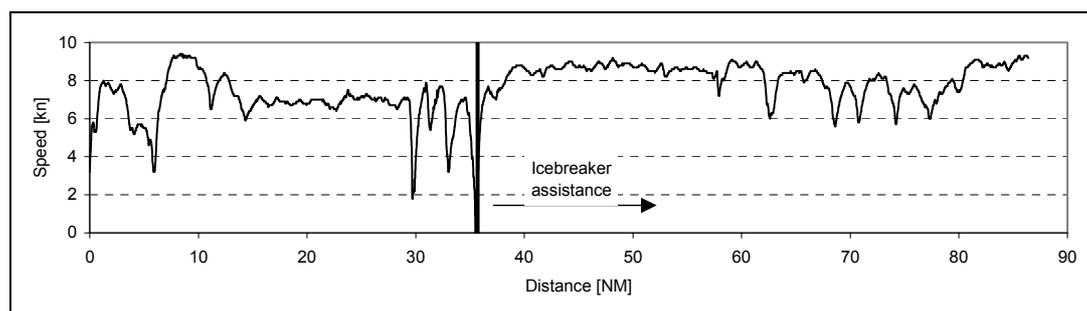
Figure 23. The speed of *Ship D* as a function of distance during her voyage from Kotka to Emäsalo.

In the beginning of the journey *Ship D* could occasionally keep up a speed of nine knots but the speed also dropped sometimes down to three knots. Again the channel was not very heavy and not close to the one metre thick rule channel. After a little more than two hours from Kotka the progression became quite difficult and in about half an hour she stopped to wait for icebreaker *Apu* that was coming from west. The

rest of the journey she was assisted by IB Apu but even then the speed decreased sometimes down to six knots without any obvious reason.

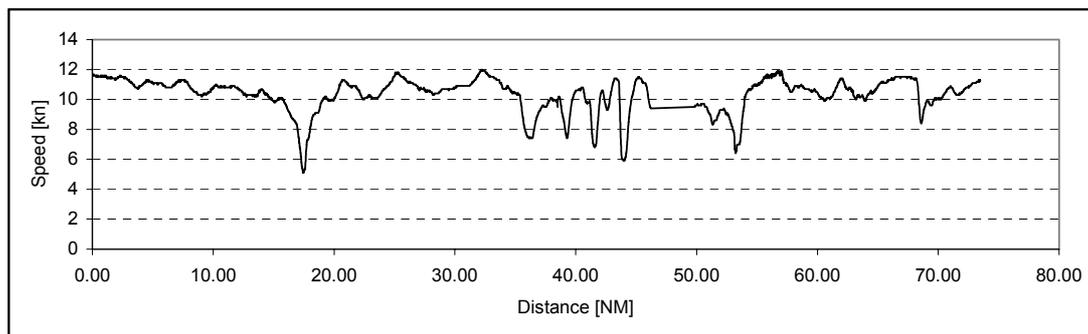
Figure 24. The speed of *Ship E* versus distance during her voyage from Utö to Naantali.

Ship E was coming into Naantali and the observations started north of Utö. The whole voyage was made in an ice old ice channel part of which was the fairway between Mariehamn and Turku. This ice channel was 100-150 metres wide and the vessel did not have any difficulties during the voyage. *Ship E* was in ballast during the voyage.

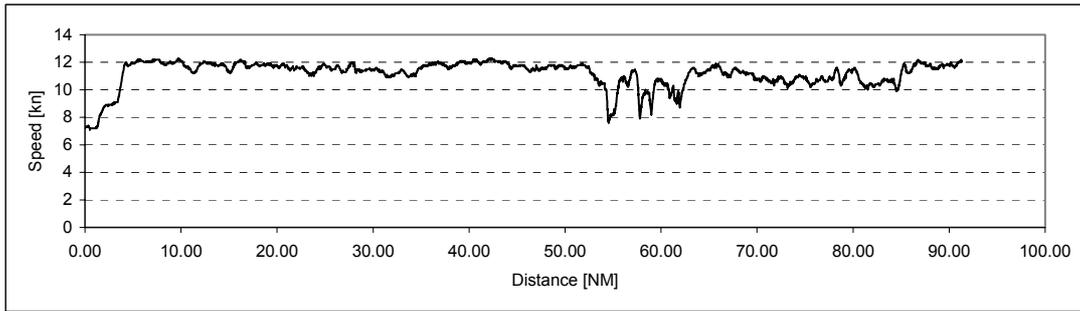
Figure 25. The speed of *Ship F* versus distance during her voyage from Södertälje to Västerås.

The voyage of *Ship F* was made in Lake Mälaren starting from Södertälje. The voyage was made maybe a little too late because the melting of ice had already started. The whole voyage was made in an ice channel but there were large open areas especially closer to Västerås, which was the destination port. The ship did not have any difficulties during the voyage.

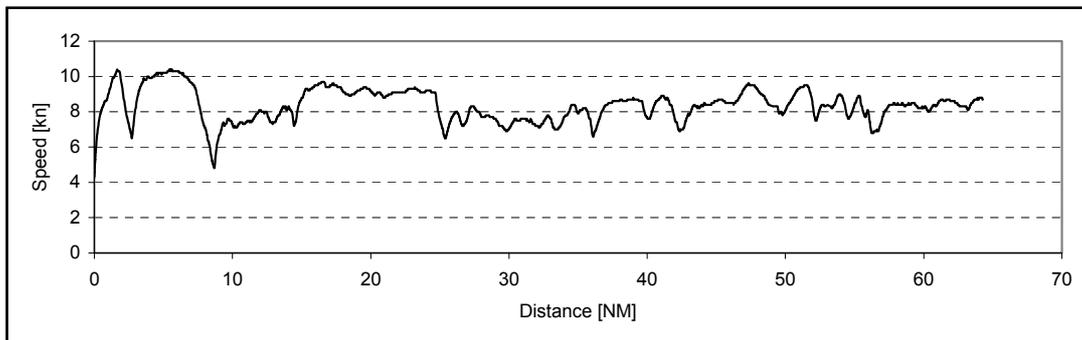
Figure 26. The speed of *Ship G* versus distance during her voyage from Loviisa to Emäsalo.

Ship G made the journey rather well being able to keep up the speed of eight, nine knots. The speed decreased below seven knots only because of some other reason e.g. when she met another ship. The journey was made in mid-March and the melting of ice had already started but the ice channel was still relatively heavy to navigate.

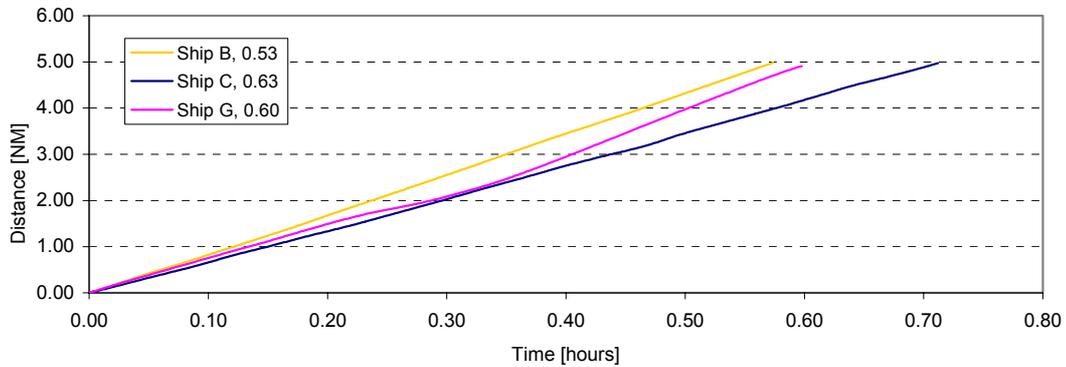
Figure 27. Distance versus time in the ice channel leading to Loviisa. The ratios between the installed power and the new power requirement are shown in the legend.

The ice channel leading to Loviisa was used by *Ship B* 28th of January, by *Ship C* a week later and by *Ship G* the 13th of March. The leg was only about 5 NM long and *Ship B* and *Ship G* did it almost in the same time but *Ship C* did a little slower (Figure 27). *Ship G* was coming out of Loviisa and she did not keep up full speed all the time because of some machines working on ice. Figure 28 shows the speed of the vessels during the leg.

Ship B and *Ship C* used full power during this part of the voyage and *Ship B* did the leg one week earlier. The average speed of *Ship C* was 7.0 knots and *Ship B* 8.7 knots. *Ship B* seems to perform a little better in ice than *Ship C*, which can also be seen in the H-V –curve (Figure 33). *Ship G* used full power only for about 2.5 miles and her average speed was about 10 knots. *Ship G* did this part of the voyage about one and a half months later than *Ship B*, and so the channel must have been heavier which indicates that *Ship G* performs much better in ice than *Ship B* and *Ship C*.

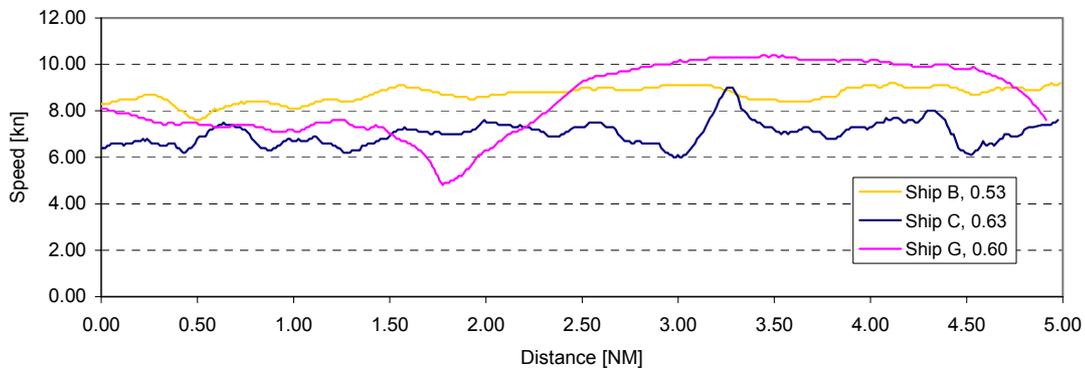
Figure 28. Speed versus distance in channel leading to Loviisa. The ratios between installed power and new power requirement are shown in the legend.

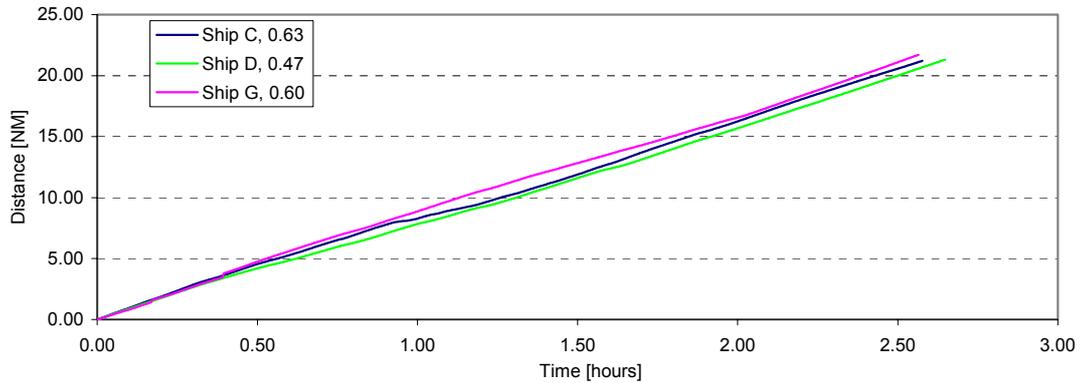
Figure 29. Distance versus time in the ice channel between Loviisa and Emäsalo. The ratios between the installed power and the new power requirement are shown in the legend.

Ship C, *Ship G* and *Ship D* used the same channel for 22 NM from the south of Loviisa to Emäsalo. The ships seem to be equally good in performing in the ice

The average speeds during this leg were for *Ship C* 8.24 knots, for *Ship D* 8.06 knots and for *Ship G* 8.30 knots. The average speeds are almost the same for all ships but *Ship G* did the voyage one month after *Ship D* and one and a half months after *Ship C* and the ice channel must have been much thicker and heavier. The ice channel south of Emäsalo was 28 cm thick, 43 cm thick and 58 cm thick (Figure 18) when *Ship C*, *Ship D* and *Ship G* did their voyages respectively, which indicates that *Ship G* performs better in ice than *Ship D* and *Ship C*. *Ship D* seems to be a little better than *Ship C* although her ratio between the installed power and the new requirement is smaller than *Ship C*'s.

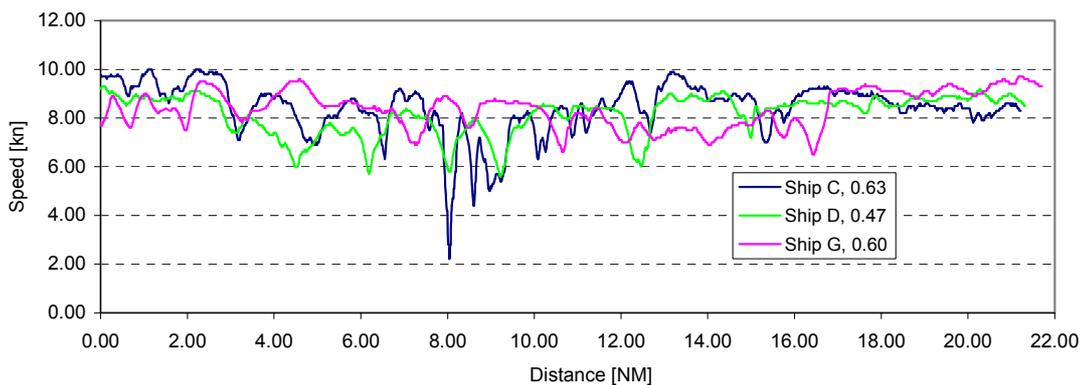
Figure 30. Speed versus distance in the ice channel between Loviisa and Emäsalo. The ratios between the installed power and the new power requirement are shown in the legend.

channel (Figure 29). Figure 30 shows that there were some differences in speeds but all three vessels could keep the speed of about 8...9 knots.

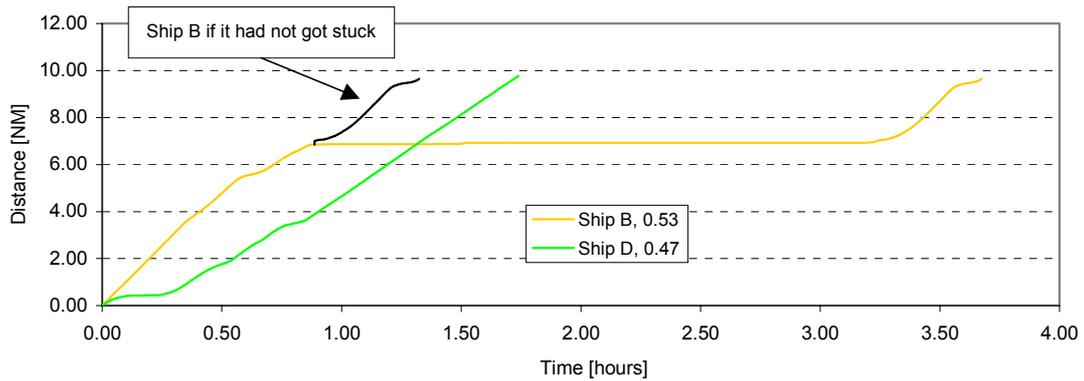
Figure 31. Distance versus time in the ice channel between Loviisa and Hamina. The ratios between the installed power and the new power requirement are shown in the legend.

Ship D and *Ship B* used the same ice channel about 10 NM east of Loviisa. *Ship D* did the voyage about two weeks later than *Ship B*. Distance versus time and speed versus distance are presented in Figure 31 and Figure 32.

Ship B got stuck in ice and she had to wait about two and a half hours before a roro vessel passed her and she got loose. Figure 31 also shows that if *Ship B* had not got stuck she would have done the voyage in almost half an hour faster than *Ship D*. *Ship D* of course did the voyage two weeks later but this part of the voyage was only 10 miles long, which gives the average speed of 5.6 knots for *Ship D* and 4.0 knots for *Ship B* but if *Ship B* had not got stuck her average speed would have been 7.3 knots. It is difficult to evaluate the order of these two vessels but it looks like *Ship B* performed a little better in ice.

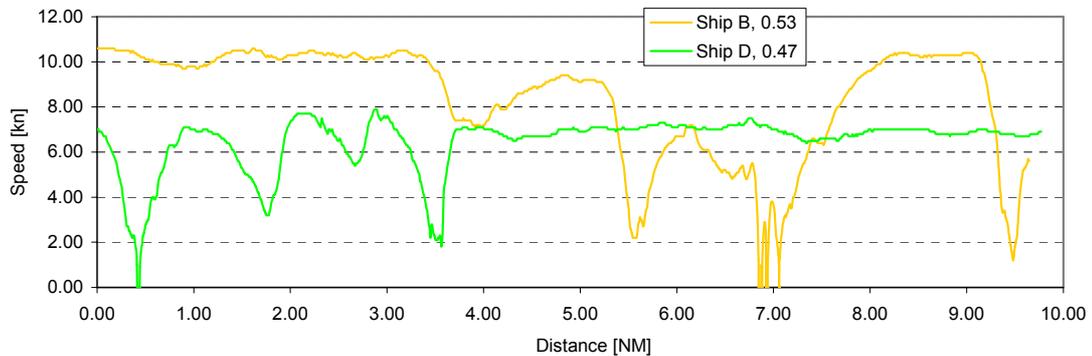
Figure 32. Speed versus distance in the ice channel between Loviisa and Hamina. The ratios between the installed power and the new power requirement are shown in the legend.

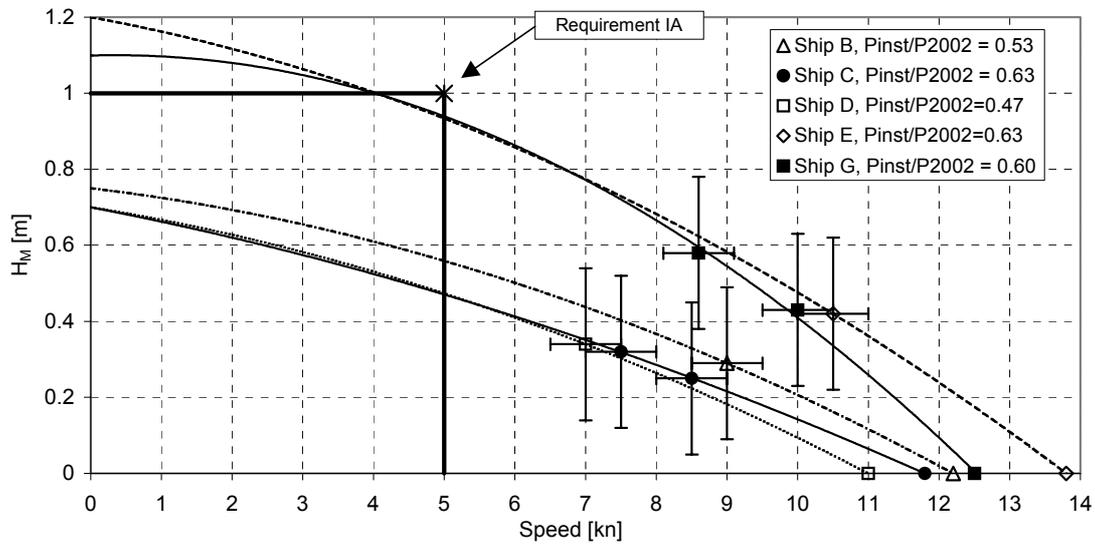
Figure 33. Estimated H-V -curves for five ships constructed using one or two speeds in an ice channel and the open water speed. The ratio between the installed and the required power for each ship is shown in the legend.

The channel profiles were measured a few times during the observation period. Some of the voyages were made approximately at the same time with the channel measurements but some thicknesses of channels had to be estimated with the help of the temperature data. The H-V –curves in Figure 33 are based on the measured and

estimated channel thicknesses presented in Chapter 4.2 and the open water speed. Error bars ± 0.20 m was used for the channel thickness and ± 0.50 knots for speed.

The H-V -curve of *Ship D* is also presented in Figure 33. The only ice channel measured in the route of *Ship D* was the Emäsalo ice channel, but an icebreaker assisted *Ship D* at that time and the data collecting was actually stopped just before the measured profile. However *Ship D* used the same route as *Ship B* and the H-V -curve was constructed as follows.

The speed of *Ship D* was 7.0 knots in February 12 and the speed of *Ship B* was about 10.0 knots in January 28 in location 60.371°N, 26.708°E. According to the H-V -curve of *Ship B* the channel thickness was approximately 0.20 m. This part of the ice channel is between Hamina and Kotka and so only ships navigating to Hamina use it. Therefore the ice channel can neither be compared to the measured one, much navigated part of the archipelago ice channel nor to the much less navigated Loviisa ice channel but the ice channel was probably something between these two. According to Figure 18 the thickness of the archipelago ice channel in the 12th of February was about 0.40 m and according to Figure 19 the Loviisa ice channel grew between the dates of the voyages of *Ship B* and *Ship D* about 7 cm, which gives the channel thickness of 0.27 m. The average of these two thicknesses, 0.34 m, was taken to the H-V -curve.

The H-V -curves of *Ship E* and *Ship G* go close to the IA rule point, 5 knots in one metre thick channel, but the H-V -curves of *Ship C* and *Ship B* are far from the rule requirement. *Ship E* is a much larger vessel than the others with deadweight of 4803 dwt, which may explain the large difference but *Ship G*, *Ship B* and *Ship C* are about the same size. One difference between these vessels is that *Ship B* and *Ship C* have CP-propellers but *Ship G* has an FP-propeller.

The H-V –curve in channel could be constructed for five ships (Figure 33). According to this curve two ships, *Ship E* and *Ship G*, almost fulfilled the requirement for ice class IA, five knots in one metre thick channel, but three ships, *Ship C*, *Ship D* and *Ship B* were relatively far from the requirement. Some of these five ships made a part of their voyages in the same ice channel and could therefore be compared with each other. The comparisons supported the constructed H-V –curve especially in the case of *Ship D* which used the same fairway with *Ship C* between Loviisa and Emäsalo and with *Ship B* between Loviisa and Hamina. In both comparisons *Ship D* seemed to have performed a little worse than the two other ships. Therefore her H-V –curve is at most the same as *Ship C*'s or *Ship B*'s, which means that she does not fulfil the requirement.
