Research Report No 50

DAMAGE STATISTICS OF ICE-STRENGTHENED SHIPS IN THE BALTIC SEA 1984 - 1987

**HELSINKI UNIVERSITY OF TECHNOLOGY
Laboratory of Naval Architecture
and Marine Engineering**

Espoo, April 1991

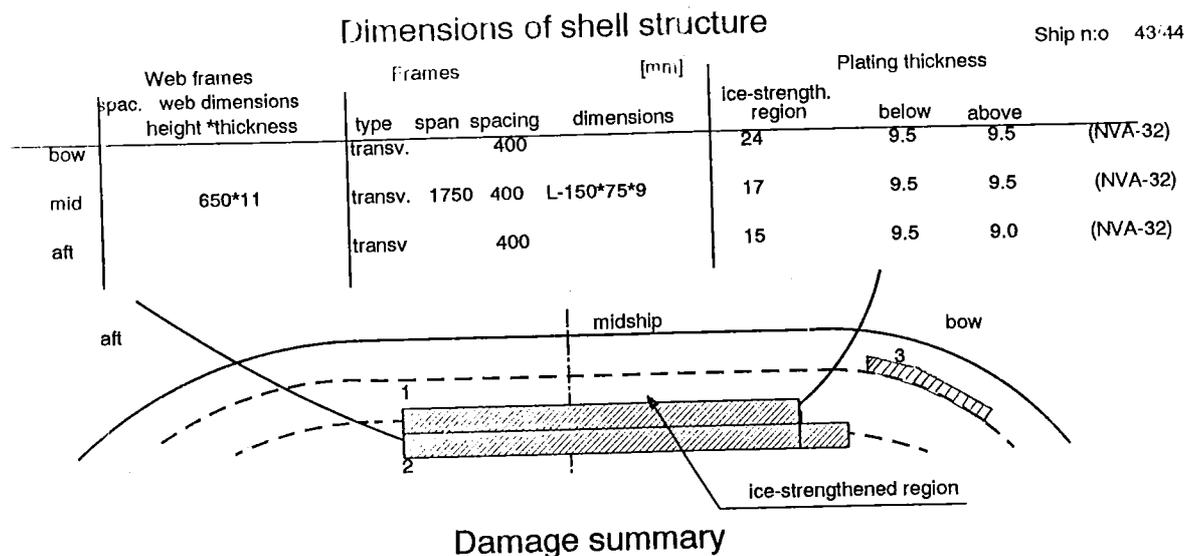
Fig. 29. Dimensions of shell structure and summary of damages onboard ship no. 43/44.

These ships are sister ships with the same navigation routine. Therefore the damages are also similar. The damage consists of denting of shell plating between frames, located either above or below the ice-strengthened region, see Fig. 29. The reason for the damage outside the ice-strengthening is obvious as the thickness of the plating changes from 24 mm to 9.5 mm when the ice-strengthening ends.

Area n:o	Damage type	length [m]	height [m]	max deflection [mm]
1	Yielding of plating (spac. = 400)		0.5	25
2	Yielding of plating (spac.=800)		1.0	30
3	Yielding of plating (spac.=400)		1.0	10

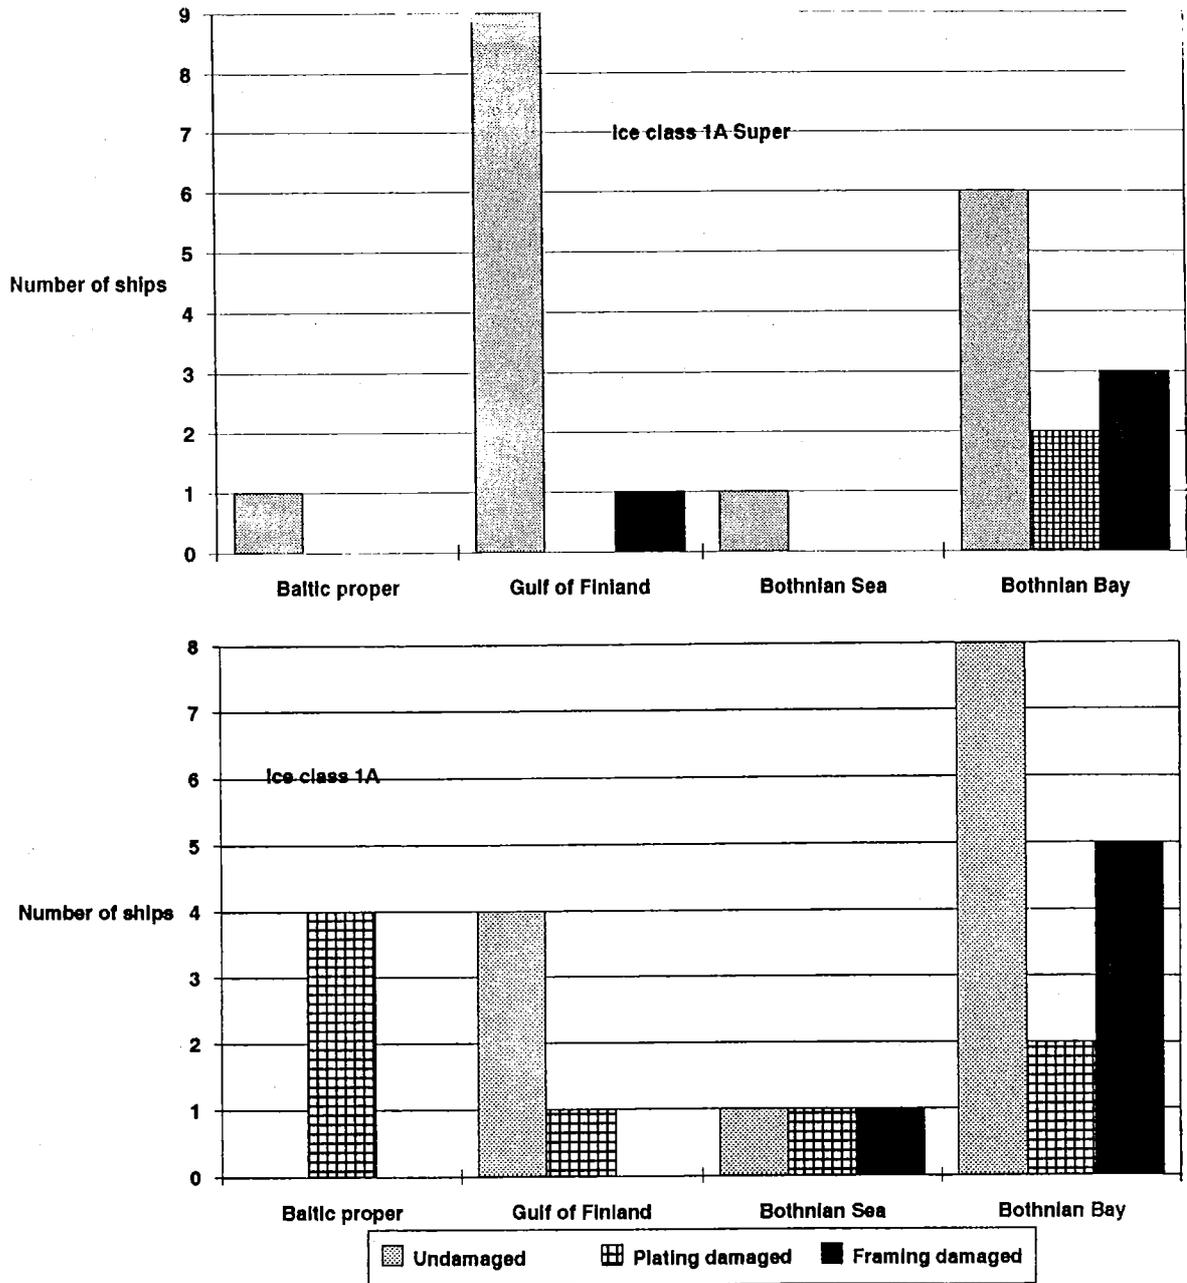
Fig. 35. Number of transversely framed ships damaged in the two ice classes in various sea areas.

Fig. 35 summarises the damages of transversely framed ships with ice classes 1AS and 1A, in various sea areas. The study includes 23 1AS class ships of which 6 (26 %) were damaged. Most damages have occurred on the ships navigating to the Bothnian Bay. Two of the ships have damage only on plating. From the 26 1A-class ships 14 (54 %) have damages. Of these, 8 ships (31 %) have damages only on plating outside ice-strengthened region and 6 ships (23 %) have damages also on ice-strengthened frames. The plating damages have mostly occurred on passenger ferries navigating in the Baltic proper and Gulf of Finland and they are above and below the ice-strengthened region. This is due to the fact that with high speed in a

fast ice channel the ice-induced loads extend to a greater area than specified in 1971 rules for the ice-strengthened region.

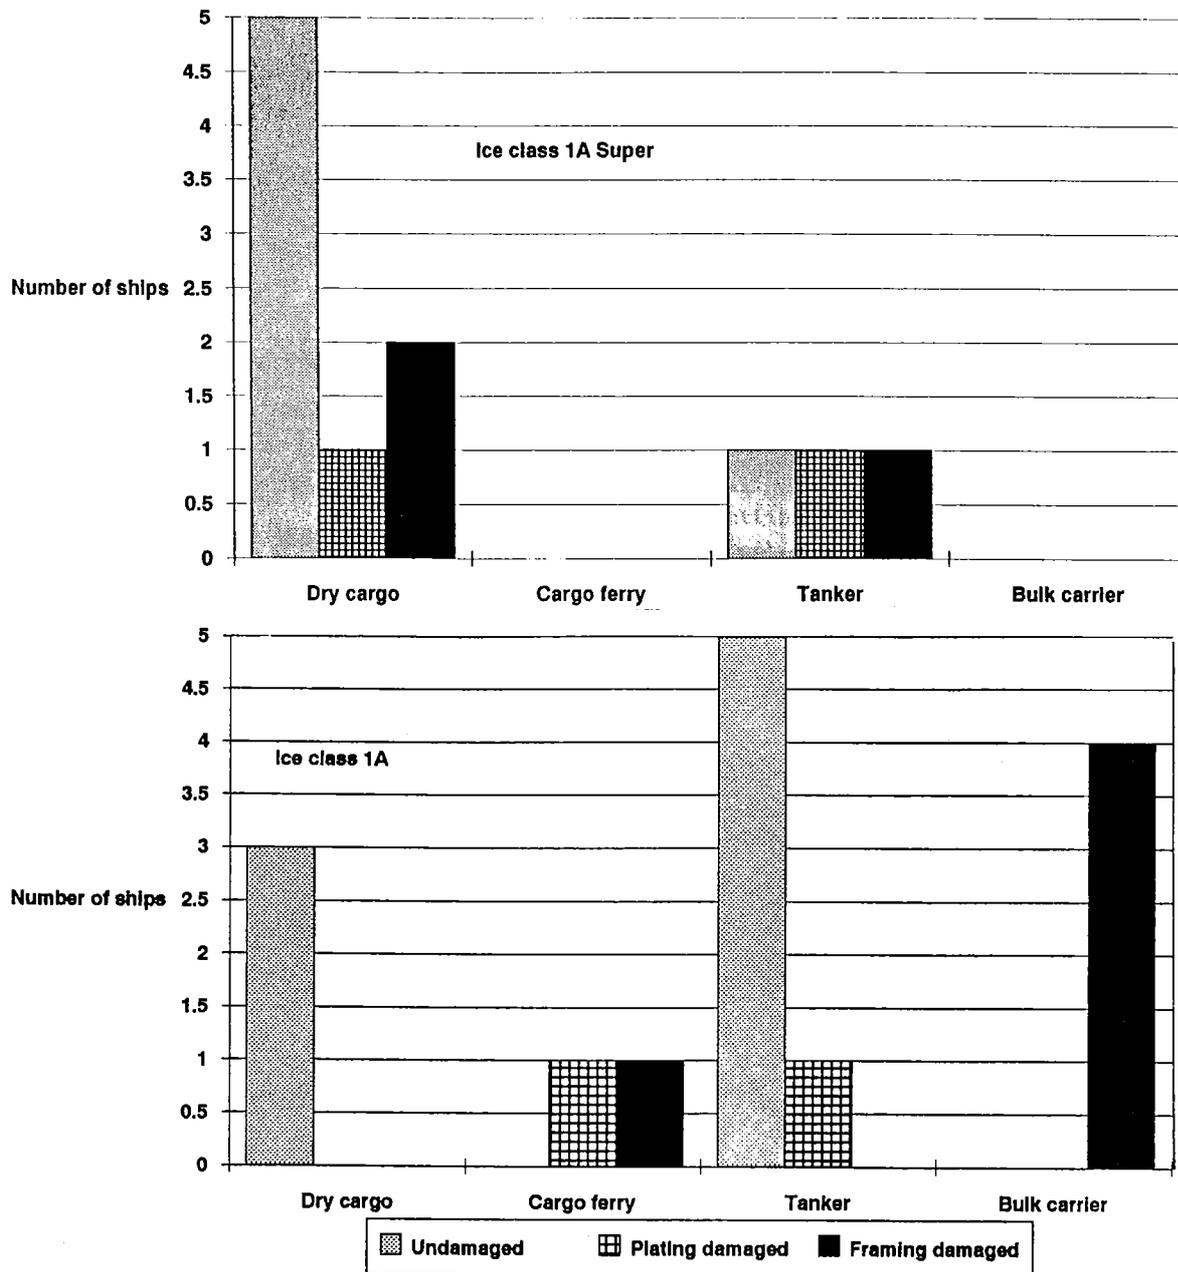
Fig. 36. Number of transversely framed ships damaged in the two ice classes when navigating to the Bothnian Bay.

The damages on frames have occurred mainly on ships navigating to the Bothnian Bay. These are also summarised in Fig. 36 using ship type as a parameter. From the 1AS class, dry cargo ships have most of the damages and from the 1A class, bulk carriers have most of the damages. Most of the damages are located at midships.

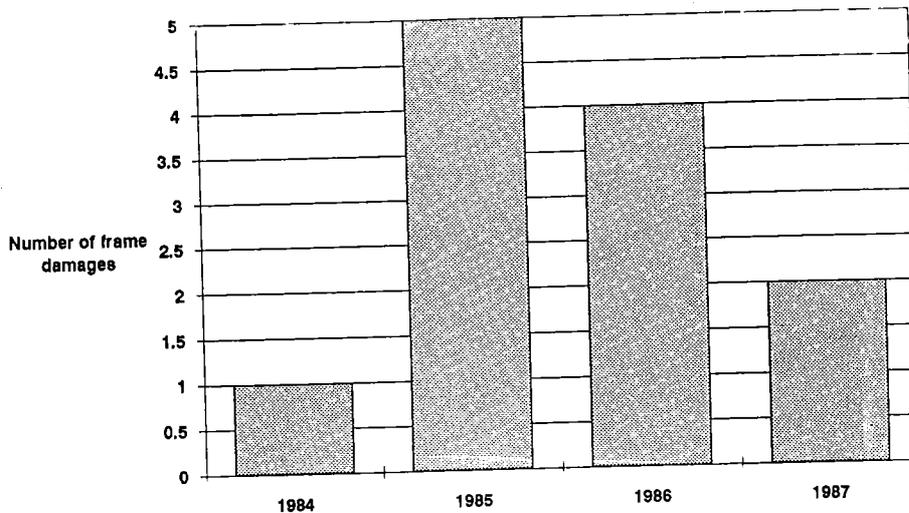
Fig. 37. Number of ships with damaged transverse frames found during various winters.

Fig. 37 summarises the number of damages found annually on transverse frames. This figure includes only the damages on ice-strengthened frames, as typically the plating damages occur gradually over several winters. The highest number of damages occurred during the winter 1985. All the damages on the ice-strengthened region of 1AS-class ships with transverse framing have occurred during the winter 1985. The damage frequency of the winter 1986 is also high. Winter 1987 was also hard, but the damage

frequency is lower probably due to the nonsystematic gathering of statistics during that winter and due to the decrease of the Finnish ice-strengthened tonnage during the year 1986. Only one damage is observed during the average winter of 1984.

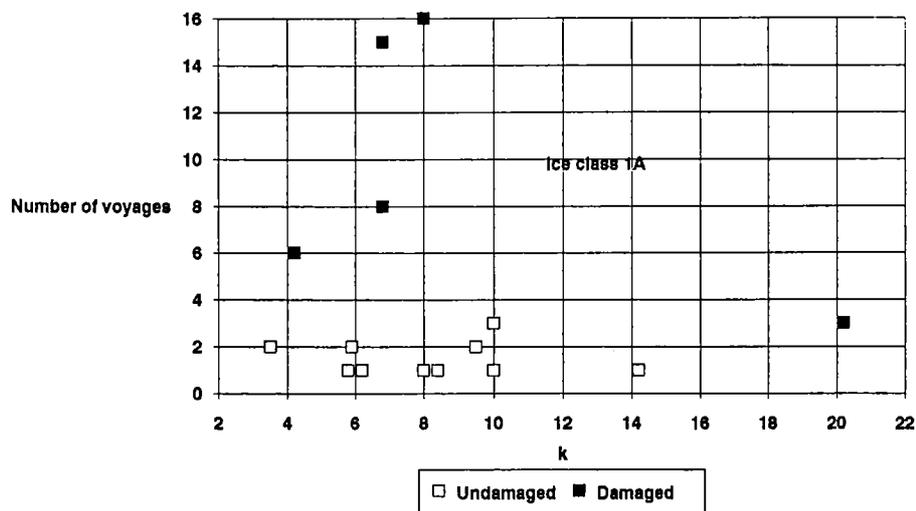
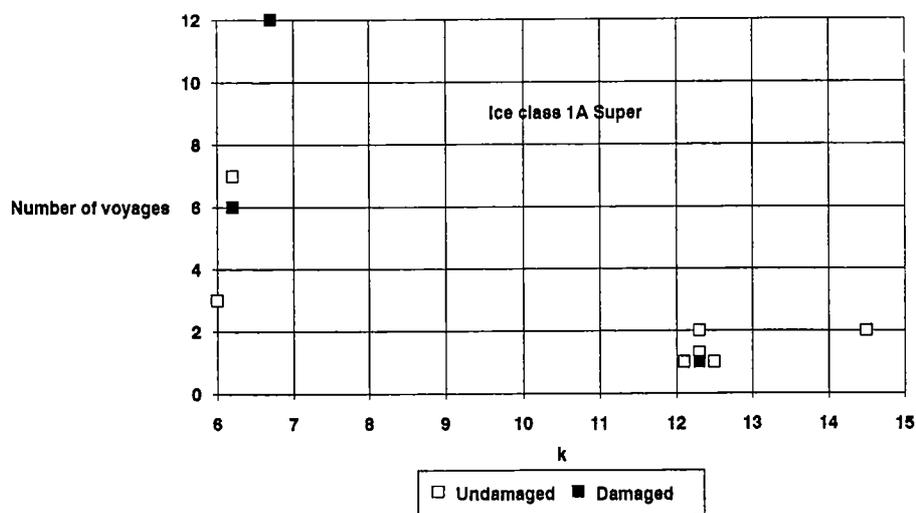
Fig. 38. Number of voyages to the Bothnian Bay during winter 1985 for the two ice class damaged or undamaged ships as a function of the factor k (see eq. 1). The figure includes only ships with damages on ice-strengthened transverse frames.

Some studies were also conducted to find the most important parameters affecting the probability of frame damages. The navigation frequency of ships to the Bothnian Bay is one of the key parameters as illustrated in Fig. 38. As can be seen from Fig. 38 all the 1A-class ships with navigation frequency higher than 3 voyages/winter have experienced frame damages. This can be understood as most damages have occurred in compressive ice, which occurs occasionally depending on movement of ice due to the wind. Therefore the probability of experiencing compressive ice increases with increasing navigation frequency.

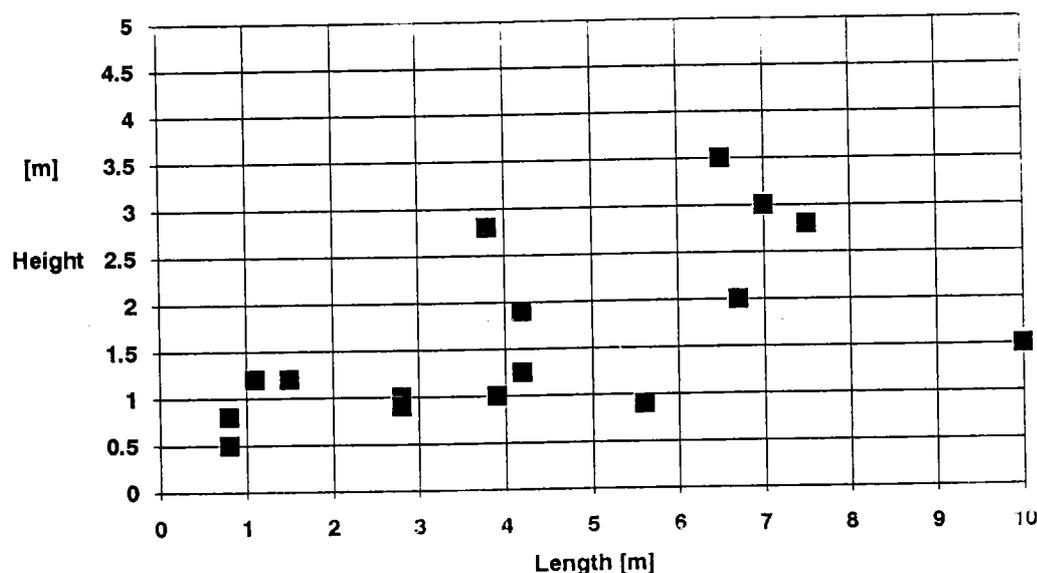
Fig. 39. The length versus height of the observed damages.

Typical damages on frames extend about 5 to 20 frame spacings with maximum deflections of about 50 mm. The height of the damages vary from 0.5 to 3 m as shown in Fig. 39.

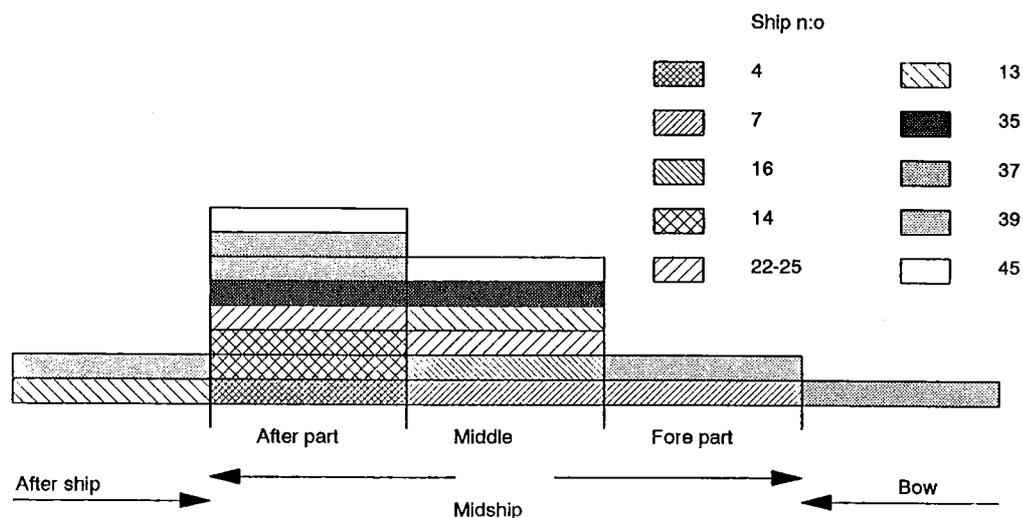
Fig. 40. The location of frame damages on various ships.

Fig. 40 summarises the location of framing damages. Most damages are located at midships on the ice-strengthened region, especially at the aft end of the midship region. Only one damage was observed on the bow area and two on the after ship area.

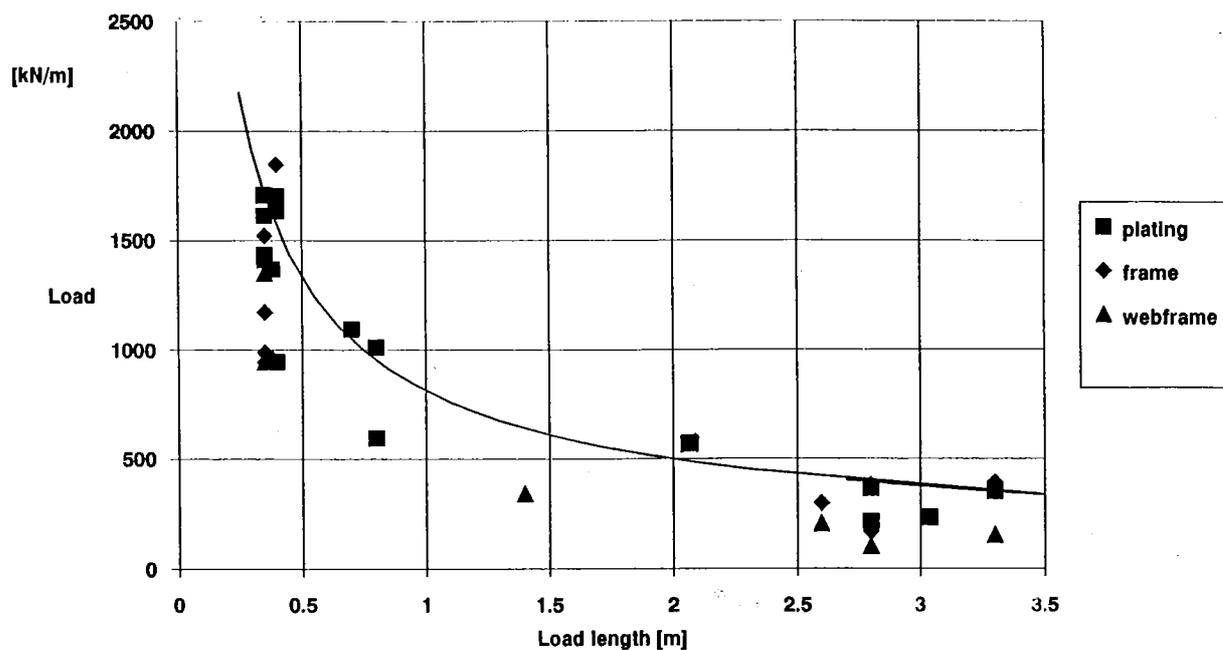
Fig. 42. The lineload intensity as a function of the load length for midship area based on the analysis of damages on various structural elements.

The load values for the midship area are also given graphically in Fig. 42, where the load is divided by the apparent load length to obtain the mean intensity of the line load. A exponential curve is fitted to the maximum load intensity values and the following curve is found to fit the data:

where the unit of q is [kN/m] and of l is [m]. This curve gives the maximum load intensity calculated from the damages on the midship area, where most of the damages are located. Formula (6) enables the estimation of the local ice-induced pressures if the load height is known. As stated earlier the nature of contact is not properly known at the present stage, but contact heights of only a couple of centimeters have been observed. Assuming $c = 10\text{mm}$ the ice-induced pressure with an apparent contact length $l = 1\text{m}$ is 81,4 MPa and assuming $c = 30\text{ mm}$ the pressure with $l = 1\text{m}$ is 27.2 MPa.

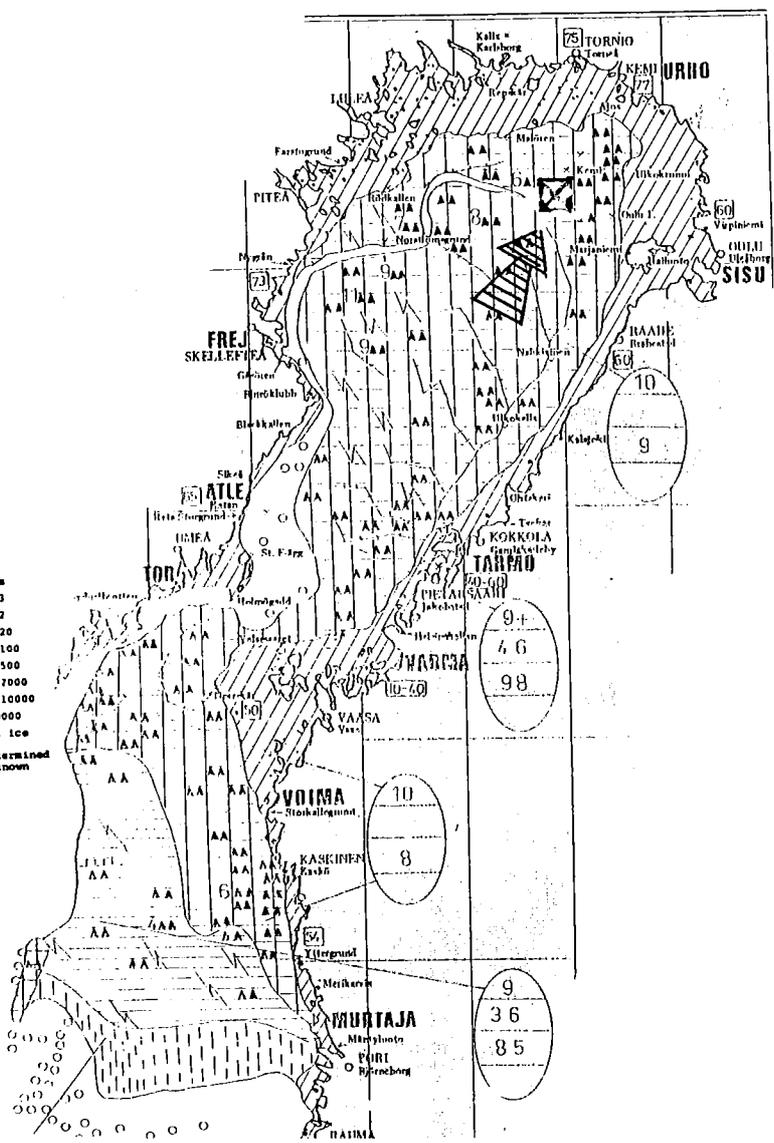
ICE CONDITIONS ON 27TH OF MARCH 1985 WHEN SHIP N:O 13 WAS DAMAGED

Wind 7 m/s from S

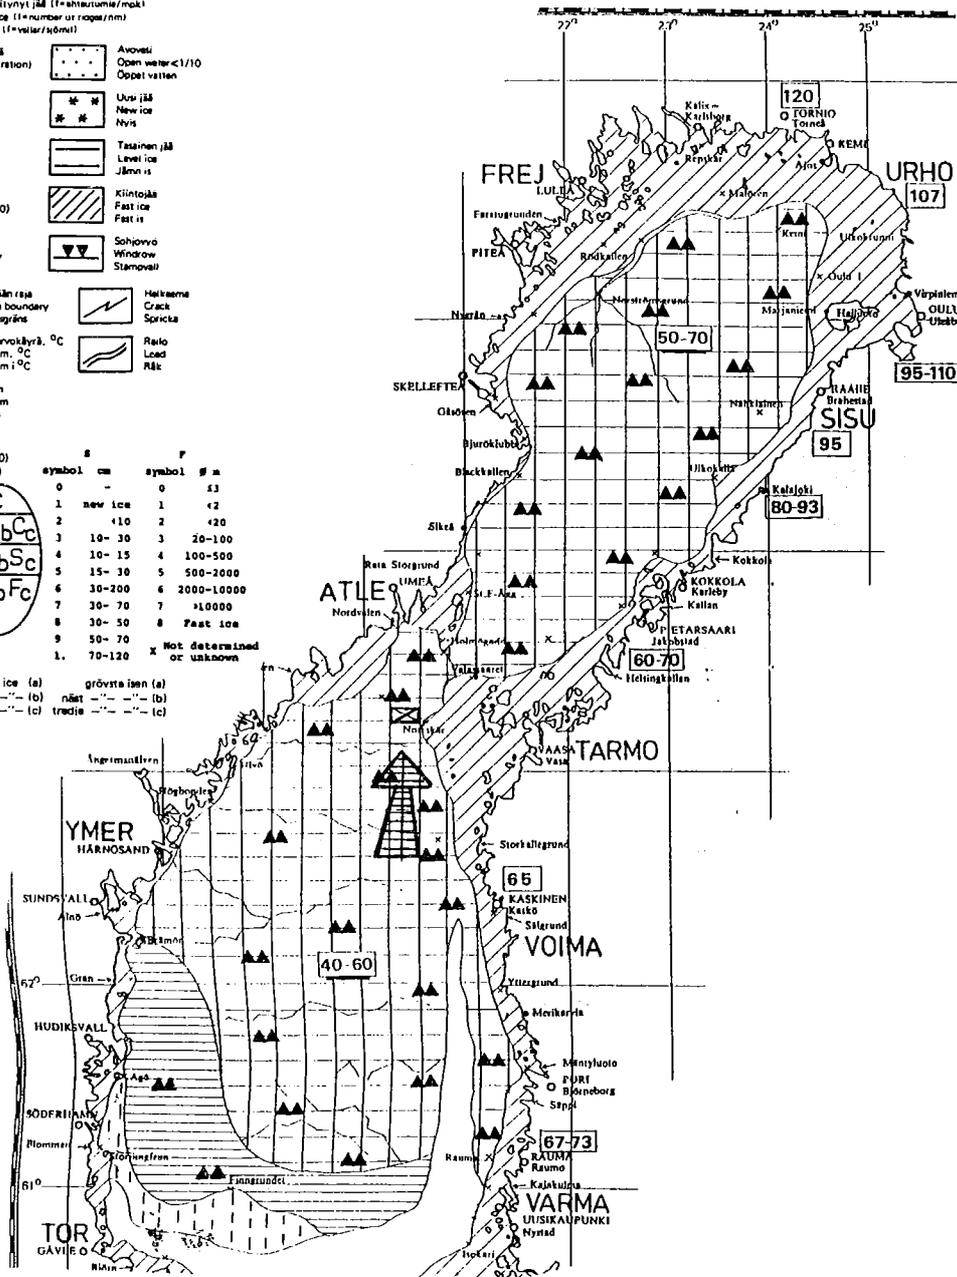
ICE CONDITIONS ON 1ST OF MAY 1985 WHEN SHIP N:O 13 WAS DAMAGED

Wind 7 m/s from NE
