STYRELSEN FÖR
VINTERSJÖFARTSFORSKNING
WINTER NAVIGATION RESEARCH BOARD

Research Report No 54

**INCIDENTS AND ACCIDENTS IN WINTER NAVIGATION IN THE BALTIC SEA,
WINTER 2002 – 2003**

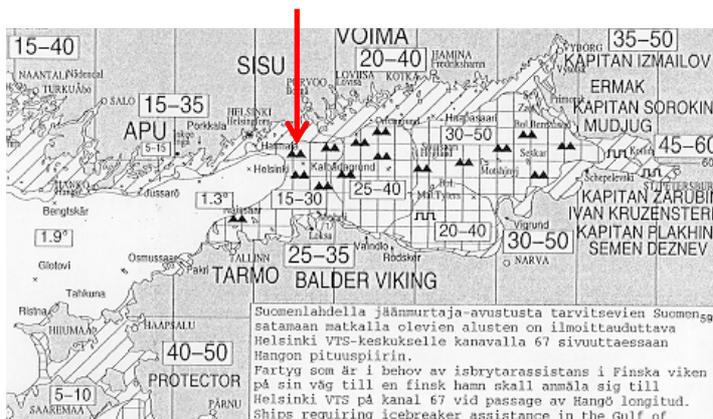
This ship was damaged in the Gulf of Finland 21st of January 2003 due to moving and compressive ice field (Fig. 7). The tug was traveling in an ice lead near Kaunissaari. The ship got stuck and started to drift sideways along the ice masses with speed of 2-3 knots. Ice pieces piled up against ship's side shell. Pile-up and drifting lasted about 20 minutes and after that ice pieces started slide below the ship bottom. When the compression eased off the ship drove to the fast ice field and waited for icebreaker assistance. Icebreaker towed the ship to the nearest harbour. The whole episode lasted about two hours until the icebreaker came.

Figure 7. Ice chart of 20th of January 2003 and the position of the incident.

The consequence was that 8 frames in SB side (frames #15-19 and #21-24) and 4 frames in PB side had a permanent deflection of 10-30 mm 20 cm below the water line depth. In

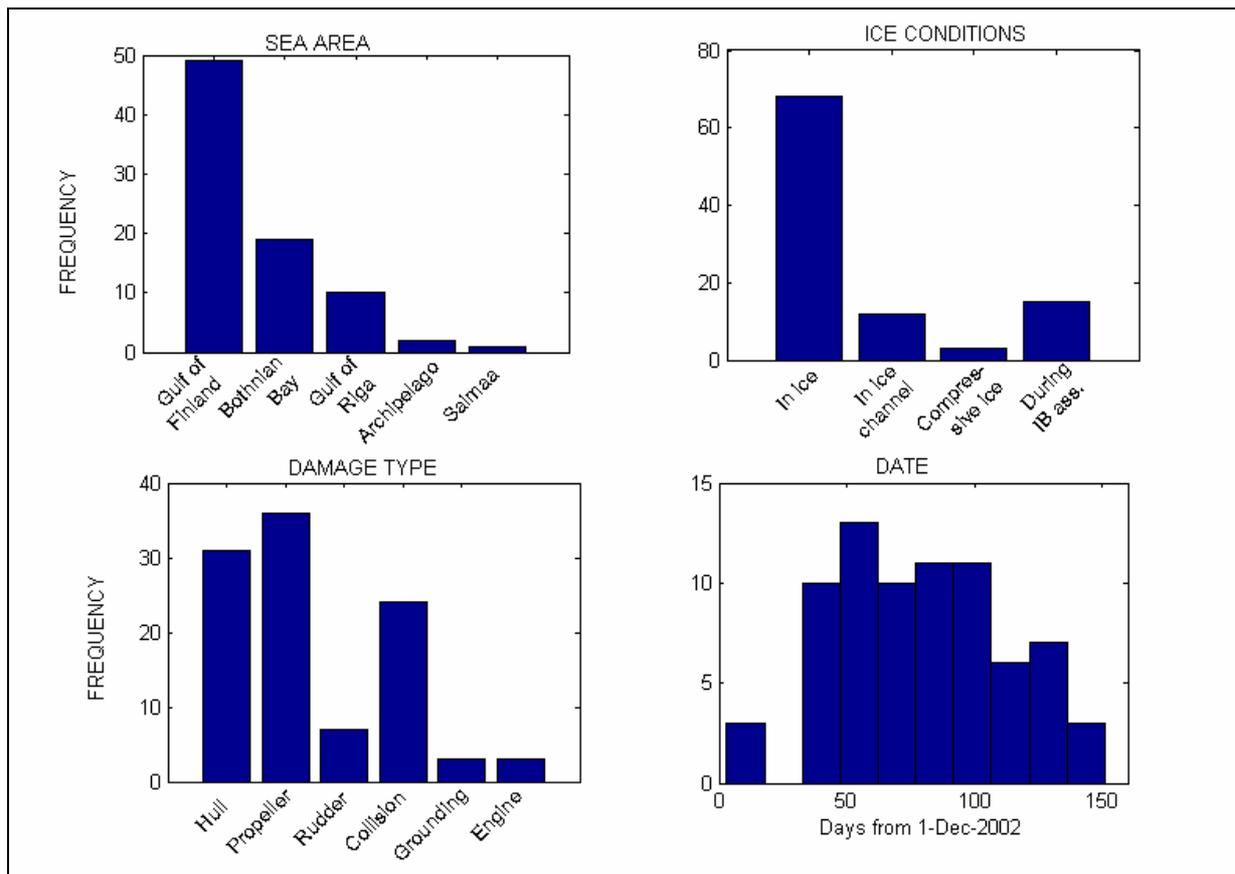
A summary of the damages that occurred during winter 2003 is presented in Figure 23. The main part of the damages occurred in the Gulf of Finland, which is the most operated sea area. Three main types of damages are propeller damages, hull damages and damages due to collision with other ships (merchant vessel or icebreaker) in heavy ice. The conditions during the incident are arranged in four groups. “In ice” means that damage occurred generally in ice. In that case the conditions are not well known. “In ice channel” means that ship was moving independently in an ice channel or in an ice lead. Ships may have damaged also during icebreaker assistance. Compressive ice may have caused direct hull ice damage or the ship may have drifted to ground with the moving ice field. Most of the damages occurred between mid January and end of March 2003. During that period the ice conditions were the most severe.

Figure 23. A summary of the ice damages included in the study.

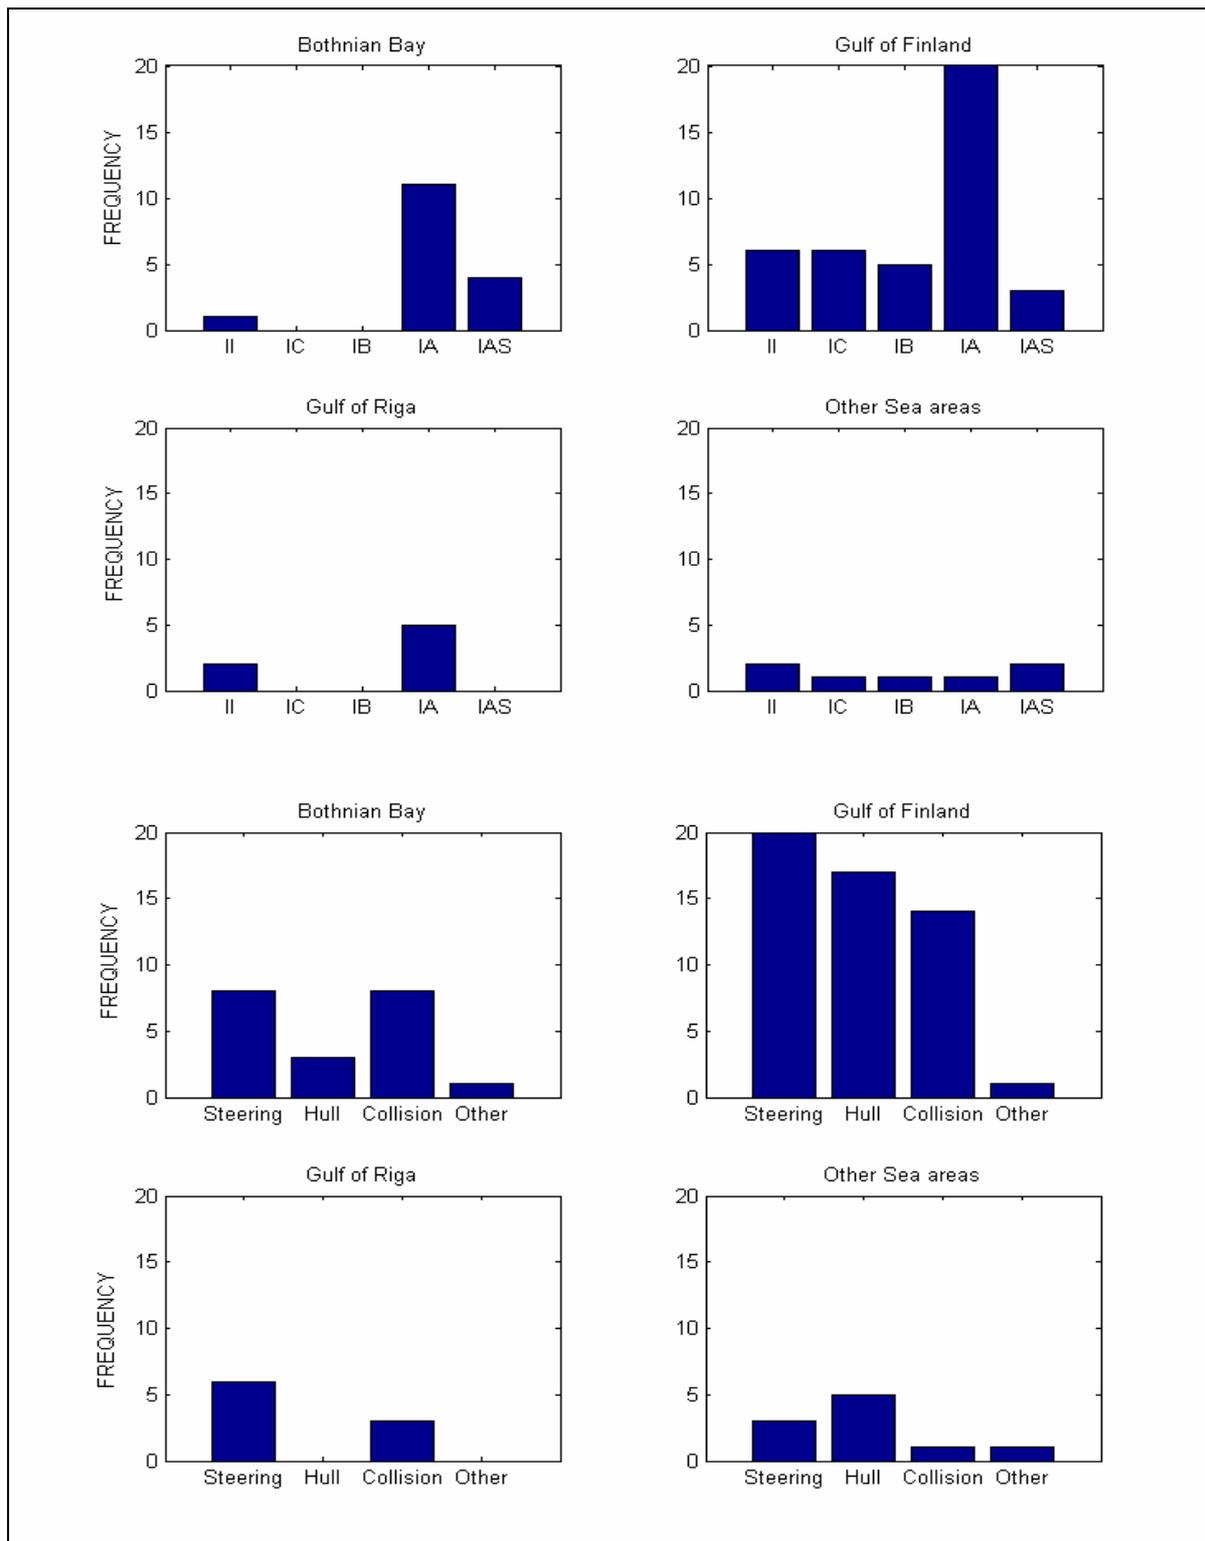
The ice classes of damaged ships and the damages are arranged for different sea areas in Figure 24. Most of the damages occurred in the Gulf of Finland. In the Gulf of Finland all ice classes were well represented. Two most typical ice damages in the Gulf of Finland were damages to steering devices and hull damages. In the Bothnian Bay there was only one incident concerning a ship that has the ice class II. This propeller damage occurred during early winter before the navigation restrictions. Otherwise the damaged ships in the Bothnian Bay had ice class IA or IA Super. In the Bothnian Bay the two most typical damages were rudder/propeller damages and ship collisions in an ice channel due to heavy ice conditions.

Figure 24. Ice classes of the damaged ships and damages that occurred in different sea areas.

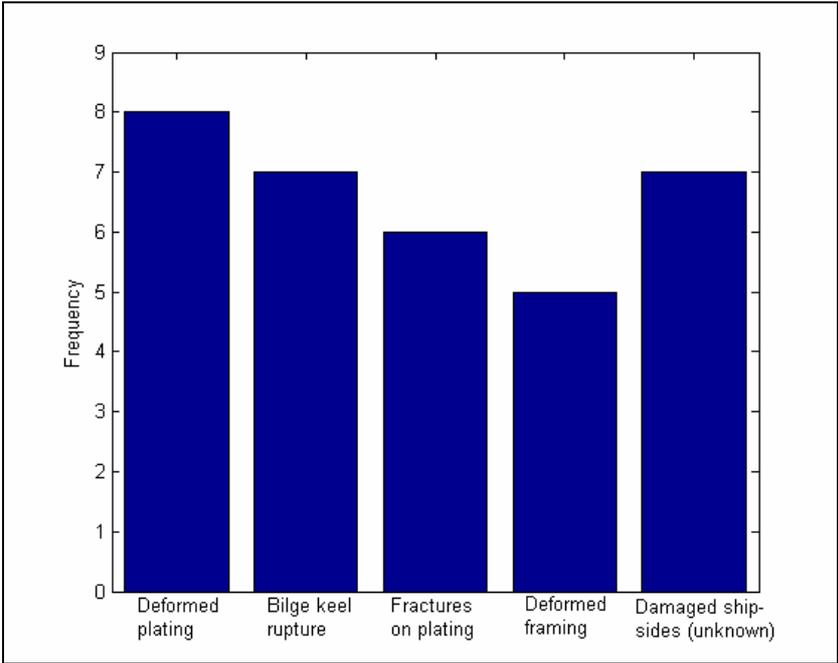
The most typical hull ice damage is that where the ship plating has a permanent deformation (Fig. 25). If frames were deflected, then plating was also damaged. The dents on the plating were normally between 10 mm and 50 mm deep (i.e. 1-3 times the plate thickness). If fractures also occurred, the dents were between 50 mm and 200 mm around the fracture. The bilge keels were damaged on ships having relatively high speed in ice and a small draught. Most of the damages occurred on the bow and on the mid ship regions (Fig. 26). In the

Figure 25. Summary of the damages found on different ships.

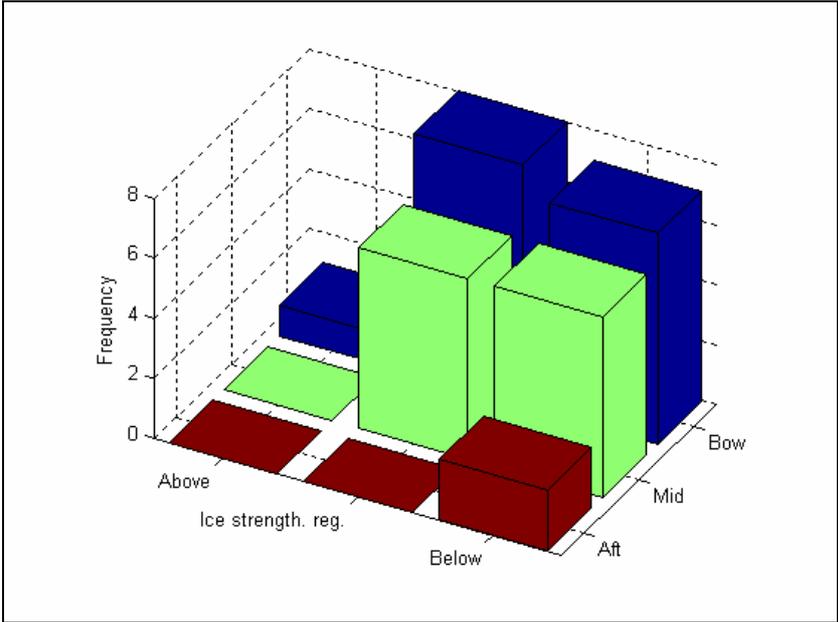
vertical direction, the damages were located on and below the ice-strengthened region. According to the ice class rules, the vertical extension of the ice belt below the ballast waterline shall be between 0.5 m and 0.75 m, depending on the ship's ice class. In some cases, indents due to ice loading were found on the bilges and the ship bottom, several meters below the ballast waterline. Aft ship damages were due to backing in ice, and damages above the ice belt were caused by the bow wave associated with high speed in ice. Most of the fractures were located on the bow area. These ships were already initially in bad condition (a lot of corrosion, abrasion and denting) or there was inadequate ice strengthening. In one case, the fracture was located on the bottom of the aft ship region.

Figure 26. Locations of damaged areas of different ships.

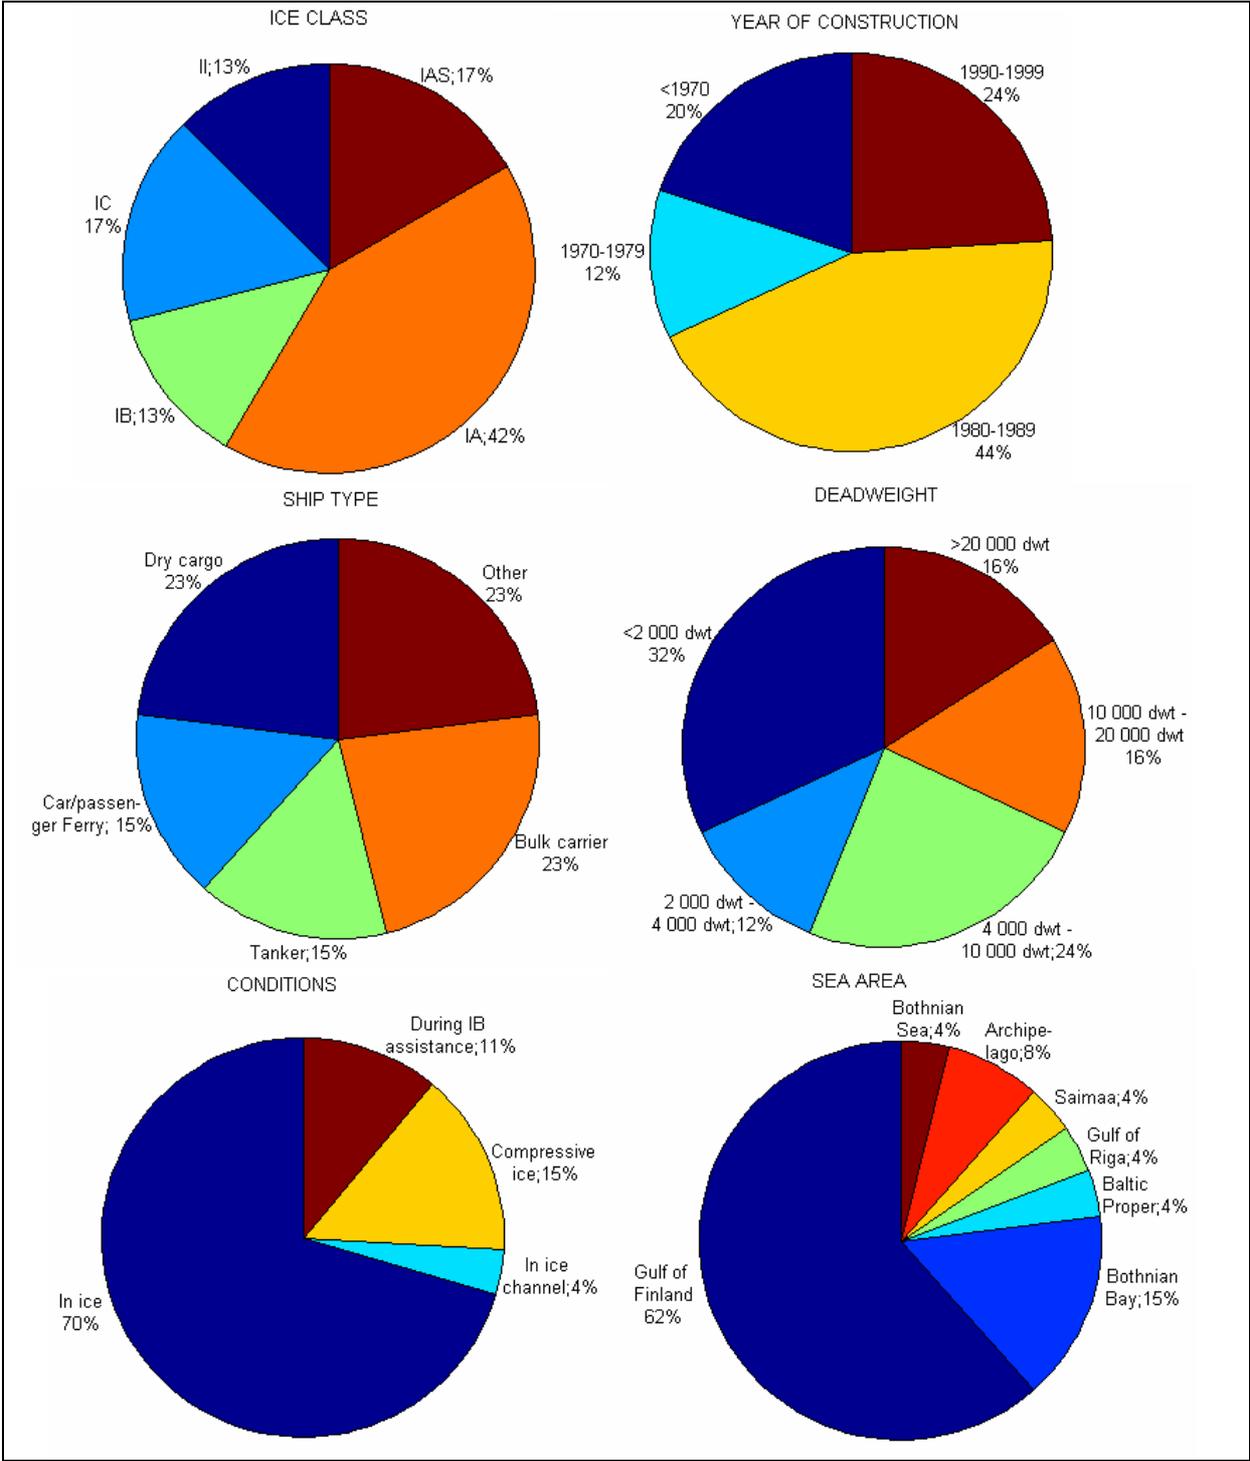
A summary of ships and ice conditions during the incidents is presented in Figure 27. Approximately 43 % of the damaged ships belong to ice classes II, IC and IB. The average age of the ships is 21 years and the average deadweight is 12 800 dwt. The same figures for all ships that visited Finnish ports during the winter season are 15 %, 16 years and 8 100 dwt. The amount of bulk carriers is 23 %. The same figure among all ships that visited Finnish ports is 4 %. Hull ice damages in ice channel are a bit more rare compared to all damage statistics. About 15 % of hull damages occurred in compressive ice field.

Figure 27. Information of ships having hull ice damages.

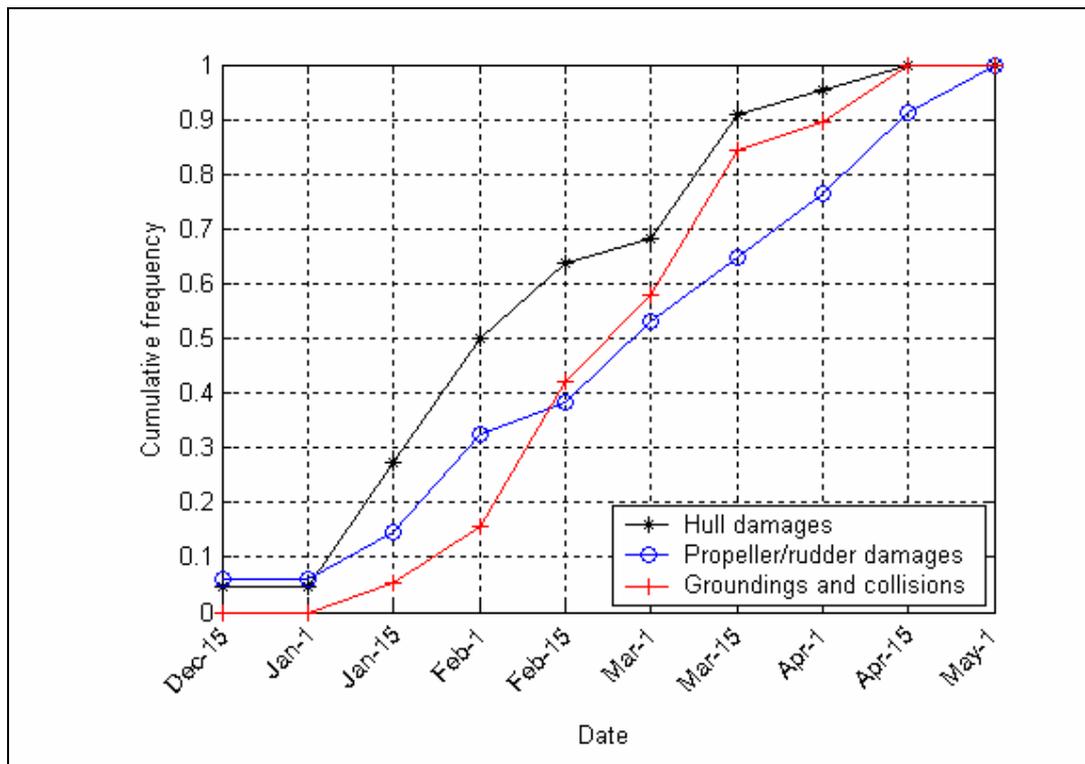
Cumulative frequencies of ice related damages as a function of time are presented in Figure 28. Most of the hull damages have occurred in the early winter. Approximately 65 % of the hull damages occurred between December 2002 and February 15th 2003. The probable reason for hull damages during early winter is that operational restrictions for ships belonging to lower ice classes were not yet placed. The other possible reason is that the ice extent and ice concentration are much lower during early winter. This means that ice moves more freely due to winds and currents. Local ice conditions can change more quickly and there is a higher risk for ships subjected to a compressive ice field. Most of the collisions, groundings, propeller and rudder damages occurred in heavy ice conditions between February and March.

Figure 28. Cumulative frequencies of the hull and the other damages as a function of time.

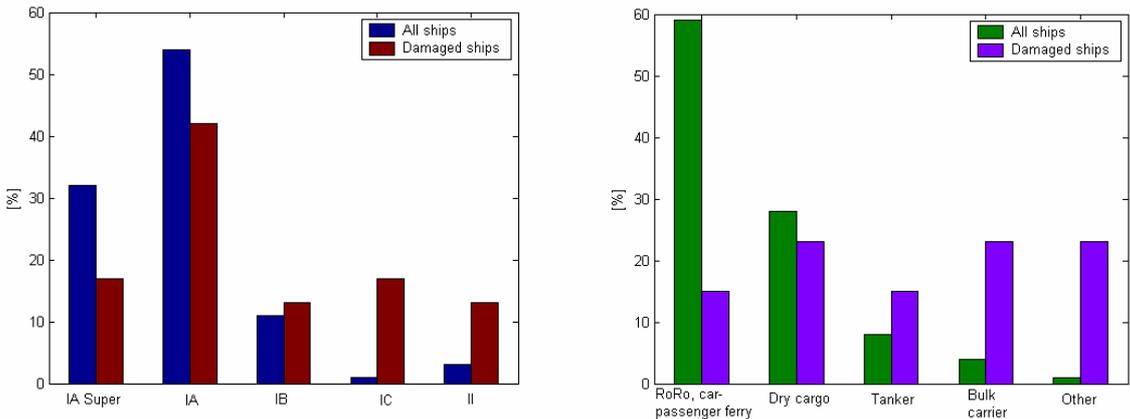
Figure 29. Comparison of ice classes and ship types of damaged and undamaged ships.

According to Figure 29, 85 % of the ships that visited Finnish ports were ice class IA or IA Super and 15 % were ice class II, IC or IB. Of the damaged ships, 58 % were ice class IA or IA Super and 42 % were ice class II, IC or IB. If we assume that during 1 % of the voyages an ice damage occurs, we get a damage probability (damages/voyage x 100 %) $58/85 \times 1 \% = 0.68 \%$ for ice classes IA and IA Super and $42/15 \times 1 \% = 2.8 \%$ for ice classes II, IC and IB. This means that ships belonging to lower ice classes suffer structural ice damage approximately four times more likely than ships having ice classes IA and IA Super ($2.8 \% / 0.68 \% = 4.1$).
